DATE: February 10, 2000

**SUBJECT:** 275 Ton Reducing Gear Shaft Key

**SERIAL NUMBERS:** 062,071,076,111,116,124,132,138,139,144

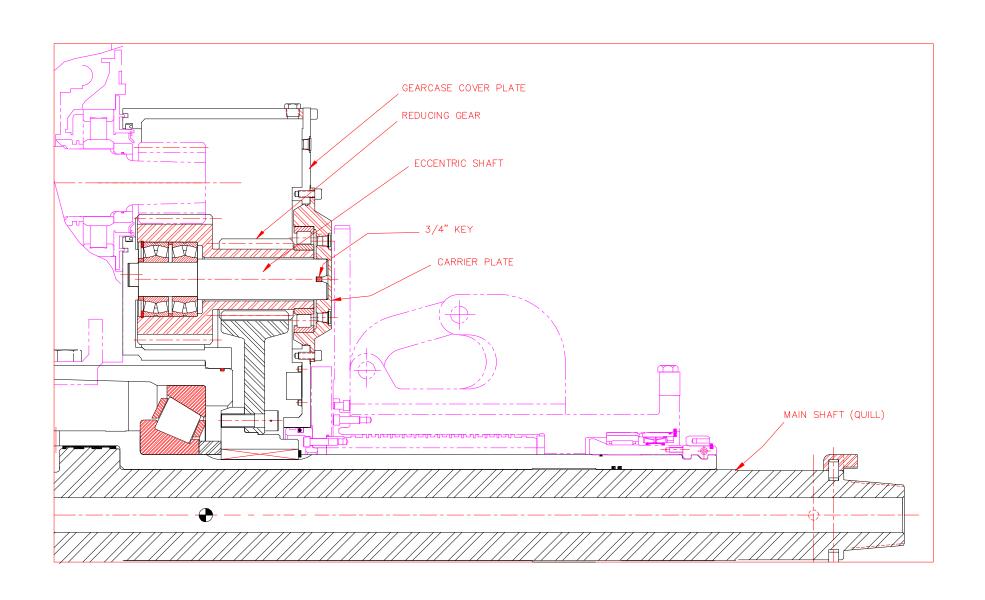
**DISCUSSION:** It may be possible on some 6.39 and 9.38 ratio 275 Ton Top Drives for the

reducing gear eccentric shaft key to break allowing the reducing gear to become mis-aligned. This may lead to a failure of the traction motor shaft. The key is located in the 'reducing gear carrier plate' bolted on the front face

of the main gearcase lid (see attached drawing).

**RECOMMENDATION:** The Carrier Plate and Eccentric Shaft design have been modified to

accommodate a ¾" square key instead of the 3/8" key. To avoid possible damage to the Top Drive, it is recommended that these components be changed at the rig's earliest convenience. The Carrier Plate (P/N 966-16-0), Eccentric Shaft (P/N 966-12-0) and ¾" key (P/N DT11320) may be supplied at no charge provided that the old parts are returned to Canrig in Magnolia,

Texas. Shipping and handling costs will be born by the customer. Alternatively, modification drawings can be supplied by Canrig for the

conversion of the existing parts.
