## **SAFETY ALERT**

| SUBJECT: | Guide Runner Adjuster Bolts |
| SERIAL NUMBERS: | 014-185 |

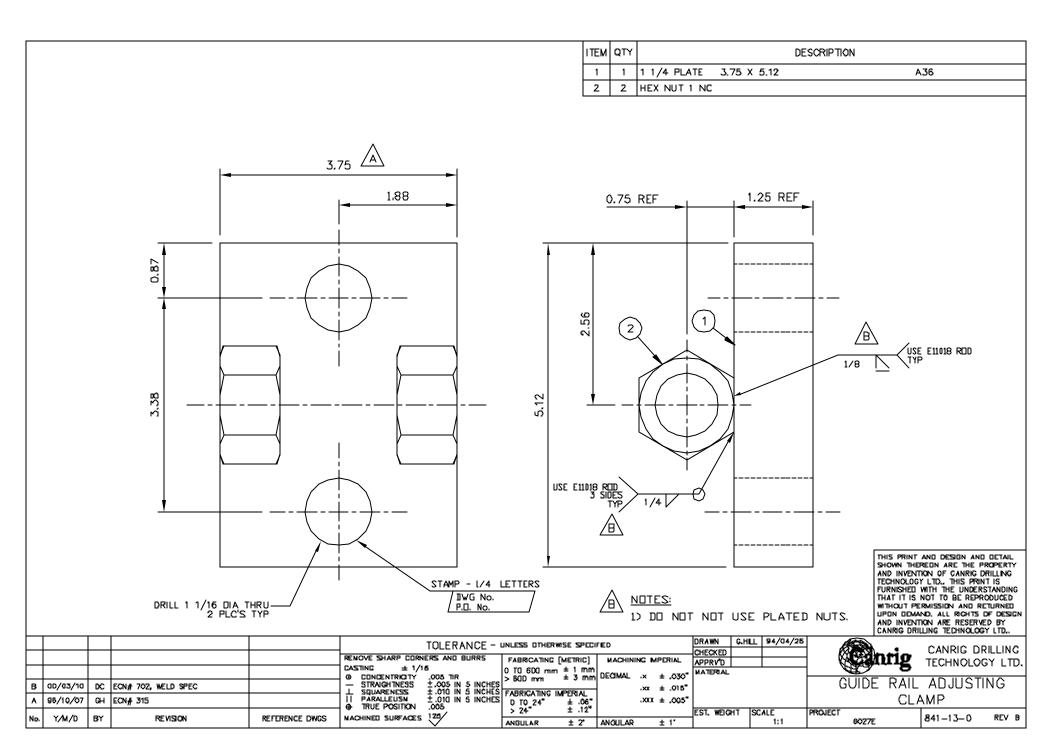
| SUBJECT: | Guide Runner Adjuster Bolts |
|---|---|
| DISCUSSION: | A near-miss incident was experienced when an adjuster bolt broke loose and<br>fell from the Top Drive. The weld that held the nut of the adjuster bolt in<br>place failed and caused the part to separate from the adjuster plate.<br>Investigation showed that the nut was only welded on two sides |

| SUBJECT: | Guide Runner Adjuster Bolts |
|---|---|
| RECOMMENDATION: | <i>Inspect each adjuster nut for penetration welds on all four sides of the</i><br><i>nut.</i> If you find any nuts that do not have adequate welding, upgrade the<br>welding to match the specification (see attached drawing) or order the<br>appropriate number of adjuster plates to rectify the situation.<br>The part number for the adjuster plates is as follows: |
| | 275 Ton<br>Rail Adjuster Plate – 841-37-0, TD Adjuster Plate – 841-39-0 |
| | 350/500 Ton<br>Rail Adjuster Plate – 841-12-0, TD Adjuster Plate – 841-13-0 |
