SAFETY ALERT

DATE: July 22, 2003
Revision 1

SUBJECT: Back Up Wrench Inspection

SERIAL NUMBERS: 002 and up

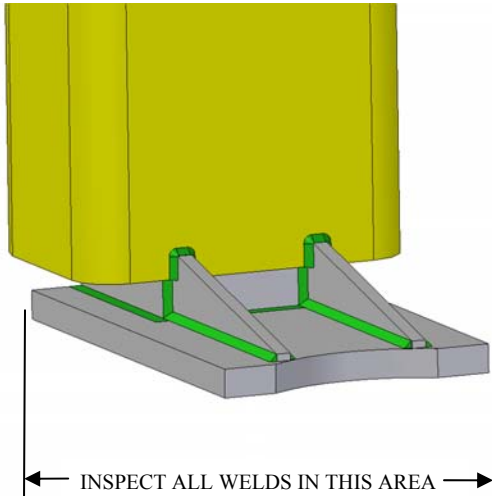
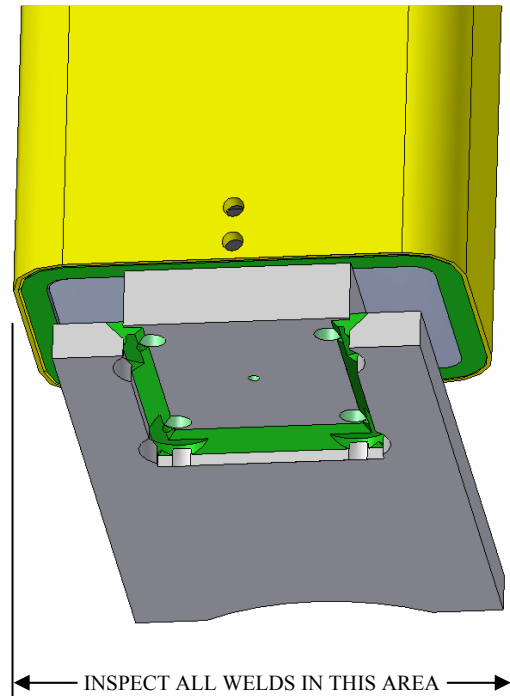
INSPECTION INDICATION MAP

Back Up Wrench Slide

Method: Dry Magnetic Particle method in accordance with ASTM E709

Visual Examination: Visually examine all other areas not designated as MPI for signs of fatigue.

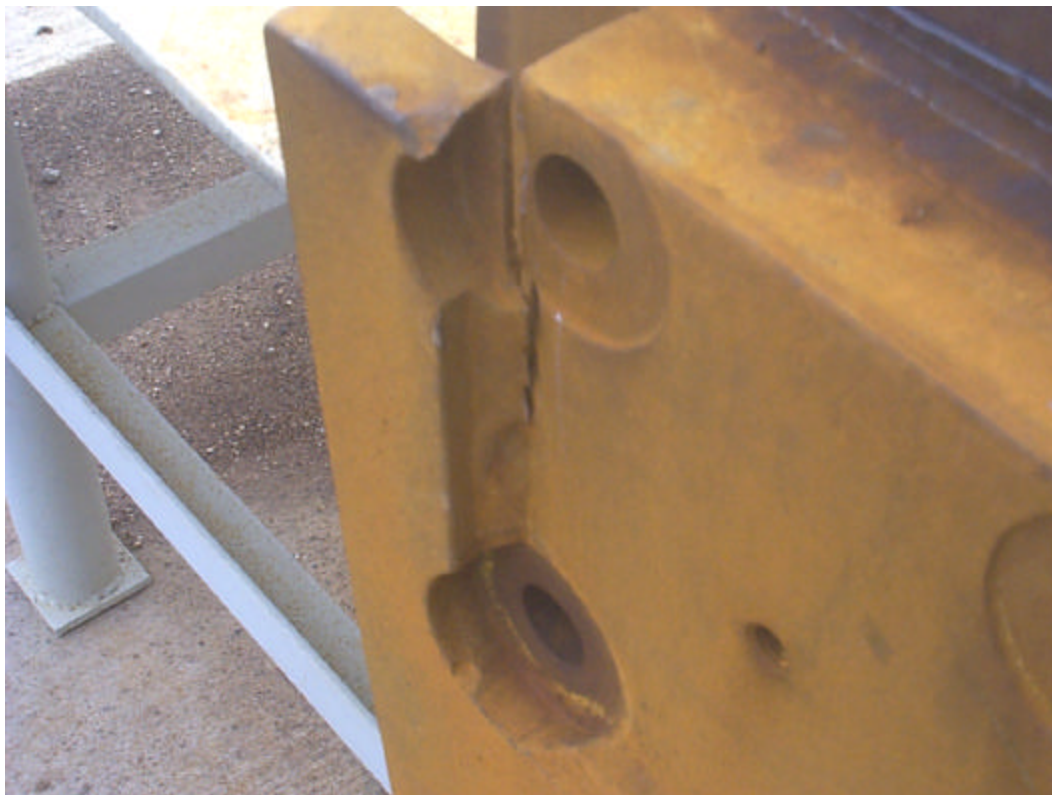
Figure 1: Typical Crack in a Slide

The slide is generally cracking at the weld joining the slide's bottom plate (1) to the center block (2) that is welded to the inner tube as shown below in Figure 1.

If the bottom plate weld has a crack and is NOT bent in excess of 1/8", use the following procedure to repair the cracked weld:

1. Remove the existing weld in the area where the crack is present, down to the base material using grinding or gouging method. To make sure that the crack is completely removed, it is necessary to grind past the visible crack.
2. Dry- MPI (Magnetic Particle Inspection) the crack area completely by going past the end of the visible crack. Ensure that the crack is completely removed.
3. If it was found that the crack was not completely removed or a new crack was discovered, grind the crack completely and Dry-MPI the area again to ensure that the crack is completely removed.

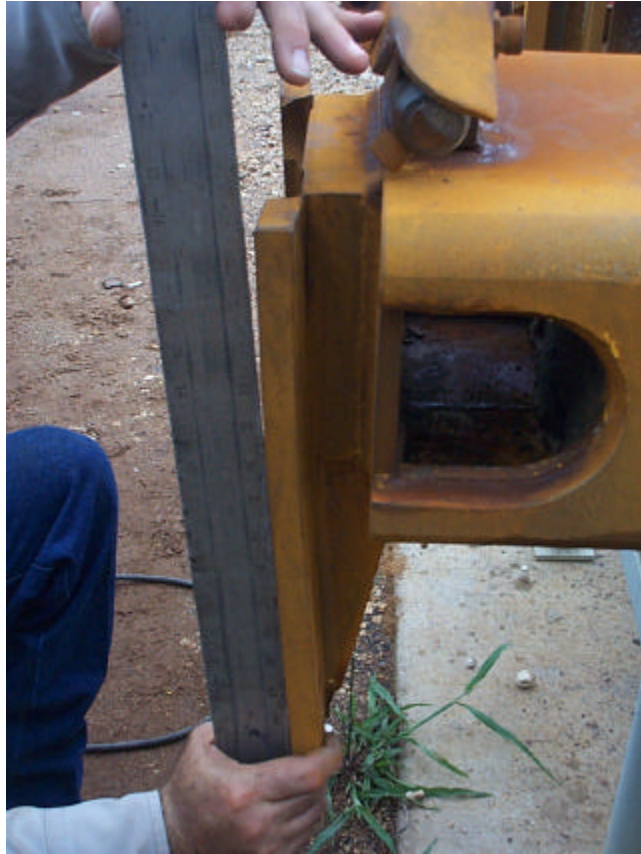
Figure 2: Bent Bottom Plate

The cause of the crack may result in bending the slide's bottom plate (1). **The BUW inner tube assembly must be replaced if the bottom plate is bent in excess of 1/8".** To check the slide's bottom plate, use a straight edge and place on the bottom of the slide as shown in the picture of Figure 2.

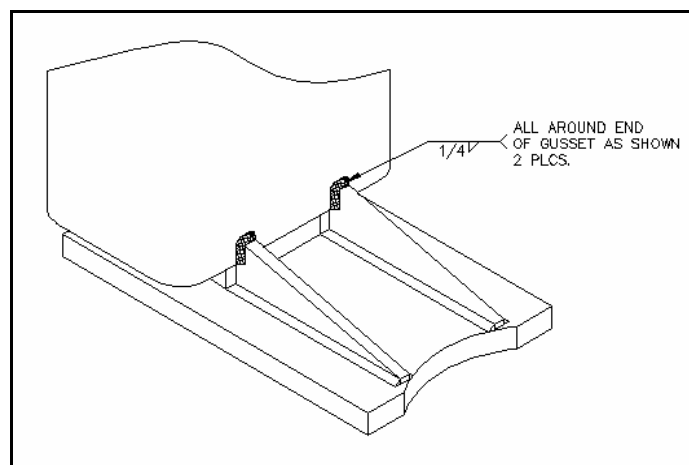
Figure 4: Gusset Weld

Cracks in the BUW Slide Gusset welds must be repaired as follows:

1. Remove the existing fillet weld around the top of the gussets (3) where they are attached to the lower end of the inner tube (4) using grinding or gouging method. It is essential that the cracks are completely removed.
2. Dry-MPI the crack area completely to ensure that the crack is completely removed.
3. Make a 1/4” fillet weld around the top end of each gusset where it attaches to the end of the inner tube as shown in figure 4. Use Low Hydrogen E7018-3/32” or E7018-1/8” welding rods or equivalent (see Notes).

4. Dry-MPI the weld to ensure that there are no cracks in the weld.

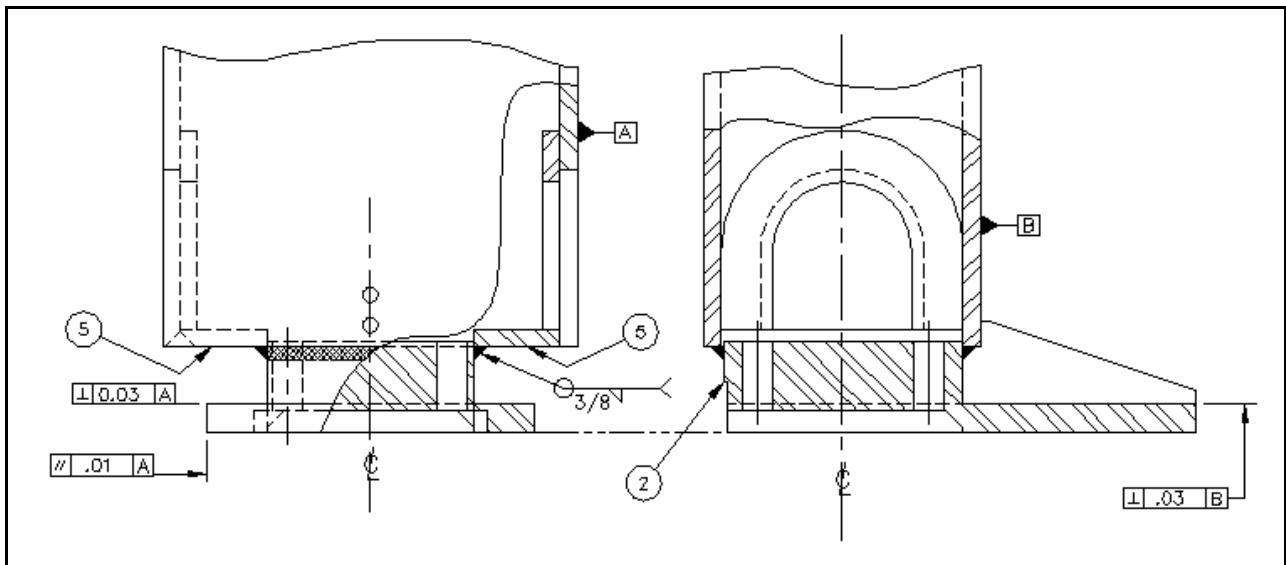
Figure 5: Slide/Inner Tube Joint

Cracks in the weld joining the Slide's center block (2) to the inner tube must be repaired as follows:

1. Remove the existing fillet weld where the crack is present down to the base material using grinding or gouging method. It is essential that the crack is completely removed.
2. Dry-MPI the crack area completely by going past the end of the crack to ensure that the crack is completely removed.
3. Make a 3/8" fillet weld using Low Hydrogen E7018-1/8" rod or equivalent (see Notes) along the prepped area as shown in figure 5.

4. Dry-MPI the weld to ensure that there are no cracks.

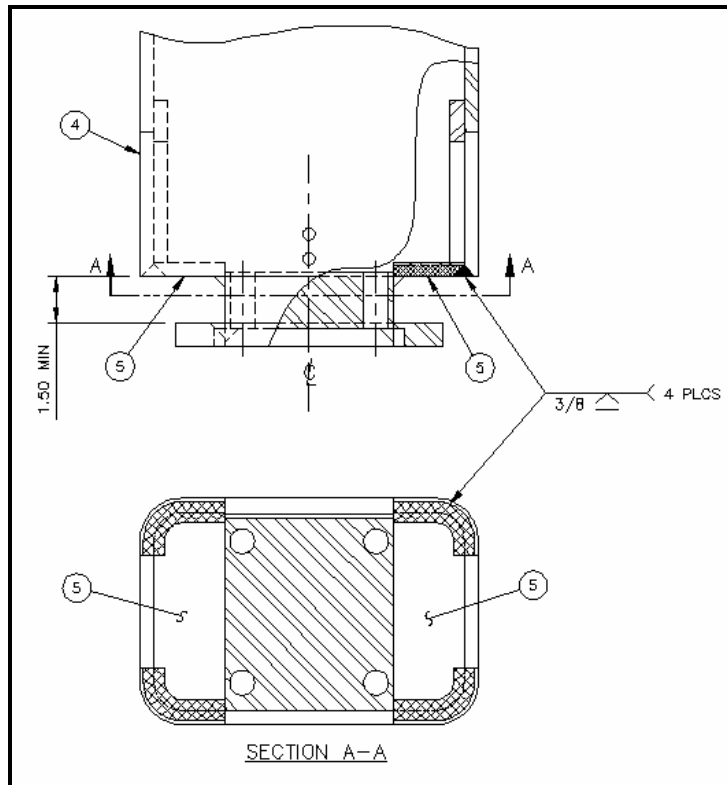
Figure 6: Inner Tube/Strips Weld

Cracks may occur at the lower end of the inner tube where it is welded to the two strips (5). For illustration see figure 6. This type of crack must be repaired as follows:

1. Remove the existing weld in the area where the crack is present down to the base material using grinding or gouging method. Make sure the crack is completely removed.
2. The inner tube end and the plate must be prepped properly with 3/8" bevels as shown in figure 6.
3. Make a 3/8" weld (double bevel) using Low Hydrogen E7018-3/32" or 1/8" welding rods or equivalent (see Notes).
4. Grind the weld flush with the base material to maintain the 1.5" distance between the end of the inner tube and the top of the slide plate as shown in figure 6.

5. Dry-MPI the weld area to ensure that there are no cracks in the weld.
