SAFETY ALERT

DATE: July 28, 2003

SUBJECT: Back Up Wrench Cylinder Clevis Backing Out

SERIAL NUMBERS: 002 and up

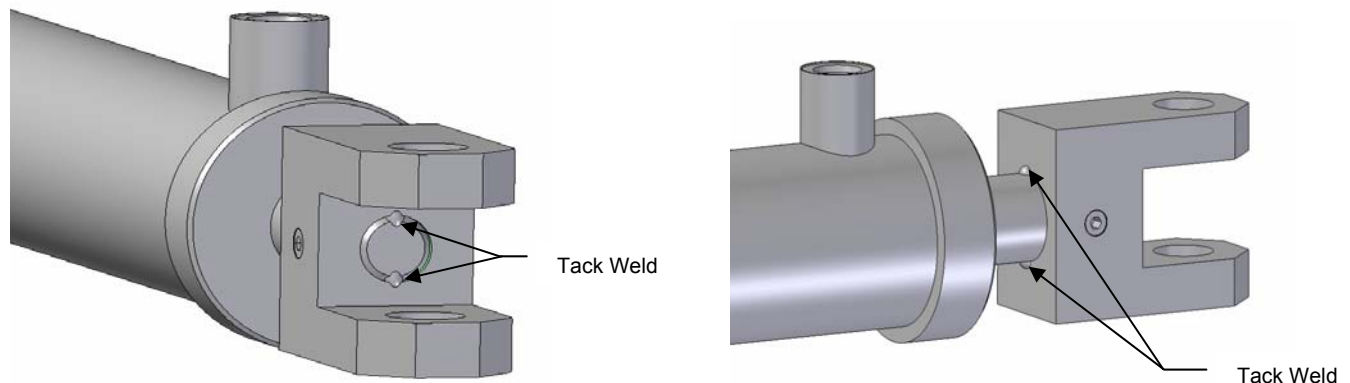
DISCUSSION: It has been reported that the Back-Up Wrench Cylinder rod is coming loose from the clevis; thus allowing the inner tube assembly to drop. It appears that the setscrew that prevents the cylinder rod from rotating had come loose and allowed the rod to unscrew off the clevis.

To prevent the cylinder rod from rotating against the clevis and coming loose, it is recommended that a **"TACK WELD"** be applied to the clevis and the cylinder rod as shown in the figures below. The tack weld length must be 0.25 to 0.5" long. Low Hydrogen welding rods 11018 or 7018 must be used for this tack welding. Pre-heating and post heating are not required when tack welding.
