Safety Alert

SUBJECT: Torque Guide – Casing Entrapment

SERIAL NUMBERS: All Portable Torque Guides on TD serial numbers below 270

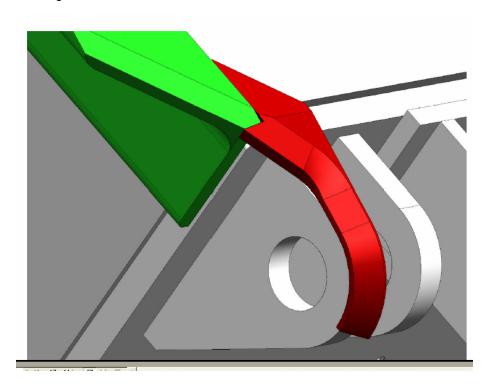
DISCUSSION: A near miss incident was reported, when a joint of casing got caught on an

edge of the bottom of section 2 and subsequently fell to the floor due to breakage of the lifting sling. Although this was considered an unusual accident, CANRIG has developed an additional guard to the hinge point on

the bottom of section 2.

Further, CANRIG has developed an additional guard that can be installed at the joint of section 2 to decrease another possible pinch point as per the attached drawings. Please order DT14141 and weld as shown on the

drawing.

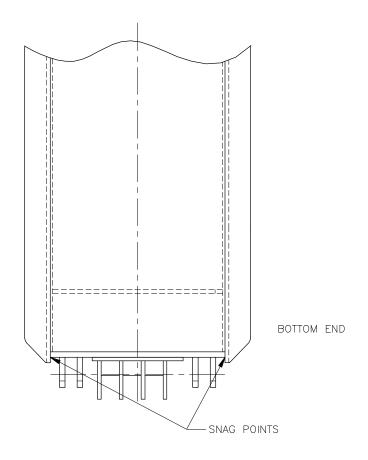
EXISTING SECTION 2

DISCUSSION: When running casing, angles on the Torque Guide Section 2 can be a snag

hazard if using a pick-up/lay down machine to push the casing.
