Safety Bulletin		
No: SB036	Rev: 1	Date: 01 Sept 2010

Retrofit – Add Torque Limiting Mechanism to Casing Drive System Link Tilt Assembly

Tesco Corporation 5616 – 80th Street SE Calgary, AB. T2C 4N5 Phone: (403) 723-7902 Fax: (403) 723-7826 www.tescocorp.com

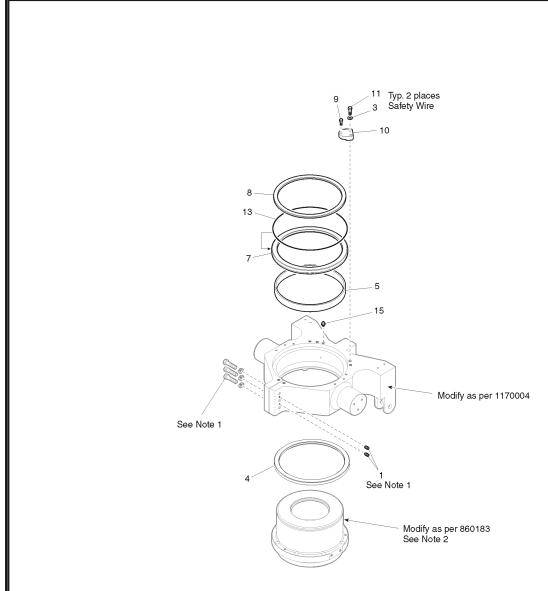
Drawing # I-860197

In the event of a Casing Drive System (CDSTM) actuator bearing failure that results in complete bearing seizure, the CDS link tilt hanger and links have the potential to rotate with the top drive quill if the CDS anti-rotation bracket fails. To address this safety concern, TESCO has created a retrofit kit to add a torque limiting breakaway system on the CDS link tilt assembly. The CDS link tilt breakaway system addresses the hazard of a rotating CDS link tilt system by providing a mechanical "fuse" that will fail before the CDS anti-rotation bracket.

A second version of the shear pin made of 4140 steel was introduced to replace the previous brass shear pin, after extensive field tests in April 2010.

- Ensure Socket Head Capscrews are 4-5 turns loose, and adjust Jacking Set Screws (item 1) to permit Carrier Installation.
 Apply Loctite 243 to items 1. Adjust until Carrier rotates without binding.
 Turn in Set Srews additional 1/4 turn clockwise each.

- Apply Loctite 243 to Socket Head Capscrews and torque to 25 ft-lbs each.
 Confirm free rotation of Carrier.
- Adjust Capscrews and Set-screws if required.

Note 2: If Top Cap rework interferes with Actuator Nameplate, remove Nameplate and install new Nameplate (Part # 860184) using Drive Screws (Part # 14439, quantity 4).
