Safety Bulletin			Tesco Corporation 5616 – 80th Avenue SE		
No: SB094	Rev: 0	Date: March 19, 2015		Calgary, Alberta, Canada T2C 4N5 Tel: 1-877-TESCO-77 (North America)	
Dropped Casing Incident Due to Incorrectly Making Up Casing Connection			Tel: 1 (7 Tel: 1 (7 Email: k www.te:	Tel: 1 (713) 359-7195 (AMSS 24-hour support) Tel: 1 (713) 359-7295 (International) Email: bulletins@tescocorp.com www.tescocorp.com www.tescoparts.com	
☐ Internal Us	se Only	✓ External Use	☐ Mandator	y Recommended

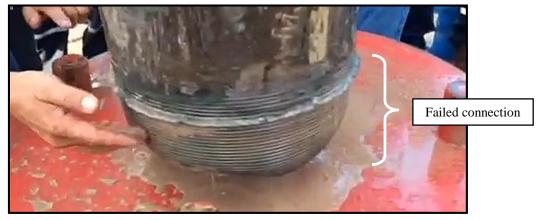
Figure 1: Failed connection on casing joint

- The coupling was not made up to the base of the triangle mark, therefore not all of the threads were engaged.
 When the casing string, which weighs approximately 267,000 lbs. (4900 ft. of 54.5 ppf. casing), was hanging
 off from the coupling, the engaged threads were "stripped out", causing the casing string to drop.

- 2. Since the threads were not engaged properly, the coupling was welded by the customer to the casing to increase the strength of the connection. However, the added weld was not sufficient enough to make up for the lost strength of the threads that were not engaged. Welding on the casing without a proper weld procedure and a properly controlled environment is not an acceptable industry practice. The weld would have adversely affected the metallurgical properties of the casing material in the heat-affected zone. The higher the grade of the casing, the worse this effect would be.

If a scenario arises similar to the one described above, all employees are empowered with full authority to stop any job they believe is being performed with compromising safety. This not only helps ensure employee well-being, but it also establishes field-wide responsibility for the safety of all operations.

The Stop Work Authority (SWA) gives every employee both the authority and the responsibility to stop work when unsafe acts or conditions are observed. When the Stop Work Authority is instituted, work must be stopped immediately. The proper management personnel must then be notified and the unsafe conditions must be corrected before work can resume.

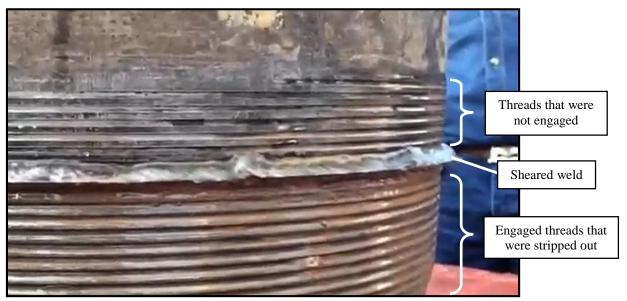
Figure 2: Casing threads that were not engaged and threads that were stripped out
