<b>Safety Bulletin</b>

<p>Tesco Corporation 5616 – 80th Avenue SE Calgary, Alberta, Canada T2C 4N5 Tel: 1-877-TESCO-77 (North America) Tel: 1 (713) 359-7195 (AMSS 24-hour support) Tel: 1 (713) 359-7295 (International) Email: bulletins@tescocorp.com www.tescocorp.com www.tescoparts.com</p>
<b>No: SB099</b>	<b>Rev: 0</b>	<b>Date: August 26, 2016</b>	
<b>Accidental Overload on Elevator Links</b>			
<input type="checkbox"/> Internal Use Only <input checked="" type="checkbox"/> External Use			<input checked="" type="checkbox"/> Mandatory <input type="checkbox"/> Recommended

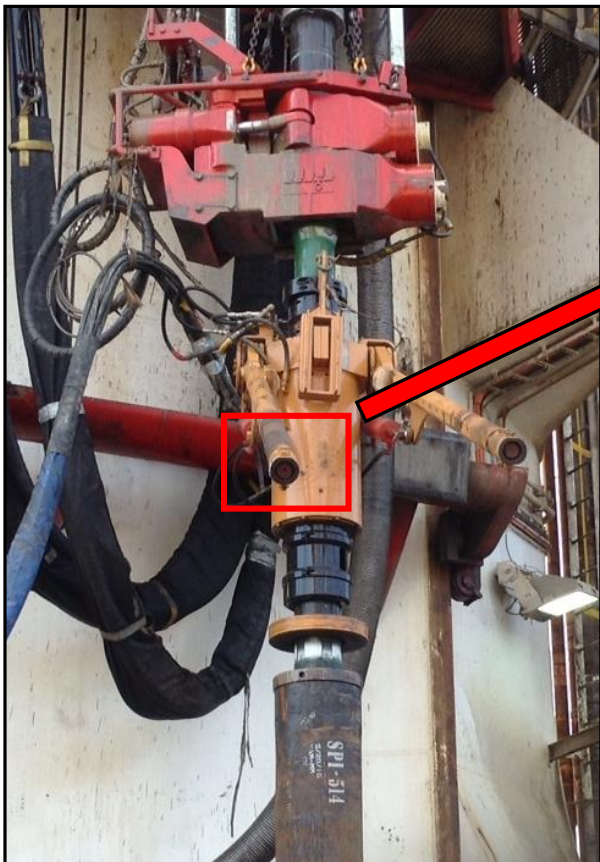
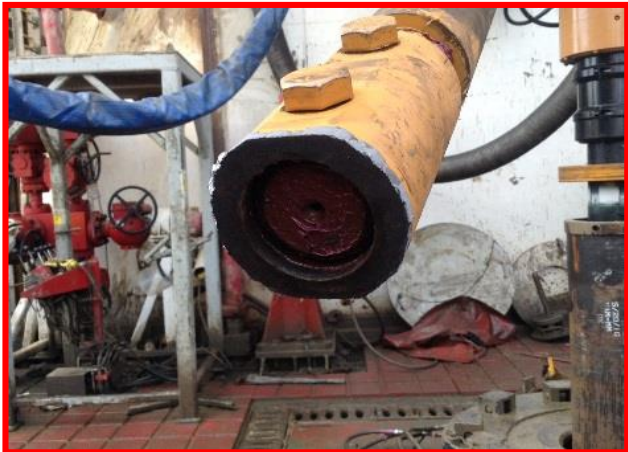
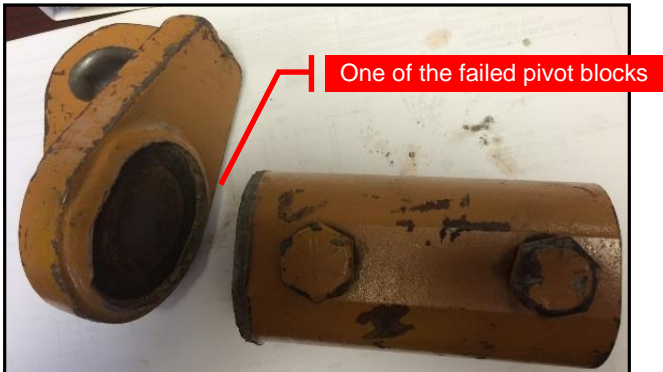
While running a two-step (VAM SLIJ II) connection casing in the well for an offshore rig using the Tesco Casing Drive System™ (CDS™), the 14" casing stand hanging in the single-joint elevator was lowered into the 14" casing string set in the rotary. The pin connection did not set into the box connection properly and hung up on the two-step threads. The driller began to lift the stand to reset the connection but it hung up on the partially engaged threads, causing a load of 40,000-lb on the CDS link tilt system. The welds on both of the CDS link pivot blocks sheared causing an uncontrolled drop of the elevator. The elevator slid along the casing and landed on the slips. No injuries were reported. The job was halted and a secondary tool was used to complete the job.

The investigation into the incident found that the CDS links and elevator performed as designed but was overloaded more than three times the working load limit.

A typical overload condition happens when the complete string is unintentionally lifted with the CDS single-joint links and elevator. One example is where a casing joint is lifted out of box to reset the connection as described in this incident above. The threads may be partially engaged causing the load to transfer to the casing string. This is particularly prevalent in two-step connections with “hooked” threads such as the VAM SLIJ II connection. Whenever casing with this type of threads are run, follow these steps to ensure this does not occur. The steps must be incorporated into local operational procedures.

1. While a single-joint casing or stand is lifted out of the box for any reason, the casing must be rotated anti-clockwise until the threads are completely disengaged even if the casing joint is just dropped into the box without making up or partly making up the connection.
2. Do not lift the casing joint out with the single-joint elevator and links. Instead, stab the CDS into the casing joint and rotate it anticlockwise until the thread is completely disengaged.
3. Stay out of the “red zone” and follow the safety policies of the rig.
4. Use an appropriate pipe guide on the casing stump to ensure the casing is centered when it is stabbed into the box.
