PRODUCT: TM-80

Orientation of spinner roller seals

Canrig Wrench Product Bulletin

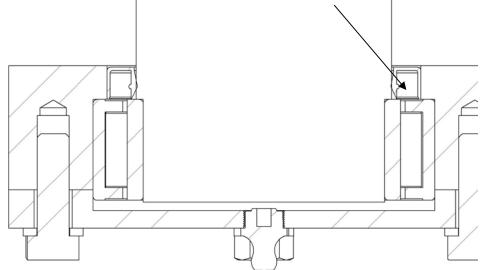
CANRIG has discovered that early production units of the TM-80 may have had the grease seals installed upside down. This prevent excess grease and pressure from exiting the cavity and may eject the seal or push the roller shaft up.

WRONG WAY TO INSTALL THE SEAL, CAVITY FACING DOWN

Check seal orientation by greasing spinner roller shafts, grease should come out under rollers. If not the seal is installed upside down, unscrew grease nipple to release excess pressure.

Contact CANRIG to ship 4 of seal P/N S10104 and 4 of bearing P/N M10644 See DWG # 188200005 for installation instructions.

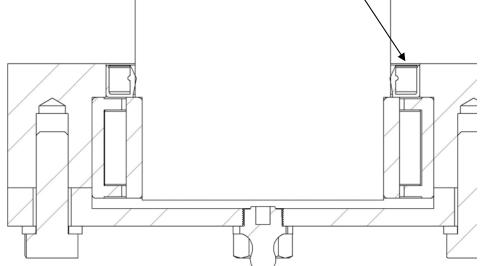
RIGHT WAY TO INSTALL THE SEAL, CAVITY FACING UP

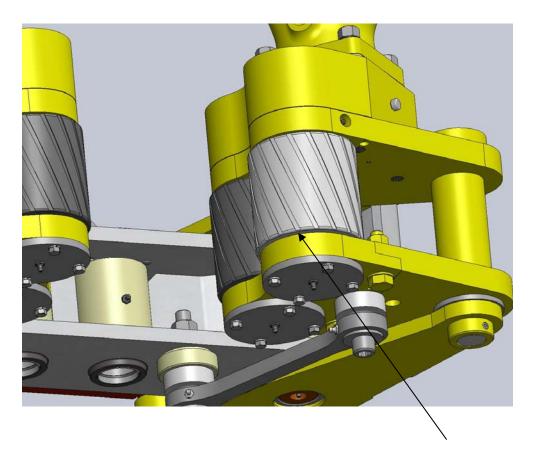
## GREASE SHOULD BE VISIBLE UNDER ROLLER
