Change Bulletin

No: CB004

Description: EMI 400 Load Collar Update

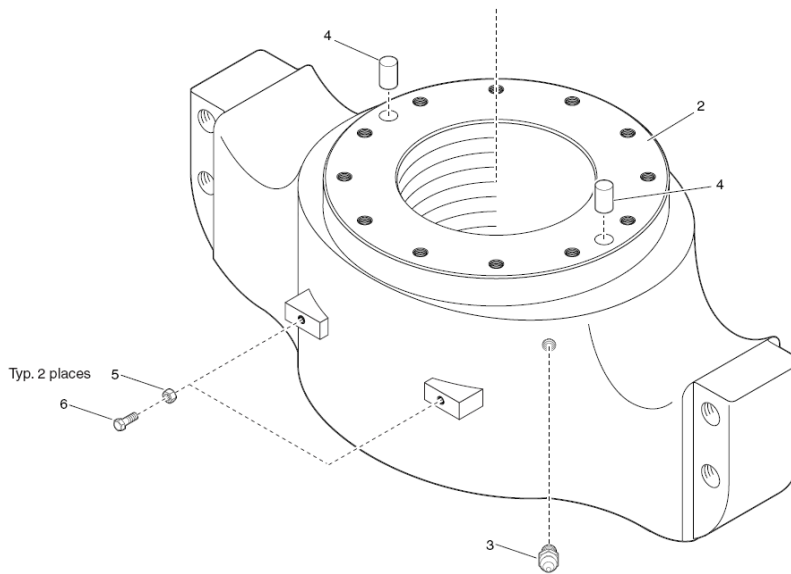
In order to provide better stabilization of the EMI 400 load collar (PN 13392), two bolts have been added to the load collar to provide a bearing point against the upper grabber leg. Figure 1 below shows the location of these bolts. The modification includes the addition of two 1/2" UNC x 1-1/2" deep threaded holes to the bosses on the load collar. Two 1/2" x 1-1/2" cap screws (PN 0983) and two 1/2" jam nuts (PN 3157), shown as items 5 and 6 below, are then used to provide a bearing point. Please refer to drawing 30001081 rev. 9 for complete specifications. This change is documented fully by ECN 084-0005.

Figure 1 – Bolts added to load collar for stabilization

1. Drill and tap two holes in load collar as per Drawing 30001081 rev. 9.
2. Install bolts and jamb nuts as per illustration 13392 (and shown above in Figure 1) using Loctite 243.
3. Adjust depth of bolt to provide 1/16" space between bolt heads and grabber leg as shown in Figure 2 below, torque jam nut to 50 ft-lb.

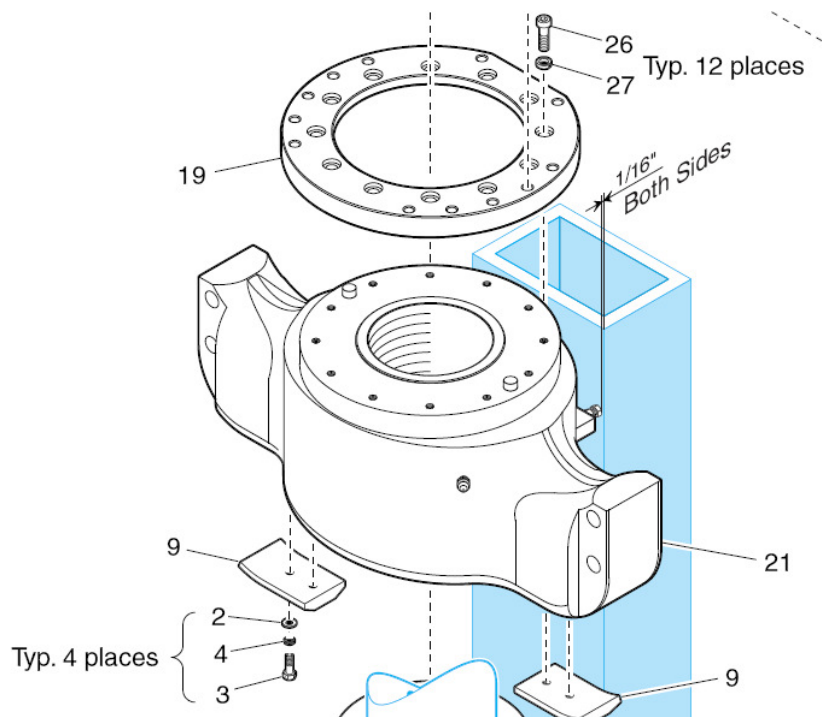
Figure 2 – Adjustment of bolt protrusion
