Change Bulletin

No: CB006

Description: EMI Quill Spline Lock Collar

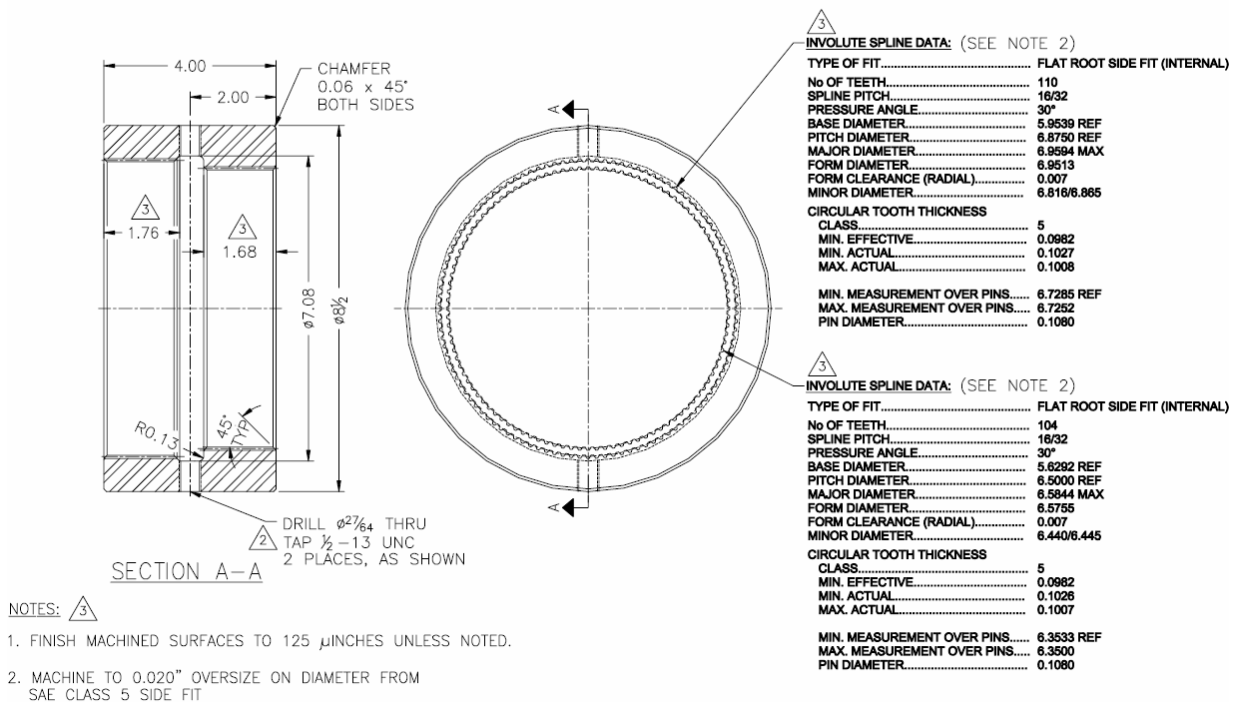
Figure 1 – Revised Lock Collar Dimensions

The quill spline lock collar (Tesco P/N 11315) that is used on the EMI 400 and EMI 450 series of top drives was manufactured with a tight spline fit. To improve the ease of installation, the spline dimensions have been modified to include a 0.020 inch oversize on diameter to provide a looser fit. The groove that separates the two splined sections has also been increased in width to improve manufacturability. These modifications are documented in Engineering Change Notification 084-0012. Figure 1 below shows the updated dimensions for the quill spline lock collar; please refer to drawing 30001101 rev. 3 for complete specifications.

If the checks above do not reveal any problems then the spline lock collar should be replaced with one of current manufacture. Alternately, the existing collar may be reworked to the dimensions shown in Figure 1 (ref. drawing 30001101 rev. 3), if required.
