Change Bulletin

No: CB010

Date: March 22, 2007

Description: Bonnet Access Window and Bonnet Bolt Length Change

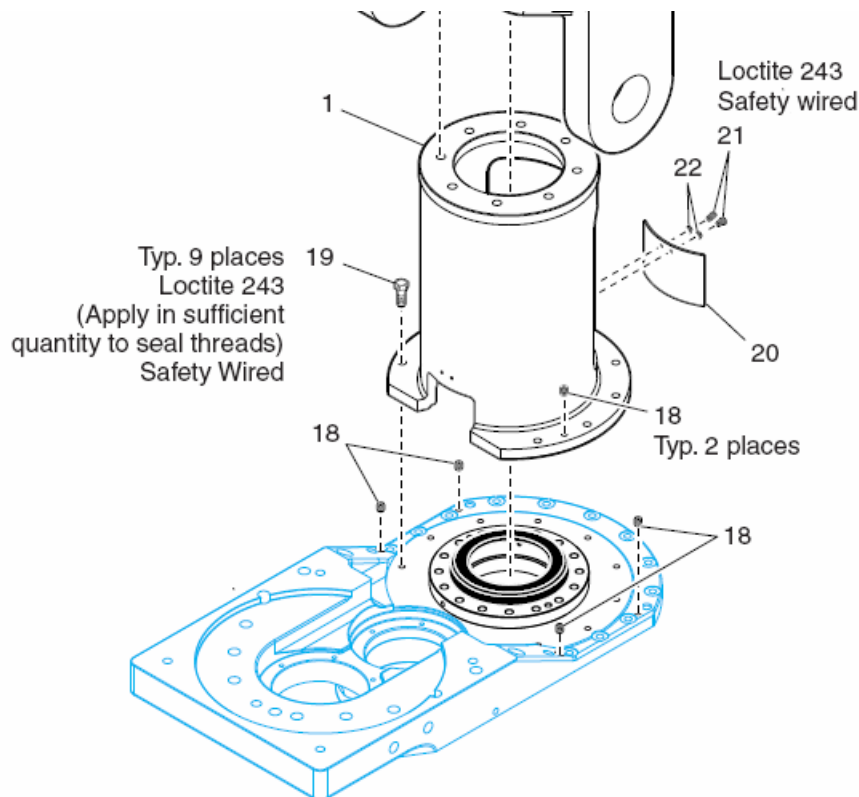
Figure 1 – Bonnet Access Window (Split Block version shown)

An access window and removable panel has been added to the bonnet on the EMI 400. This change will allow better access to the fittings on top of the gearbox that make up part of the gearbox lubrication system. Figure 1 shows the location of the access window in the bonnet (Item 1) and the removable panel (Item 20).

The bolts that were used to connect the bonnet to the gear box lid (Item 19) were originally specified as 1/2"-13UNC x 1-1/2". The combined thickness of the bonnet flange and flat washer resulted in a thread engagement of approximately 3/8" making this connection susceptible to failure from highly torqued fasteners or impacts to the attached components. This bolted connection has been modified to use 1/2"-13 UNC x 1-3/4" fasteners without a washer to provide an improved connection.

The bonnet access window is a non-essential upgrade that may be added to the top drive when a unit is brought into a Tesco Service Centre for routine maintenance. The modification can be made to existing units by a number of machining/cutting operations including torch cutting and grinding. Please refer to the correct drawings for the specific top drive configuration as follows,

To date only two top drives have experienced a failure of the bonnet connection. The first of these failures was directly associated with an impact event while the second was not conclusive as to cause. Given the very limited occurrence of this problem, it is recommended that the modification be performed during routine maintenance. The corrective action required is to replace the existing 1/2"-13 UNC x 1-1/2" fasteners (PN 3116) with longer 1/2"-13UNC x 1-3/4" fasteners (PN 5967) and to omit the flat washer. When applying Loctite to these bolts make sure to apply around the full circumference of the threads and in sufficient quantity to ensure a water tight seal.
