Change Bulletin

No: **CB015**

Description: Torque Bushing Assembly Upgrade

Tesco Corporation
6204 – 6A Street SE
Calgary, AB. T2H 2B7
Phone: (403) 692 5700
www.tescocorp.com

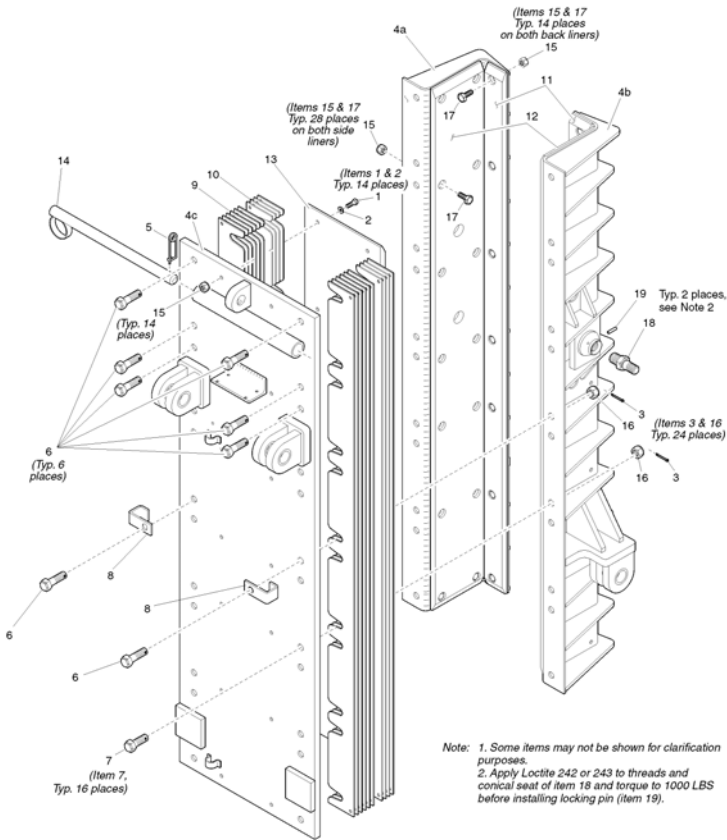
Earlier version:
 Note the bolting holes are round

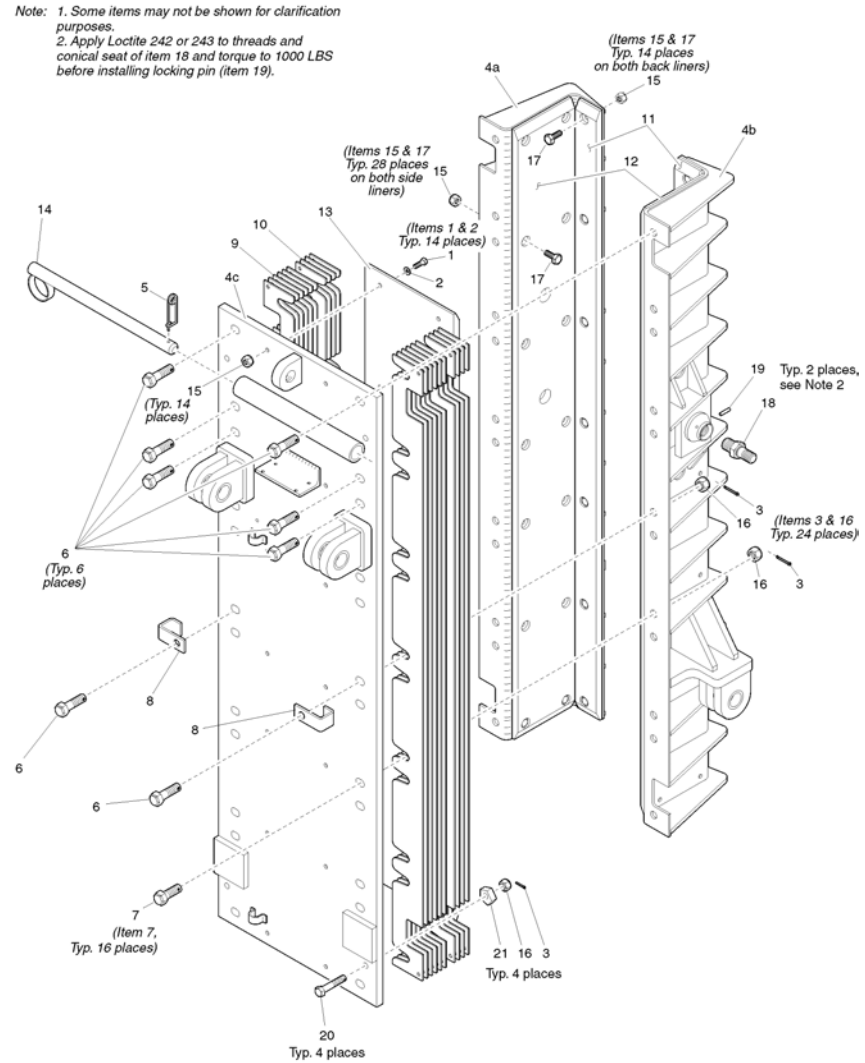
Revised version showing the slotted side plate mounting holes, notched side plates, 5-sided adjuster nuts, notched extend frame shim plates. Accumulator mount modifications are not shown but are to clear the new 5-sided adjuster nuts.

- The mounting holes for the side plates have been slotted
- Dimensioning and GD&T scheme for the front plates has been revised
- A 5-sided adjuster nut has been added to the torque bushing assemblies
- The accumulator mounts and standard pin have been modified, and the frame pads have been extended to accommodate the adjuster nuts.
