# Change Bulletin

No: CB029

## Description: Charge Filter re-plumbing

The information contained in this bulletin applies for the following Tesco products:  
#730612- Kit, Charge Filter, D4P  
Reference ECN-s 111-0074

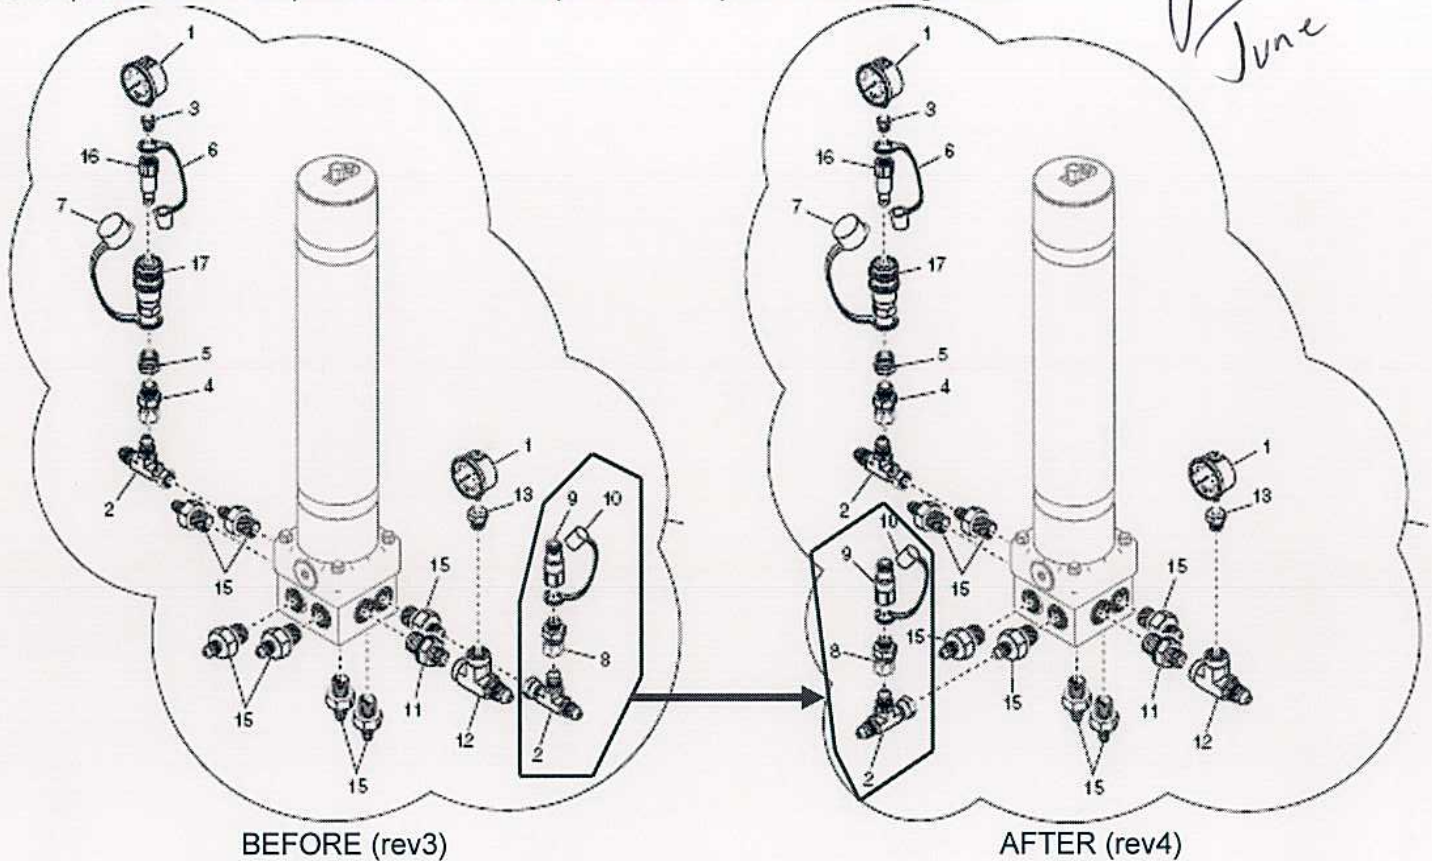
According to feed back from commissioning and engineering investigation it was revealed that unfiltered oil gets into the swash pump controller of a D4P power unit. Affected products are the D4P power units for HCI and HXI top drive systems.

Move quick connect for pilot control from IN port to OUT port of the charge filter.

Plumb according to new rev 4 level of illustration I-730612 (detail shown above).  
Hose kit connections to the charge filter (see I-730770) do not change.
