Change Bulletin

<p>Tesco Corporation 6204 – 6A Street SE Calgary, AB. T2H 2B7 Phone: (403) 692 5700 www.tescocorp.com</p>
No: CB030	Rev: 0	Date: 29 Dec 2008	
Description: Replace Nylon Locknut with Stover Locknut on EMI400 Torque Restraint

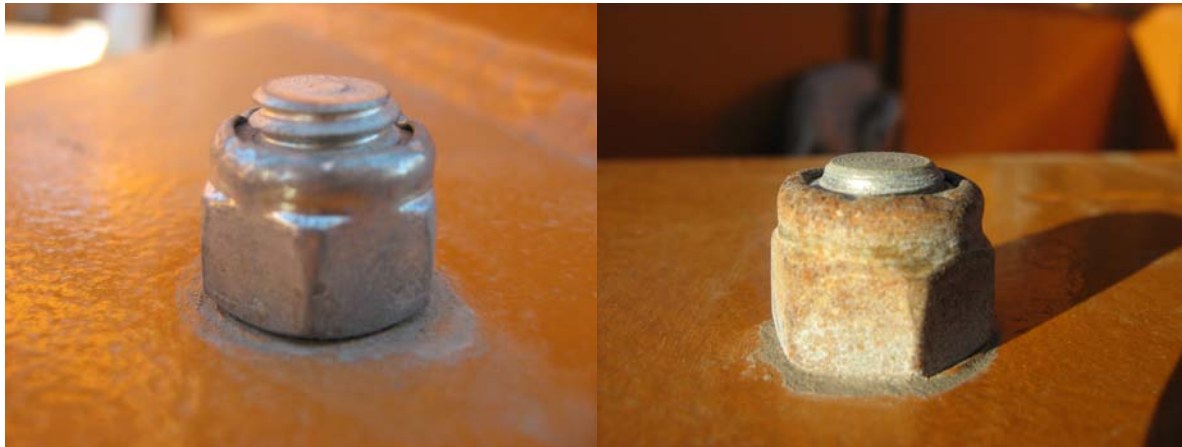
It came to Tesco’s attention that in some instances the special bolts used to mount UHMW liners to torque restraint may not have enough threads protruding through the nylon locknuts. ECN-141-0086 updated the bill of materials to use Stover locknut (Tesco#1410105) instead of nylon locknut (Tesco# 4333).

Acceptable
At least 2 threads
Protruding through nylon

Not Acceptable
Not enough thread
protruding through nylon

Nylon locknut (Tesco# 4333) was replaced with Stover locknut (Tesco# 1410105)

Nylon locknuts shall be replaced with Stover locknuts if not at least 2 threads protrude through nylon locknut.
