# Change Bulletin

No: CB037

## Description: Change Seal installation for EMI 400 Gearbox Assembly

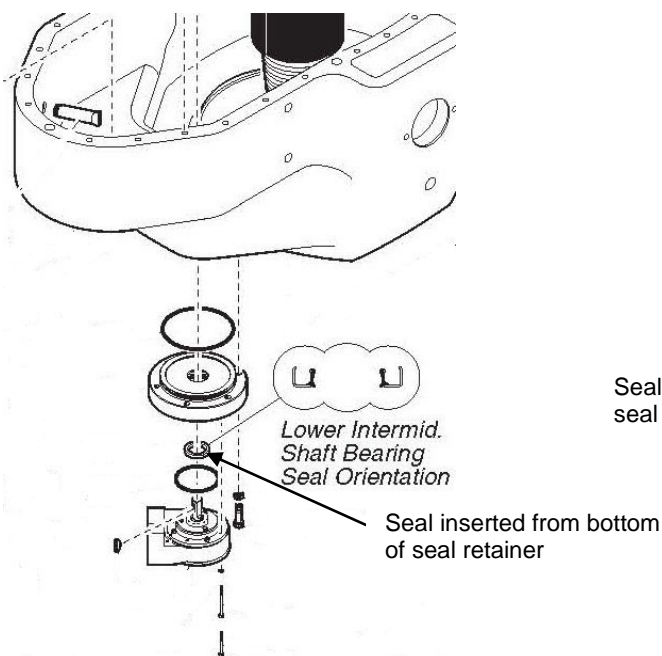
During gearbox assembly, it was noticed that tolerance stackup could result in the input shaft chamfer sitting on the edge of the seal which could cause leaks.

Figure 1: Seal Placement Before

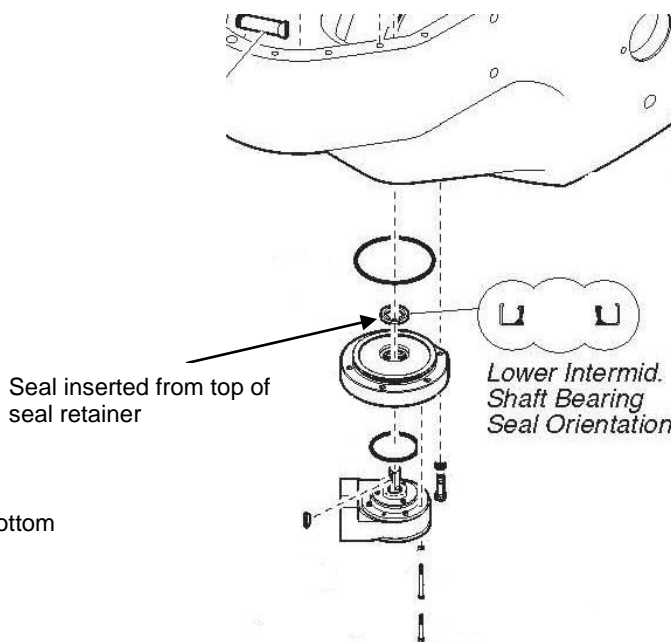
Figure 2: Seal Placement After

TESCO changed the seal retainer so that the seal is inserted from the top rather than the bottom (see Figure 1 and 2 below).
