<h1>Change Bulletin</h1>			  <p>Tesco Corporation 5616 – 80th Avenue SE Calgary, Alberta, Canada T2C 4N5 Tel: 1-877-TESCO-77 (North America) Tel: 1 (713) 359-7195 (AMSS 24-hour support) Tel: 1 (713) 359-7295 (International) Email: bulletins@tescocorp.com www.tescocorp.com www.tescoparts.com</p>
No: CB046	Rev: 0	Date: 14 Sept 2011	
<h2>Update EXI Gearbox Seal and Grease Procedures</h2>

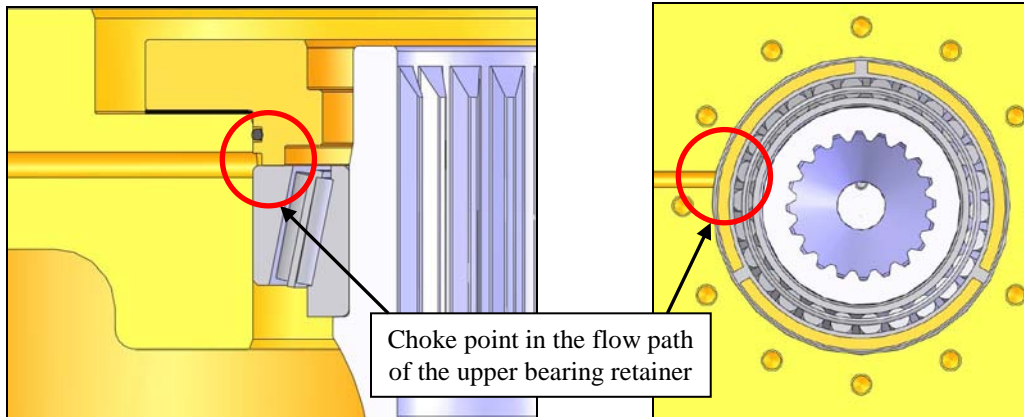
Four EXI Top Drives have been identified to be leaking gearbox oil from the upper section of the gearbox. These incidents occurred even though the top drives were operating for very short periods of time. After investigation, it was discovered that a choke point in the flow path of the upper bearing retainer (P/N 810387) caused an unwarranted increase in pressure (Figure 1 and Figure 2).

Figure 1: Upper bearing retainer (side view)

Figure 2: Upper bearing retainer (top view)

TESCO has modified the flow path for the gearbox upper bearing retainer (Figure 3 and Figure 4), removing the choke point to eliminate any reoccurrence of increasing pressure.

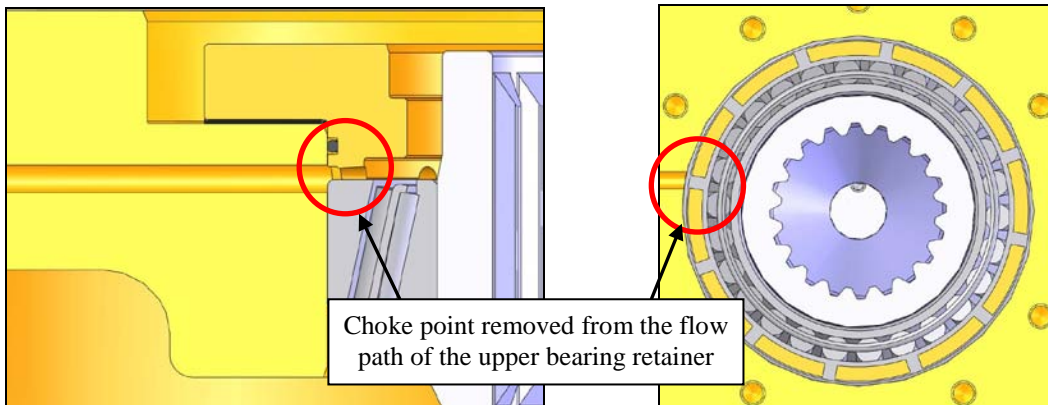
Figure 3: Modified upper bearing retainer (side view)

Figure 4: Modified Upper bearing retainer (front view)

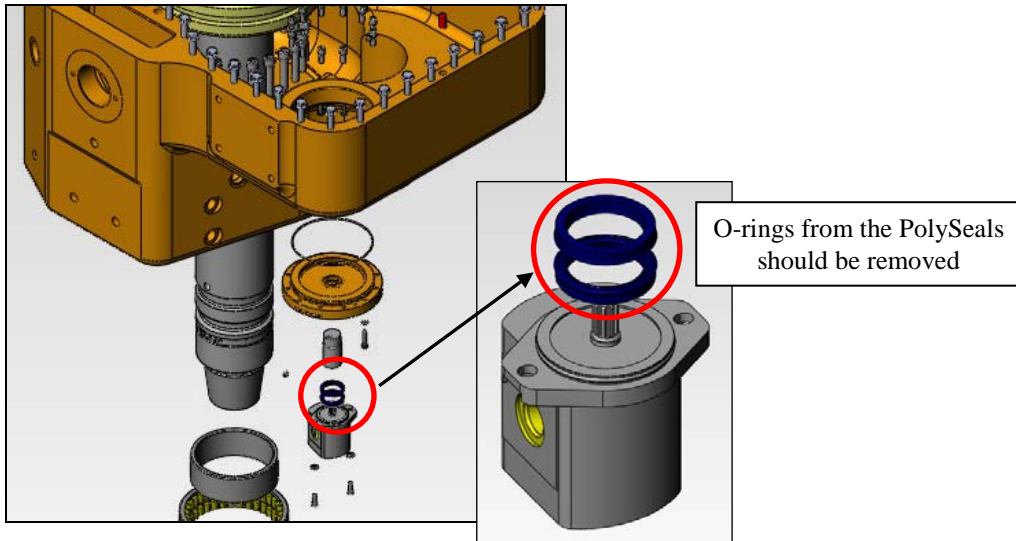
It was also found that the lower bearing retainer seals on the main pinion were wearing out prematurely due to improper installation. This, in combination with low grease levels surrounding the pinion, was compromising the seals and leading to premature seal failure.

EXI illustrations have also been updated to clearly communicate greasing procedures and to ensure that the O-rings from the PolySeals (P/N 820275) on the lower bearing retainer (P/N 820274) are removed to reduce excess wear on seals (Figure 5).

Figure 5: PolySeals on lower bearing retainer

When installing PolySeals on the EXI lower bearing retainer, ensure that the O-rings are removed from the PolySeals before installation.

Before completing the EXI gearbox assembly, a minimum of 10 shots of grease (P/N 510486) must be inserted into the grease port attached to the lower bearing retainer, along with 1-1/2 tubes of grease being put into the upper cavity of the motor pinion.
