Change Bulletin

Tesco Corporation 5616 – 80th Avenue SE Calgary, Alberta, Canada T2C 4N5 Tel: 1-877-TESCO-77 (North America) Tel: 1 (713) 359-7195 (AMSS 24-hour support) Tel: 1 (713) 359-7295 (International) Email: bulletins@tescocorp.com www.tescocorp.com www.tescoparts.com
No: CB052	Rev: 1	Date: October 30, 2013	
PLC Upgrade and Siemens VFD Update

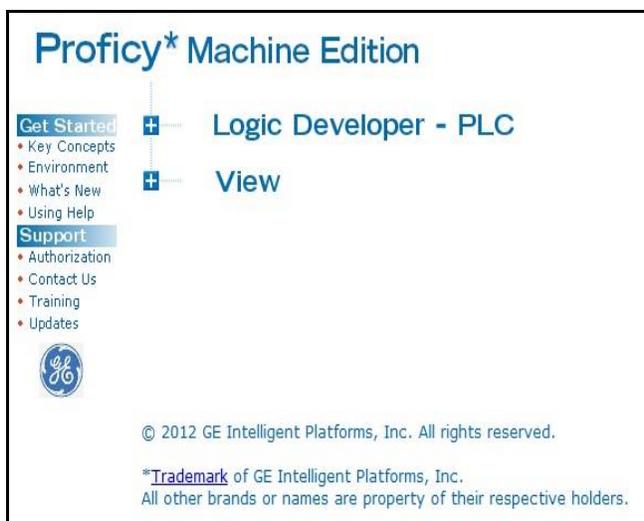
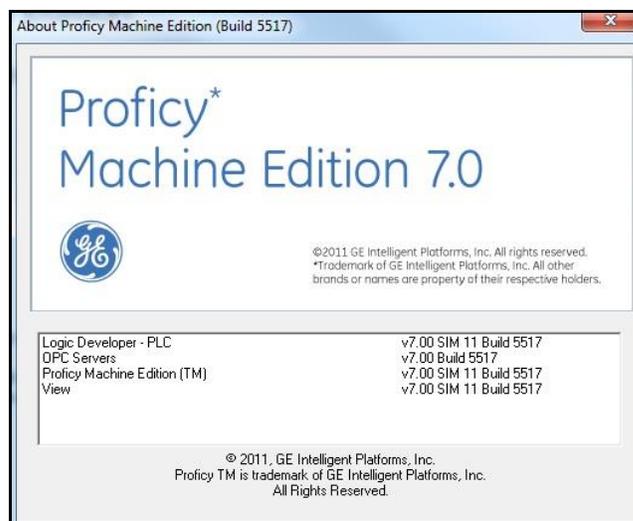
Figure 1: Proficy Software Required

- TESCO uses the GE FANUC 90-30 series PLC in a number of Top Drives for the control system, however, GE is phasing out the 90-30 series. The new GE PACSystem™ RX3i series PLC has been selected to replace the 90-30 series PLC. In order to download PLC code to the GE RX3i PLC, a Proficy Machine Edition (PME) 7.0 Professional SIM 11 is required.
- ESI Models Only: In order to download code to the Human Machine Interface (HMI) unit on the ESI-1350 driller's panel, a Proficy View license is required. It is typically installed with the Proficy software but requires license activation at an extra charge.

- TESCO Technicians' laptops must be upgraded with PME 7.0 SIM 11.
- IT must add Proficy View license on the upgrade timelines being scheduled by the TESCO IT Department.

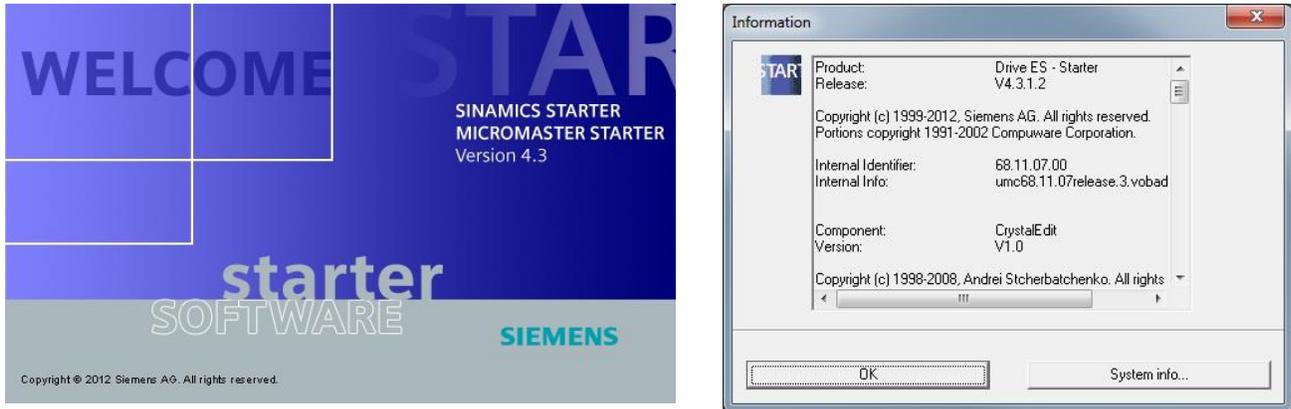
Figure 2: Siemens Software Required

The Siemens' VFD (ESI models only) requires the following updates:

- Update the Siemens STARTER Software to Release V4.3.1.2 (version 4.30).
- Update the Siemens Drive CPU firmware to version 4.05 (TESCO #5018012). This allows the loading of new files to the memory card.
- Upgrade the Siemens Advanced Operator Panel (AOP) display unit to Rev 5 (Tesco# 5018009). Use Rev4 or earlier ONLY if new firmware is NOT being installed.

- Siemens VFD firmware update requires Starter software to be updated to version 4.3 and only works with AOP with Rev 5 or above (ESI models only).
- GE RX3i CPU Model IC695CPE305 (TESCO #5027302) might be loaded with an earlier version of the firmware and would require an update to 7.75 to take advantage of all the features.

- TESCO Technicians will update the Siemens Drive CPU firmware to version 4.05, update the VFD parameter file and replace the AOP with Rev 5 or above.
- TESCO IT Department must install STARTER 4.3 software on TESCO Technicians' laptops.
