Chan	ge Bulletin	Tesco Corporation 5616 – 80th Avenue SE
No: CB053	Rev: 0	Date: November 30, 2013	Calgary, Alberta, Canada T2C 4N5 Tel: 1-877-TESCO-77 (North America)
HMI Ge	arbox –	MK1 Quill Assembly	Tel: 1 (713) 359-7195 (AMSS 24-hour support) Tel: 1 (713) 359-7295 (International) Email: bulletins@tescocorp.com www.tescocorp.com www.tescoparts.com
☑ Intern	al Use Or	nly External Use	☐ Mandatory

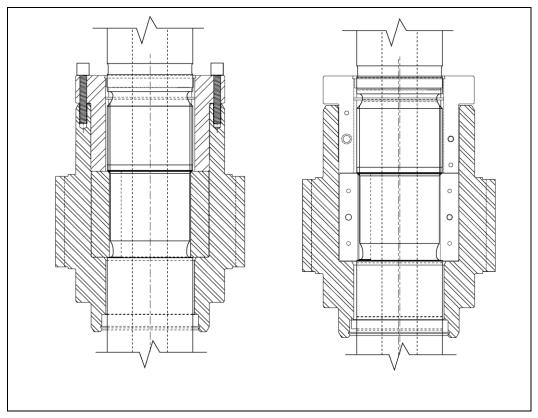
Figure 1: Original HMI gearbox quill connection

With the shift to horizontal drilling, the HMI top drive has been subject to increasingly demanding drilling programs. It was found that the connection from the drive gear to the quill's drive bushing could begin to slip and wear and eventually require repairs. To improve this connection, a prototype MK1 design was designed and several units were produced and tested. The performance of these prototypes in the field was established and determined to be an improvement over the initial design, proving to extend service life in the more extreme drilling programs. The prototype MK1 design was incorporated into several production units beginning in 2012. Based on feedback from the production and testing teams, some modifications were made to the prototype MK1 design to improve

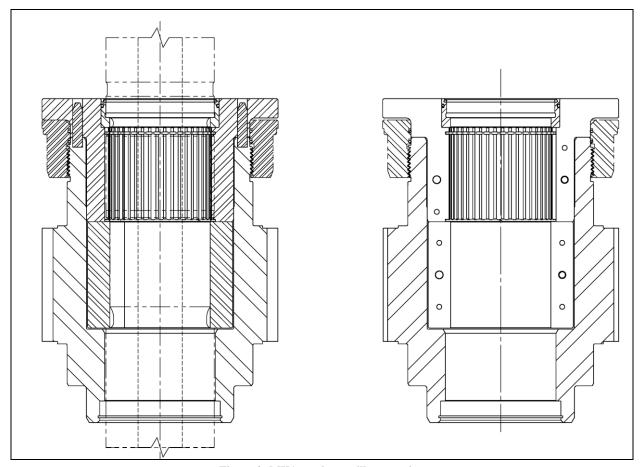
Figure 2: MK1 gearbox quill connection

The MK1 quill connection design increases the torque transmission capacity of the gearbox quill connection. Instead of directly fastening the drive bushing to the gear, a clamping ring is added between the drive gear and the drive bushing. The 12 threaded holes on the quill gear are replaced with a buttress thread to which the clamping ring is assembled. The connection between the new drive bushing and the clamp ring is now sixteen 5/8 in.-11UNC cap screws on a 10.50 in. base circle diameter (BCD). Increasing the number and size of the cap screws increases the clamping force between the drive bushing and the gear, greatly reducing the potential for slippage and the resulting wear. This also increases the torque transmission capacity.
