# Safety Bulletin

SB No: 013

Description: Ring Spring Handling Caution

These instructions apply to Topdrive models 900/1350 ECI(S) and HCI(S). The Ringfeder ring spring is part #7362.

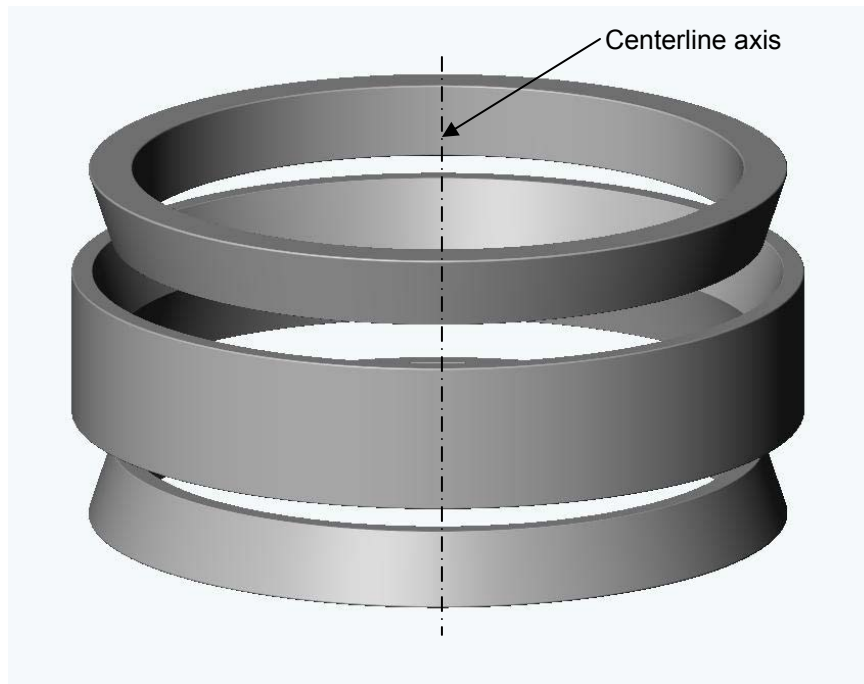
Figure 1 – Ringfeder Ring Spring Exploded View

It has been noted that the quill preload assembly Ringfeder ring springs can become seized during service, in a partially compressed state. This may occur as the result of loss of lubricant, incorrect lubricant or inadequate lubricant application during assembly or service. Inadequate lubrication will permit corrosion, and increase the friction between the spring components, causing them to lock when compressed, or in their preloaded state. **If Ringfeder springs have seized, considerable energy may be stored in the spring assembly, which can cause the ring segments to separate with considerable velocity and energy with the potential to seriously injure personnel.**
