# Safety Bulletin

No: SB017    Rev: 1    Date: 22 December 2011

## Elevator Horn Catch Hazard

**TESCO**

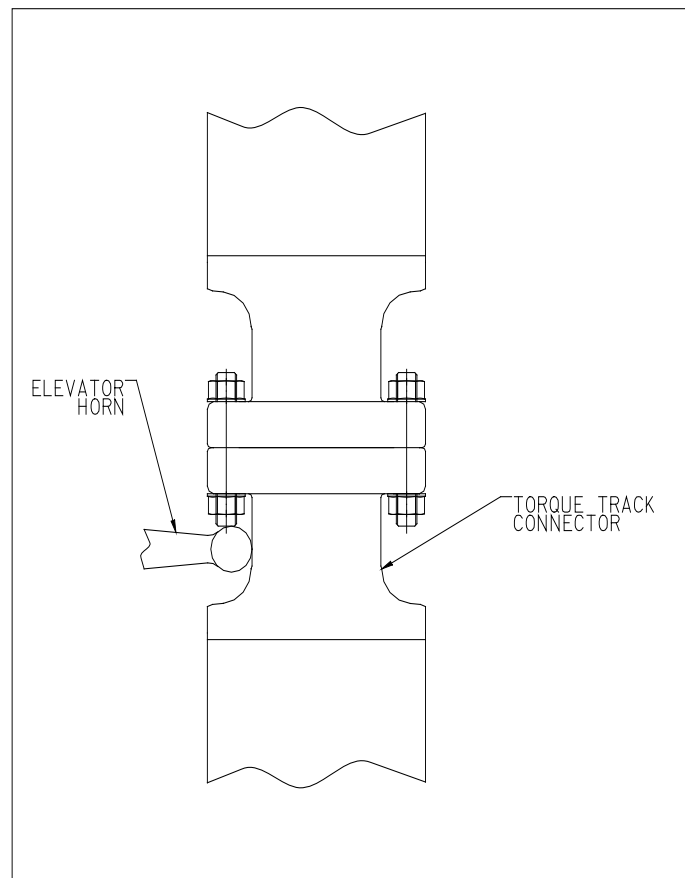
There has been a reported incident where, as the result of an error in top drive operation, the elevator horn(s) became caught in the torque track connector flange cavity. This can cause the lower end of the tubular held by the elevator to move with uncontrolled and unpredictable motion.

1. Hoisting or lowering with tubulars latched in elevators and
2. Elevators are reversed having the elevator horns facing the torque track and
3. Elevator links are tilted toward the torque track.

See Figure 1 to illustrate this condition.

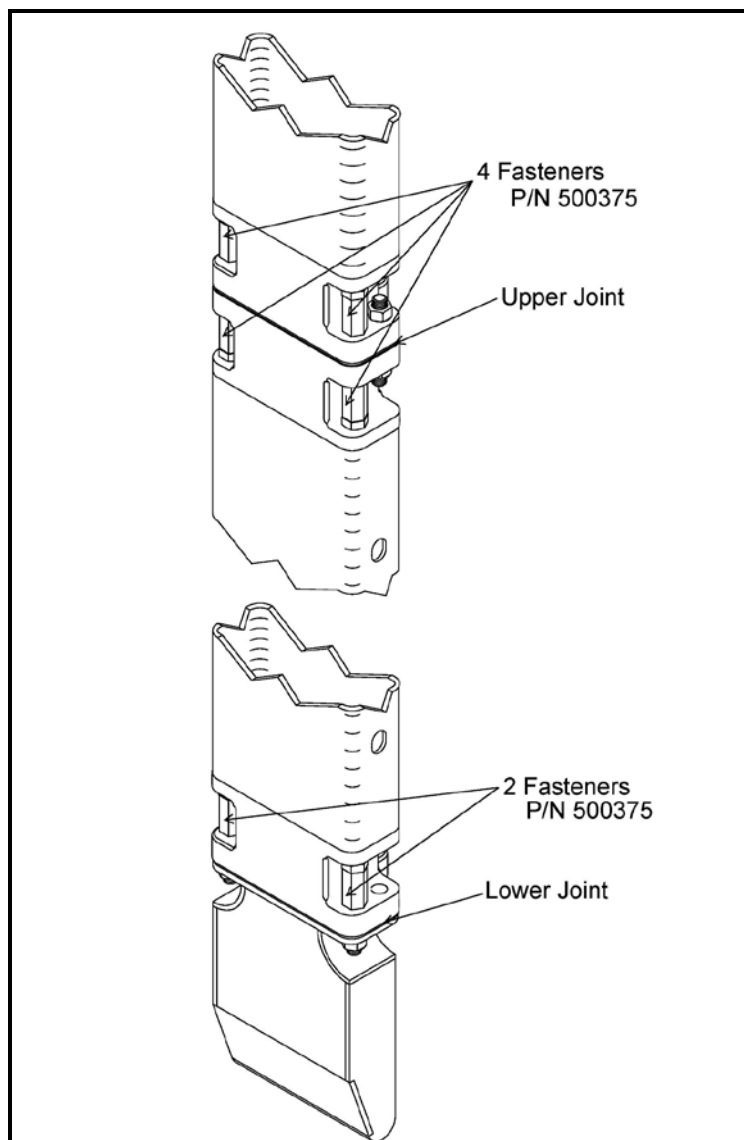
**Figure 2:** Torque track nuts (fasteners) in a typical installation

Replace the existing forward facing nuts, at vulnerable flange connection locations, with fasteners P/N 500375 (qty. 4 and 2 for upper and lower joints respectively). This will prevent the elevator horns from entering the torque track connector cavity. Ensure that the nuts are torqued with the flats facing forward. See Figure 2 for a typical configuration.

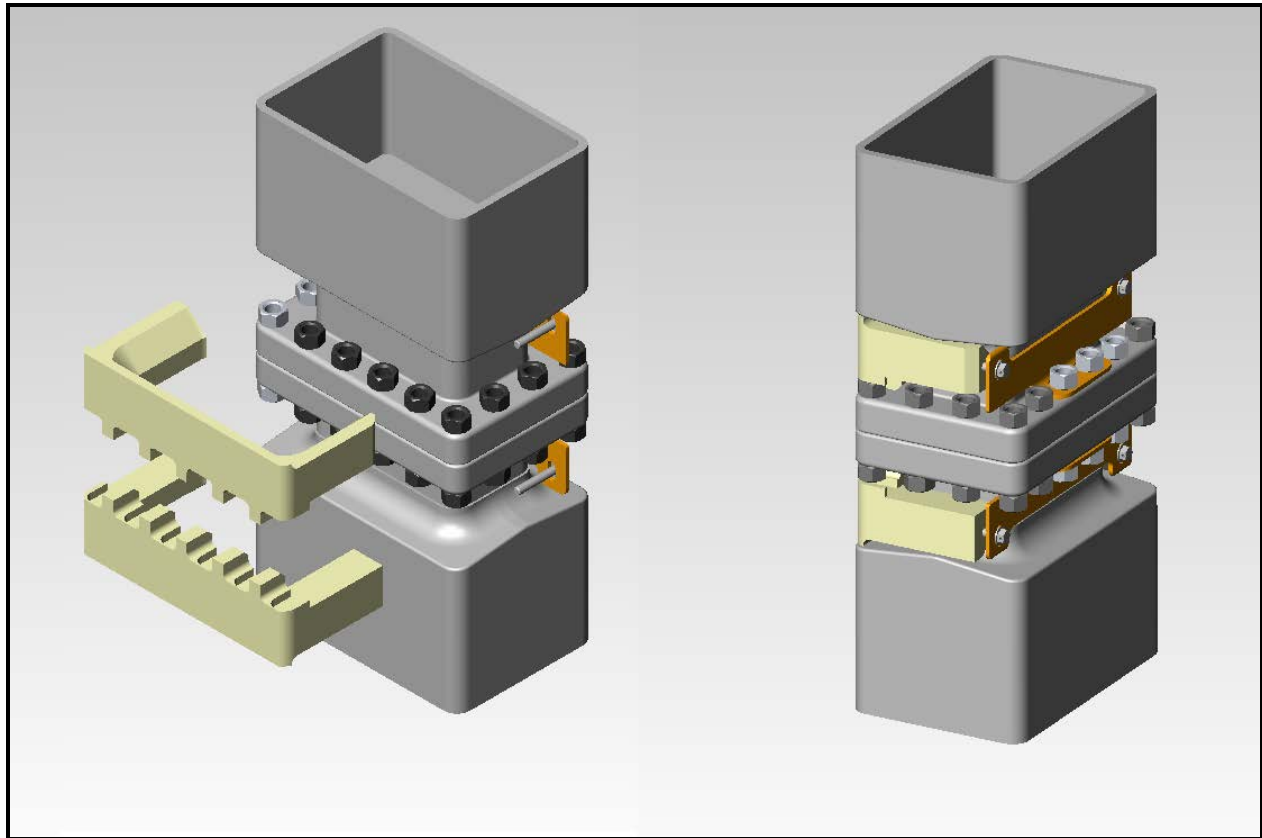
**Figure 3:** Torque track, guard installation (well side) and guard latched (mast side)

Obtain and install Insert Kit(s) P/N 720524-1 (qty. 1 per joint) at vulnerable flanged connector locations to prevent the elevator horns from entering the torque track connector cavity. See Figure 3 for a typical configuration.
