Safety Bulletin

No: SB039 Rev: 0 Date: Jun. 19, 2008

Description: 350 EXI 600 Top Drive Guard Door Secondary Restraint and Hinge

Upgrade

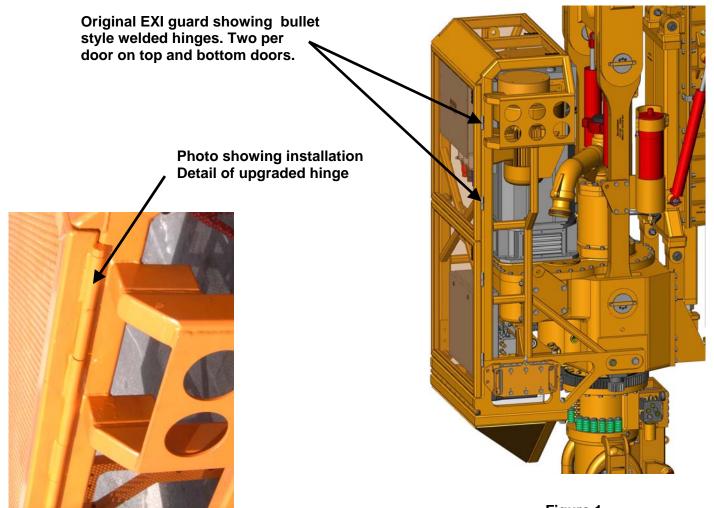
TESCO has received a report of a hinge failure on a guard door of the 350 EXI 600 top drive. The failure of the hinge resulted in the guard door falling to the rig floor. This bulletin outlines instructions for the installation of a more robust hinge design, and the addition of a secondary restraint for affected product until the upgraded hinge repair has been made.

Figure 2.
Upgraded Hinge detail

Figure 1.
Original EXI Guard Hinge Detail

- 1. Prior to having hinge upgrades performed, TESCO strongly advises operators to add secondary restraint to both the upper and lower guard doors. A suitable restraint can be accomplished by welding a short length (approx. 1 foot) of 3/8" link chain between the guard door, and the guard frame. This chain should be welded to the hinge side of the door so as not to interfere with normal operation of the door.
- 2. Refer to Figures 3 and 4 below for specific information regarding fabrication of replacement hinges, and modification to guard and doors.
- 3. After the modifications are completed, the secondary restraint may be removed if desired, or left in place.
