| | Safety B | | Tesco Corporation | |
| • | • | ^{11 Dec 2008} Drive – Grabber Lift Interference | TESCO | 6204 – 6A Street SE Calgary, AB. T2H 2B7 Phone: (403) 692 5700 <u>www.tescocorp.com</u> |

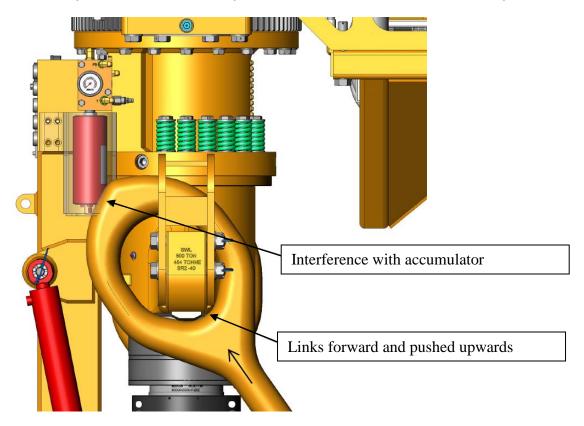
A potential mechanical interference risk has been identified wherein the driller side upper elevator link eye is able to come into contact with the grabber lift accumulator guard. The area of contact is shown in Figure 1.

Figure 1 – Location of elevator link eye contact.

This interference may occur if the elevators are allowed to contact the rig floor or other obstructions and the elevator links are pushed into the bottom of the load collar horns while the elevator links are tilted forward. Other factors that may contribute to this interference include,

- Incorrectly positioned elevator link clamps allowing excessive tilting of the elevator links.
- The use of links with large eyes.

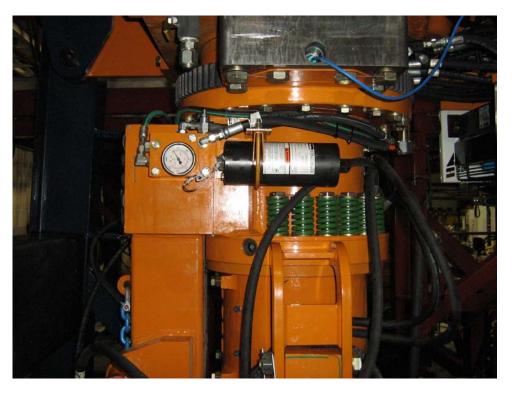
Figure 2 – Relocated Accumulator, Clamp Bracket and Safety Cable

To eliminate the potential for mechanical interference TESCO has relocated the grabber lift manifold and accumulator to a position above the elevator link retainers as shown in Figure 2. Further, a safety cable has been implemented as a positive secondary retention for the accumulator in its new location.

TESCO recommends that all EXI model top drives have the grabber lift manifold and accumulator retrofitted to this new location.

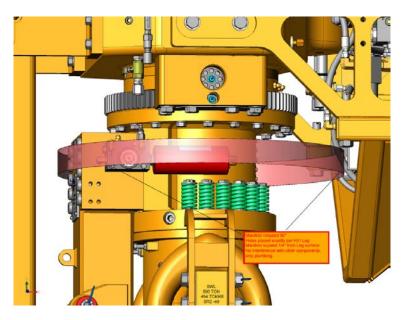
As shown in Figure 3 the cooler fan motor hoses need to be re-routed to avoid the potential for catching on the relocated manifold block when the pipe handler is rotated. Figure 4 shows the new hose routing for the motor supply and return lines that should be implemented to avoid catching.

Figure 3 – Original fan motor hose routing

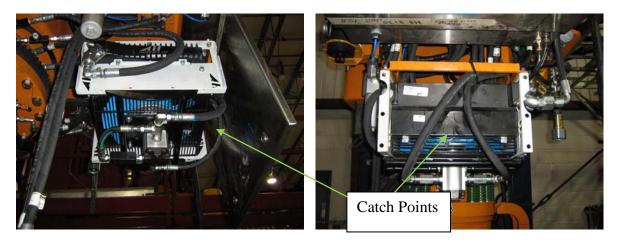
Figure 4 – Modified hose routing towards front of cooler
