Safety Bulletin

No: SB057

Description: Support Plate for HXI Gearbox Expansion Chamber and Counterbalance Accumulator Mount

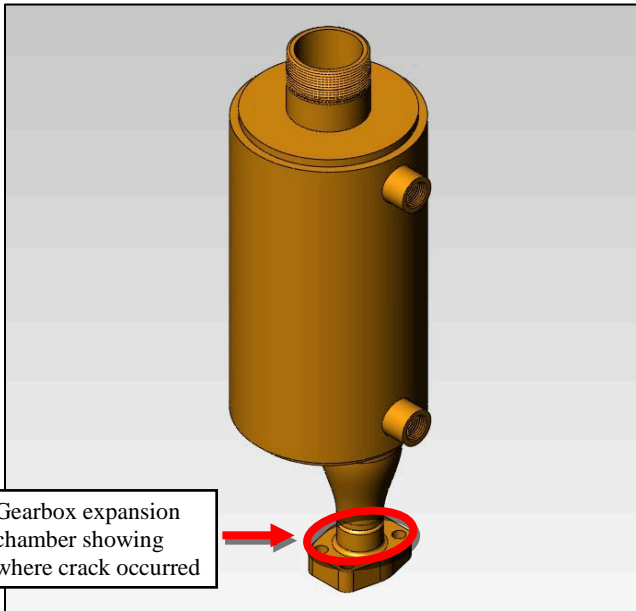
Figure 1: Gearbox expansion chamber

An incident occurred in which an HXI gearbox expansion chamber cracked and fell from the top drive during operation. In a separate incident, an HXI counterbalance accumulator mount also cracked and fell from the top drive. It was found that the cracks occurred at the butt flange of the expansion chamber (Figure 1) and mounting plates of the counterbalance accumulator (Figure 2), resulting in these dropped object incidents.

Gearbox expansion chamber showing where crack occurred

TESCO has developed reinforcement kits for the expansion chamber and expansion chamber gooseneck, which features a reinforcement clamp (Figure 3) that secures the expansion chamber onto the bonnet. The accumulator mount assembly (Figure 4) features a re-designed counterbalance clamp with mounting plates that are now twice as thick, and a swivel link lug that is modified to accommodate the new mounting plate thickness.

On HXI top drives in which the gooseneck is turned towards off-driller’s side (or in the case of reverse-installed top drives that utilize a torque restraint rather than a torque track system, if the gooseneck is turned towards driller’s side), order and install the Expansion Chamber Reinforcement Kit (TESCO part number 5006719).

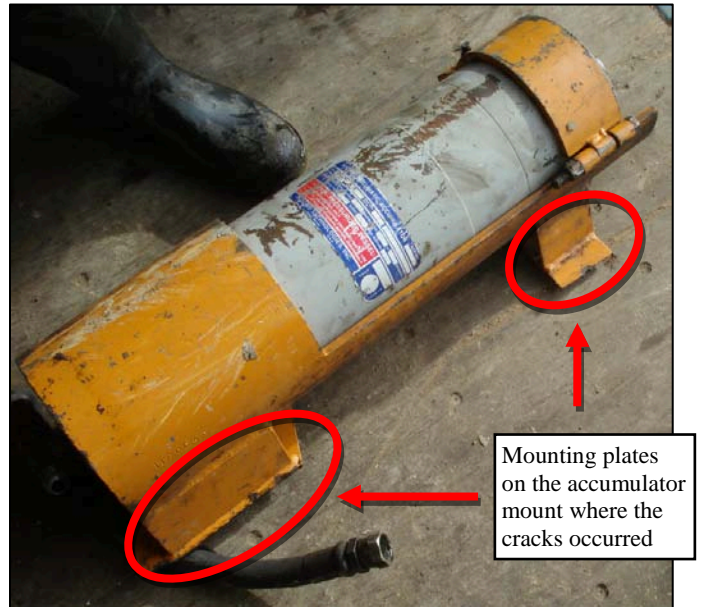
Figure 2: Counterbalance accumulator mount

Mounting plates on the accumulator mount where the cracks occurred

Furthermore, order and install the Driller’s Side Accumulator Mount Assembly (TESCO part number 1100040-1) and the Off-Driller’s Side Accumulator Mount Assembly (TESCO part number 1100042-1). For each accumulator mount, order and install one of the new Counterbalance Swivel Link Lugs (TESCO part number 1100126-1). Two Counterbalance Swivel Link Lugs will be required per top drive.

TESCO Business Units should advise customers operating HXI top drives to remove and scrap the old Driller's Side Accumulator Mount Assembly (TESCO part number 1100040), Off-Driller's Side Accumulator Mount Assembly (TESCO part number 1100043), and Counterbalance Swivel Link Lugs (TESCO part number 1100126).
