Safety Bulletin			 	Tesco Corporation 5616 – 80th Avenue SE Calgary, Alberta, Canada T2C 4N5 Tel: 1-877-TESCO-77 (North America) Tel: 1 (713) 359-7195 (AMSS 24-hour support) Tel: 1 (713) 359-7295 (International) Email: bulletins@tescocorp.com www.tescocorp.com www.tescoparts.com
No: SB058	Rev: 0	Date: 31 May 2011		
Description: Swivel Sub Clamping Mechanism			TESCO®

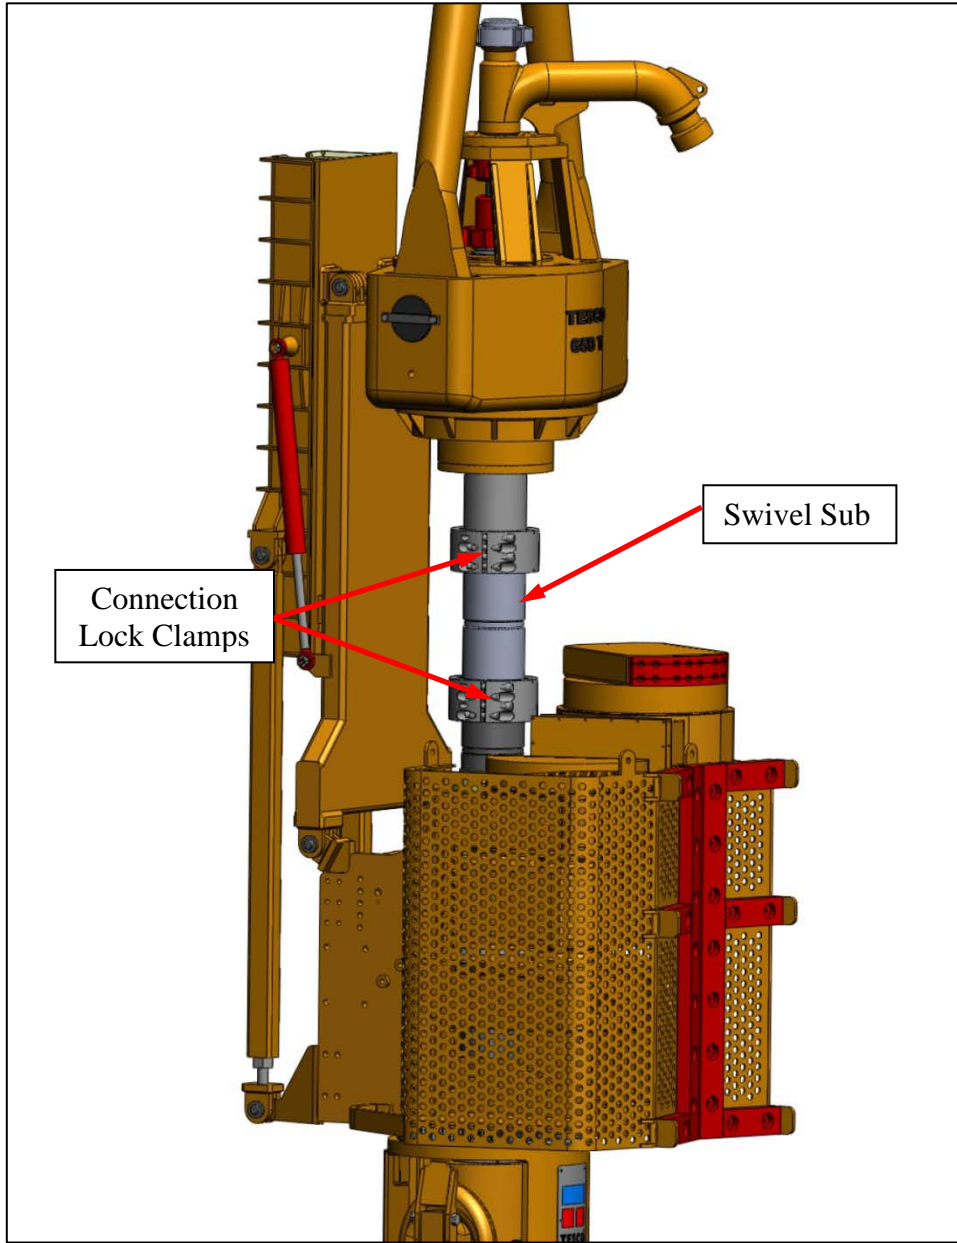
TESCO manufactures many models of swivel subs and corresponding connection lock clamps, and can design and fabricate virtually any configuration necessary according to customer requirements. The figure below shows the ECI-900 Top Drive with swivel sub and connection lock clamps.

If abnormal conditions such as a locked or seized swivel are noted then the unit should not be operated in the reverse direction without the use of a connection lock clamp.

Contact TESCO for more information on installing swivel subs and clamps.
