<b>Safety Bulletin</b>			  Tesco Corporation 5616 – 80th Avenue SE Calgary, Alberta, Canada T2C 4N5 Tel: 1-877-TESCO-77 (North America) Tel: 1 (713) 359-7195 (AMSS 24-hour support) Tel: 1 (713) 359-7295 (International) Email: <a href="mailto:bulletins@tescocorp.com">bulletins@tescocorp.com</a> <a href="http://www.tescocorp.com">www.tescocorp.com</a> <a href="http://www.tescoparts.com">www.tescoparts.com</a>
<b>No: SB060</b>	<b>Rev: 0</b>	<b>Date: 18 July 2011</b>	
<b>250-HXI-700 Quill Pin Failure</b>

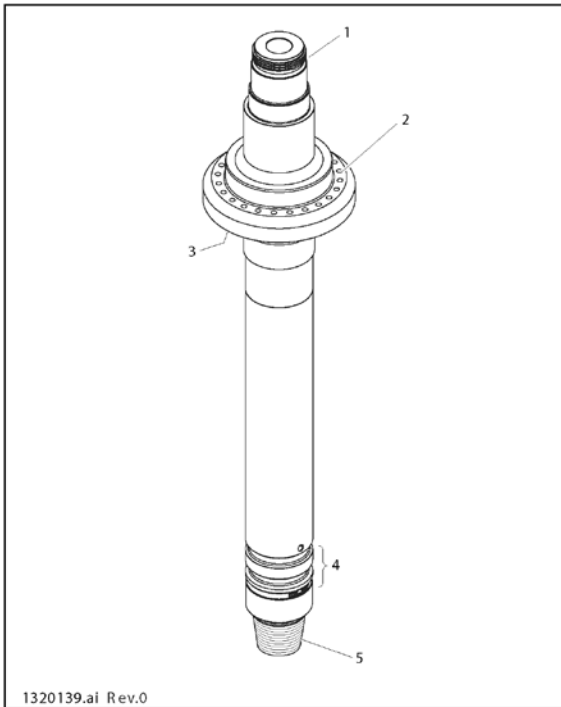
Point	Name	Frequency (Operating Days) and Inspection Type*				
		Every 60	At 250	At 500	At 750	At 1000
1	Threads on the lower gland nut and bore	—	A	A	A	C
2	Upper thrust surface	—	—	—	—	C
3	Lower thrust surface	—	—	—	—	C
4	Load nut grooves	—	—	—	—	C
5	Quill pin end and seal face	A,B	—	—	—	C

TESCO recommends that the customer immediately performs an MPI inspection of the six HXI Top Drive units and to continue inspections on a 60-day basis (as per HXI Maintenance Guide document # 1570015) until quill replacement is scheduled. TESCO is recommending that wet fluorescent magnetic particle inspection (WFMPI) be conducted on the lower portion of the quill including the pin, seal face, and the load nut grooves on this schedule. See below for inspection specifications.
