<b>Safety Bulletin</b>

**BACKGROUND INFORMATION:**

All service loops used on the EXI and ESI-1350 Top Drives are affected.

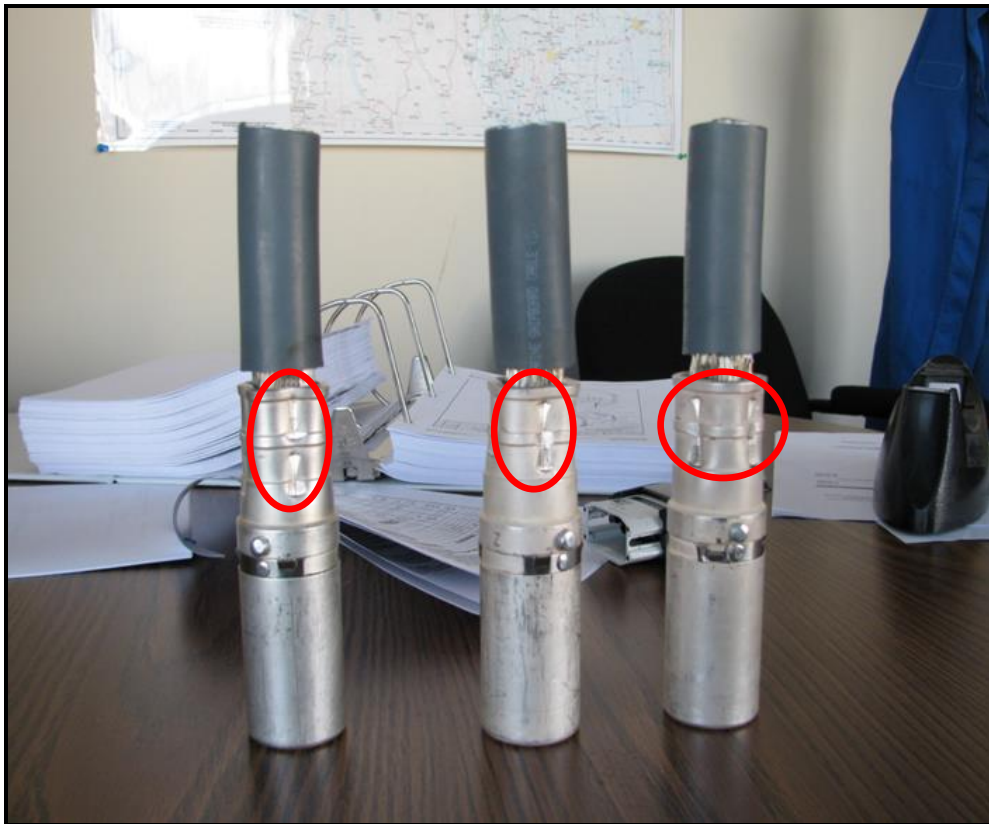
It was discovered that the service loop power cables on the TESCO EXI and ESI-1350 Top Drives were not properly crimped at the 600 volt connector female/male end (Figure 1). The cables were crimped at the lugs using a four-point crimp style. Four-point crimping does not have the necessary grip to securely tighten the lugs. This increases the possibility of the cables parting from the connector at the crimp. As a result, there is potential for the cables to overheat and severely damage equipment during operation.

**Figure 1: Cables improperly crimped at the lugs using a four-point crimp style**

TESCO recommends taking remedial action to correct the issue of cable crimping.

- Remove the outer boot by using a TESCO approved removal tool (TESCO part number 5018050). If the outer boot is damaged, it must be replaced. Appendix B contains more information and instructions on using the removal tool.
- Visually inspect and manually conduct an elongation test on the cable and lug (pull test) to verify that the lug has been properly installed and crimped correctly.
- Check the lug for crimp style. It should be a six-point crimp and not a four-point crimp. If it is crimped as a four-point, the lug will need to be replaced and crimped properly using a TESCO approved six-point crimper and die set. (TESCO part number 8060; Appendix A, Figure 4).

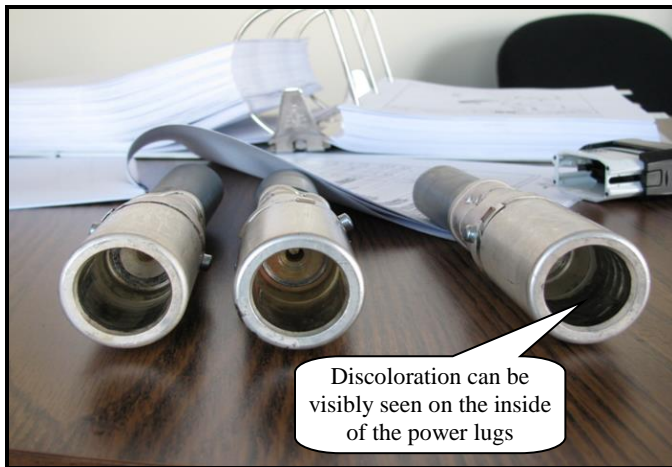
- All service loop power cables must be inspected for possible discoloration (Figure 2 and Figure 3). If there is discoloration on the inside of the power lugs, inspect the style of crimping that was done on the lugs.

Figure 2: Discoloration on the inside of the power lugs

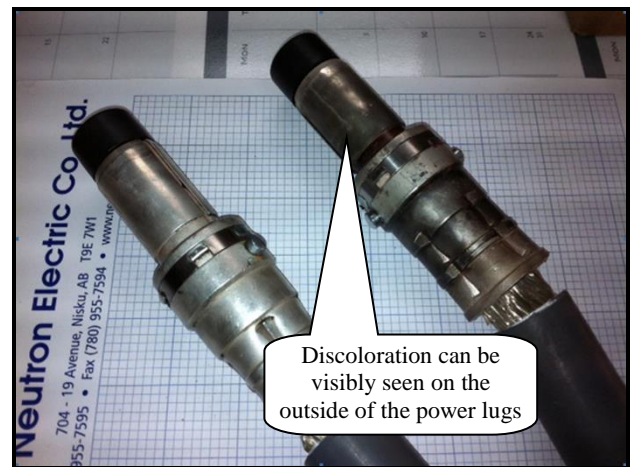
Figure 3: Discoloration on the outside of the power lugs
