Safety Bulletin			Tesco Corporation 5616 – 80th Avenue SE	
No: SB064	Rev: 0	Date: March 12, 2012		Calgary, Alberta, Canada T2C 4N5 Tel: 1-877-TESCO-77 (North America)
Shackle Failure on HCI Top Drives		TESCO	Tel: 1 (713) 359-7195 (AMSS 24-hour support) Tel: 1 (713) 359-7295 (International) Email: <u>bulletins@tescocorp.com</u> <u>www.tescocorp.com</u> <u>www.tescoparts.com</u>

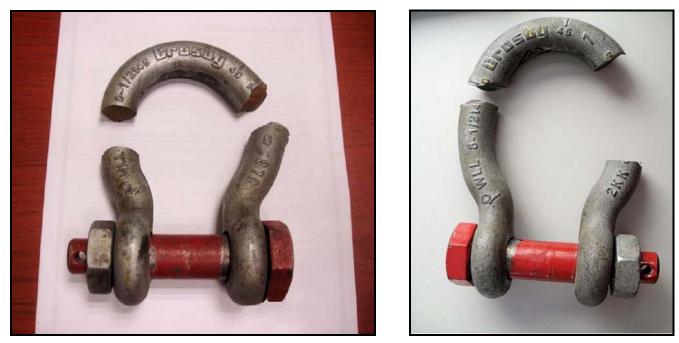
Two separate incidents occurred in the field in which the shackle installed between the crown and the torque track section of two TESCO HCI Top Drives (units 957 and 735) broke during operation (Figure 1) and fell to the rig floor. No injuries to personnel and no damage to equipment were reported.

Figure 1: Broken shackle on HCI top drive unit 735 (left) and 957 (right)

Upon further investigation by Crosby's laboratory and another independent laboratory, it was revealed that both shackles had broken by way of fatigue failure. Both shackles experienced fatigue that had progressed more than ³/₄ through the cross section (primary fracture) before the remaining section broke under the load (secondary fracture). Then after one column of the bow had broken, the other column became overloaded and broke also (tertiary fracture) at a second fatigue site. The first shackle (unit 735) broke in August 2011, while the second shackle (unit 957) broke in December 2011 and had been in operation for 46 days. According to the TESCO HCI top drive maintenance manual #880004, the torque track hanging sling is to be visually inspected every week and documented. Therefore the second broken shackle should have been inspected about six times prior to it breaking.

TESCO recommends that the old style torque track hanging sling (TESCO part number 4537) equipped on all top drive installations be immediately subject to visual and wet fluorescent magnetic particle inspection (WFMPI) in accordance with Crosby's field inspection guideline, see Appendix A.

- All top drive maintenance manuals are being updated to include Crosby's field inspection instructions.
- TESCO is changing the inspection frequency of the visual check of the torque track hanging sling to be 'daily'.
- TESCO is including a WFMPI non-destructive evaluation (NDE) requirement for the torque track hanging sling that will be 'monthly'.
- TESCO is adding a proof load test followed by WFMPI NDE requirement for the torque track hanging sling assembly to be completed prior to the parts leaving the factory and being delivered to the customer.

TESCO further recommends, for all top drive installations that had not been originally equipped with torque track hanging sling (TESCO part number 4537) and torque track hanging lug (TESCO part number 19025), that those customers replace this hanging equipment, and revert to the torque track hanging sling and torque track hanging lug that had been originally supplied with the top drive unit. Substituting this equipment back will improve the factor of safety of the torque track hanging sling.
