Safety Bulletin			  TESCO [®]	Tesco Corporation 5616 – 80th Avenue SE Calgary, Alberta, Canada T2C 4N5 Tel: 1-877-TESCO-77 (North America) Tel: 1 (713) 359-7195 (AMSS 24-hour support) Tel: 1 (713) 359-7295 (International) Email: bulletins@tescocorp.com www.tescocorp.com www.tescoparts.com
No: SB071	Rev: 0	Date: July 31, 2012		
Mounting Bolts from Blower Motor Become Loose and Fall Off. 750-ESI-1350, 500-ESI-1350.

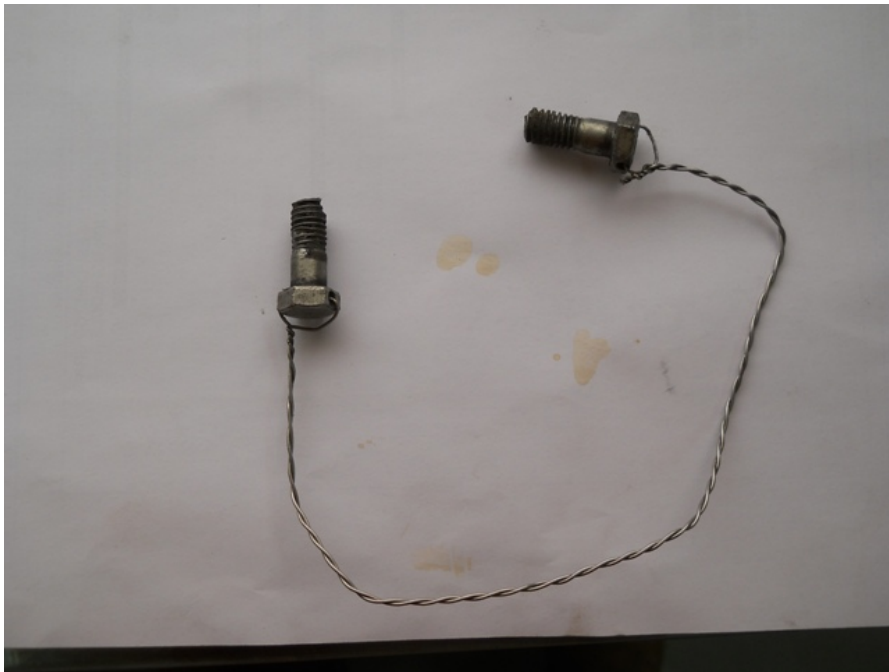
An incident occurred on a 500-ESI-1350 Top Drive where the mounting bolts from the blower motor became loose; eventually falling out during a period of very rough drilling. It appears that some blower motors were mounted with 3/8" bolts and others with 1/2" bolts.

Figure 1 - Bolts that have come loose and fallen off an ESI 500 Ton Top Drive

1. Inspect the blower motor mounting bolts to determine whether 3/8" or 1/2" bolts were used to fasten the motor. This is best done if one bolt is removed and measured.
2. If it is determined that the bolts used were 1/2" bolts, loosen them slightly and re-torque them to 100 ft-lb with a proper torque wrench. This is to ensure the bolts were not over torqued during installation. Re-apply the lock wire.

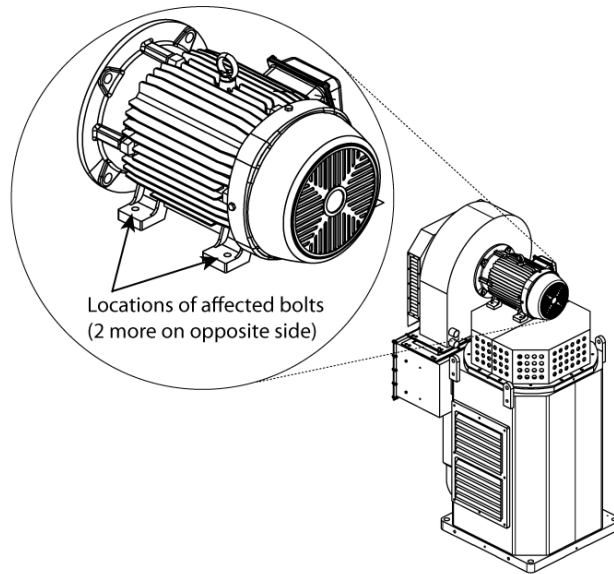
Figure 2 - Location of affected bolts

4. Once it is practical, replace the 3/8" bolts with 1/2" -13UNC x 2" long grade 8, drilled head bolts (Tesco prt# 3536). (in metric countries, M14 x 2 pitch x 50mm, grade 8.8 may be used) using the following steps:
 - Remove the brake cover from the main motor
 - Drill out the blower motor mounting holes in the brake cover to 9/16" (or 16 mm) diameter
 - Weld four 1/2" (or M14) nuts to the inside of the brake cover. 1/8" fillet weld all-round should suffice.
 - Reinstall the brake cover on the main motor
 - Install the blower motor with 1/2" (or M14) bolts
 - Use a proper torque wrench and Torque the 1/2" bolt to 100 ft-lb (140 Nm for the M14 bolts). Do not lubricate the bolts. Take care not to over torque the bolts.
 - Lock wire the bolts to secure it.

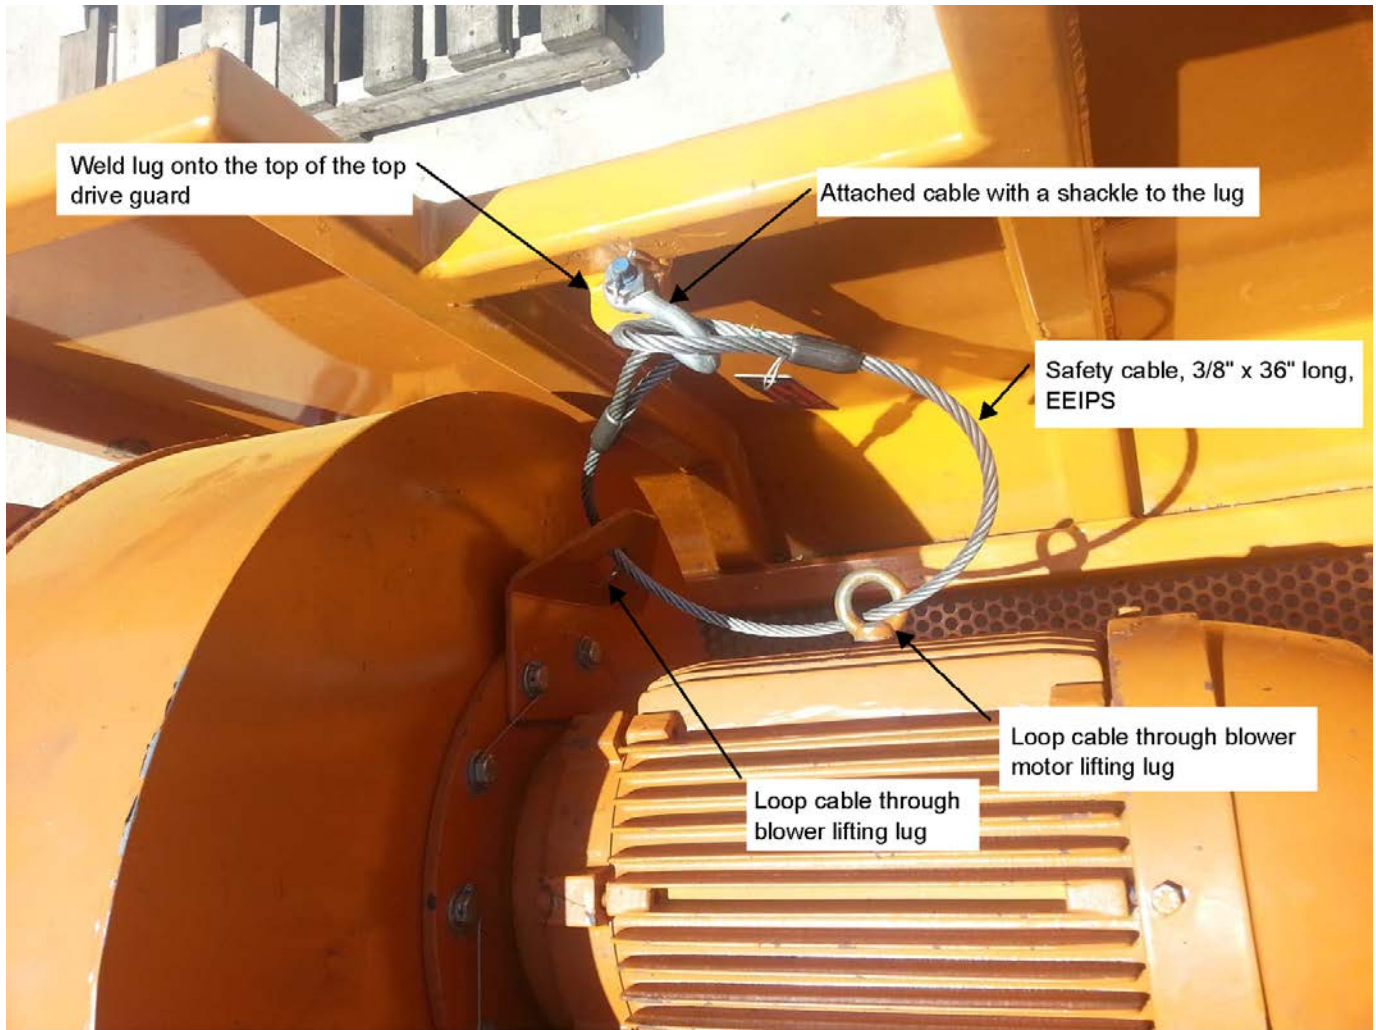
Figure 3 - Safety Cable attached to Blower Motor

3. If it is determined that 3/8" bolts were used to mount the blower motor, the blower motor assembly must be secured with a safety cable until it is practicable to replace with 1/2" bolts (see figure 3)
