Safety Bulletin

No: SB072 Rev: 0 Date: December 20, 2012

Modification Required to T-bar for Dual Pin Torque Track

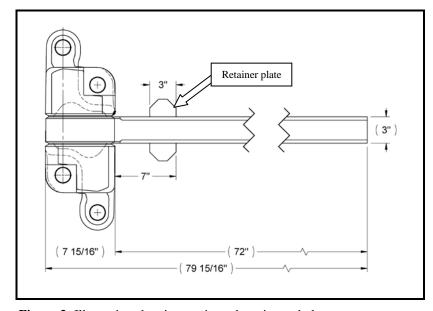
Figure 3: Illustration showing retainer plate size and placement

The potential for collision if the T-bar clamp became loose is eliminated with the addition of a retainer plate to the T-bar shaft. The retainer plate prevents the T-bar from sliding all the way into the clamp, ensuring that sufficient clearance is available for the torque bushing to pass. Figure 2 shows the T-bar with the retainer plate added. The retainer plate will be added to all new T-bars to eliminate such a hazard. Figure 3 shows the retainer plate size and placement. For a more detailed view, refer to drawing number 5007241-1.
