<b>Safety Bulletin</b>

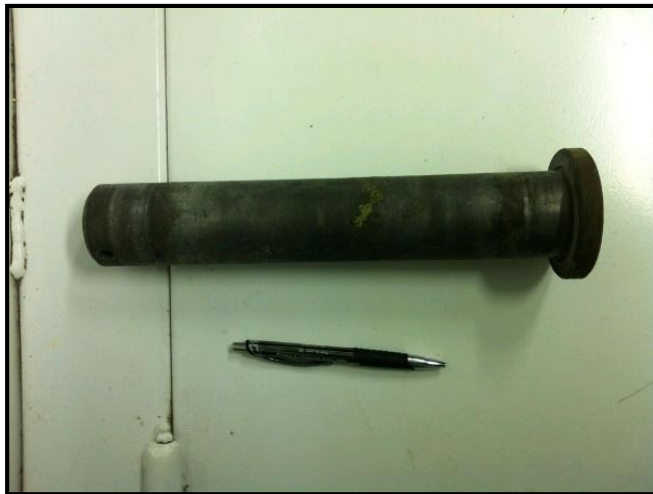
**Figure 1: Hanger pin (15930)**

An incident occurred where the hanger pin (15930, Figure 1) of a torque track, telescoping top section became dislodged during drilling. The hanger pin fell to the rig floor where it struck a rig worker on the foot causing injury. The safety bolt pin retainer was not found after the incident.

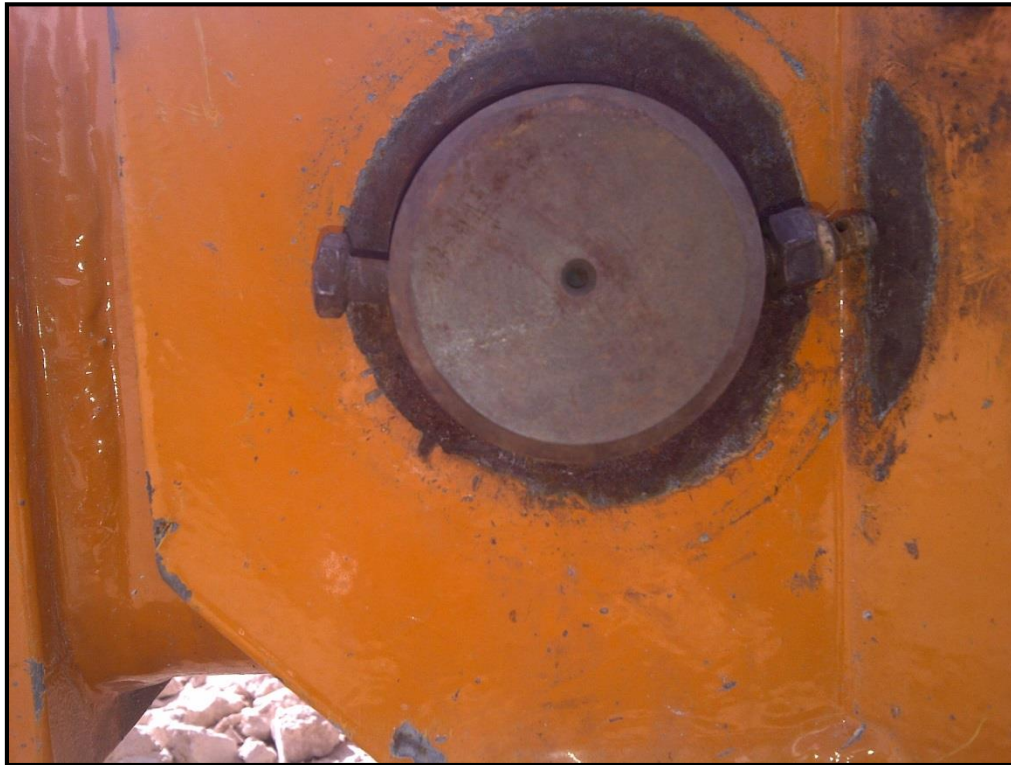
**Figure 3: Pin rotation**

The hanger pin (item 3) is retained by a safety bolt pin retainer that provides both primary retention and secondary retention. The primary retention is by means of a 1/4" Grade 8 bolt and 1/4" Grade 8 nylon lock nut (items 4 and 5, respectively). The secondary retention is by means of a 1/16" cotter pin (item 6).

In extreme circumstances, vibrations can cause the pin (item 3 in Figure 2) to rotate. This slowly damages the nut and bolt (items 4 and 5 in Figure 2). See also Figure 3, above. This damage would be apparent during daily visual inspections as per the TESCO Maintenance Guides.

For **Non-ESI track installations** (16124, 1340104, 1340036, 1680006 and 5023786), **replace these parts** (see Figure 2):

- hanger pin (15930)
- cap screw (16435)
- hex nut (9785)
- cotter pin (16434)
