Safety Bulletin

<p>Tesco Corporation 5616 – 80th Avenue SE Calgary, Alberta, Canada T2C 4N5 Tel: 1-877-TESCO-77 (North America) Tel: 1 (713) 359-7195 (AMSS 24-hour support) Tel: 1 (713) 359-7295 (International) Email: bulletins@tescocorp.com www.tescocorp.com www.tescoparts.com</p>
No: SB076	Rev: 4	Date: Sept 13, 2013	
Blower Motor Mounting Failure 750-ESI-1350, 500-ESI-1350

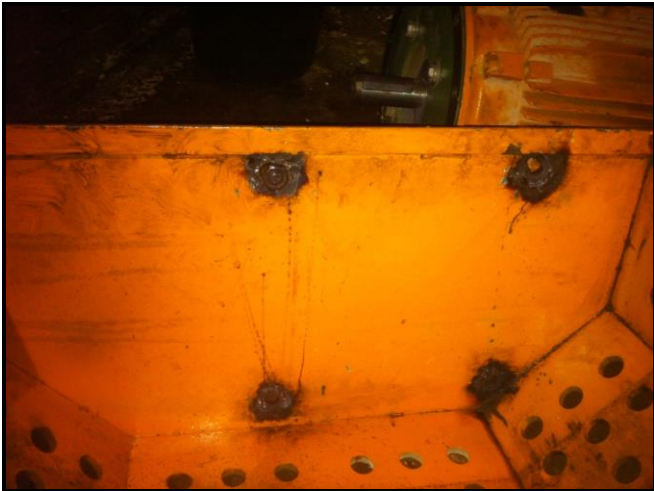
A TESCO 500-ESI-1350 Top Drive, which had the blower motor mounting upgraded to 1/2" bolts and weld nuts as specified in SB071, had failures in the welds securing three of the nuts for mounting the blower motor. In addition, one of the mounting feet of the blower motor had fractured. This failure occurred after a period of rough drilling with excessive vibrations.

Figure 1: Welding of mounting nuts failed on ESI 500 Ton Top Drive

The half of the brake cover to which the blower motor is mounted shall be replaced as soon as possible with the reinforced version (Figure 4).

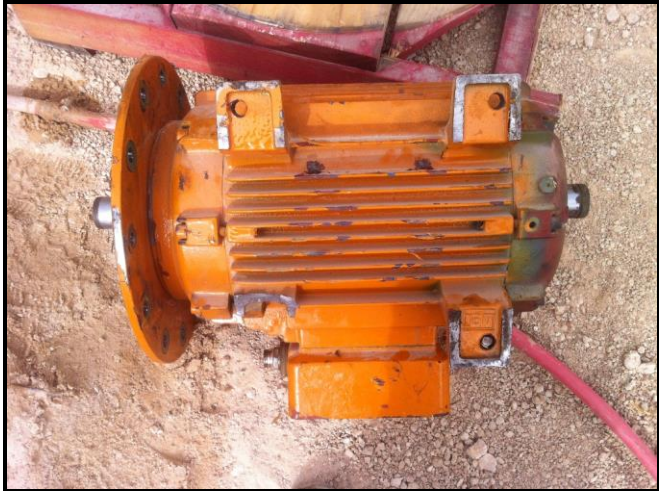
Figure 2: Mounting foot of blower motor failed

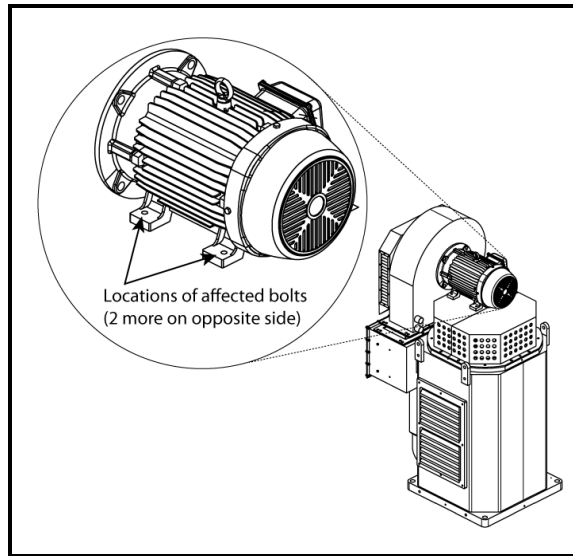
It was identified that the brake cover of the ESI's 1350 HP motor, to which the blower motor is mounted, may be susceptible to some frequencies of vibrations from the drilling operations. To prevent possible vibration induced damage to the brake cover and the blower motor, the cover will have ribs added to increase its stiffness; raising its natural frequency. This change will also serve to increase the overall strength of the cover, reducing susceptibility to damage from jarring incidents.

Figure 3: Location of affected bolts

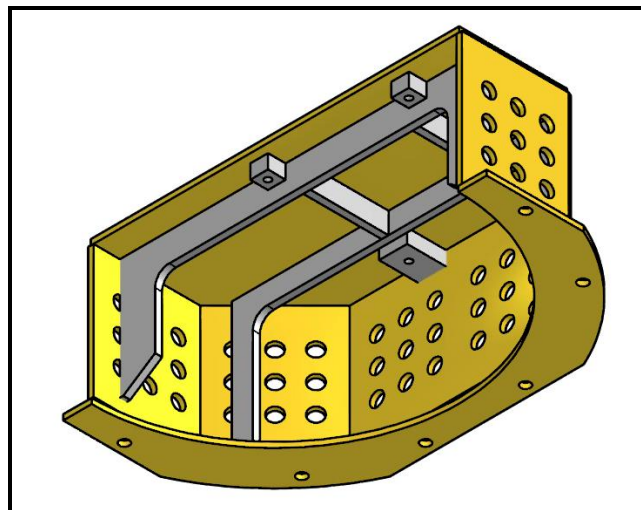
Figure 4: New brake cover with reinforced ribs for added stiffness

A kit for replacing the brake cover is available from TESCO; the part number is 5031360 (Kit, Upgrade, Brake Cover, ESI 1350 HP Motor). This kit includes the replacement brake cover, motor mounting hardware, shims and a secondary retention sling. Instructions for replacing the cover and shimming the motor follow in Appendix B.

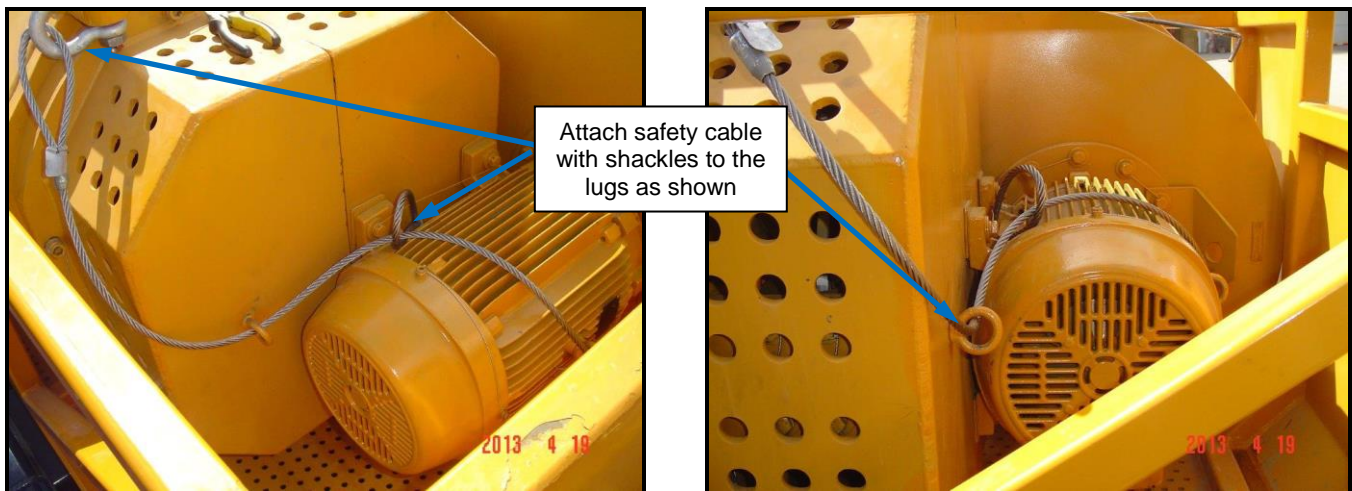
Figure 5: Safety cable attached to blower motor

1. Inspect the blower motor and the mounting bolts every 6 hours of operation; more often during rough drilling.
2. Secure the blower motor assembly with a 1/4" x 84" safety cable (TESCO part number 5036166) and 3/4", 4-3/4 ton Crosby shackle (see Figure 5).
