Safety Bulletin

<p>Tesco Corporation 5616 – 80th Avenue SE Calgary, Alberta, Canada T2C 4N5 Tel: 1-877-TESCO-77 (North America) Tel: 1 (713) 359-7195 (AMSS 24-hour support) Tel: 1 (713) 359-7295 (International) Email: bulletins@tescocorp.com www.tescocorp.com www.tescoparts.com</p>
No: SB077	Rev: 0	Date: March 12, 2013	
500/650-ECI/S-900/1350 and 500/650-HCI/S-750 Torque Bushing Clevises

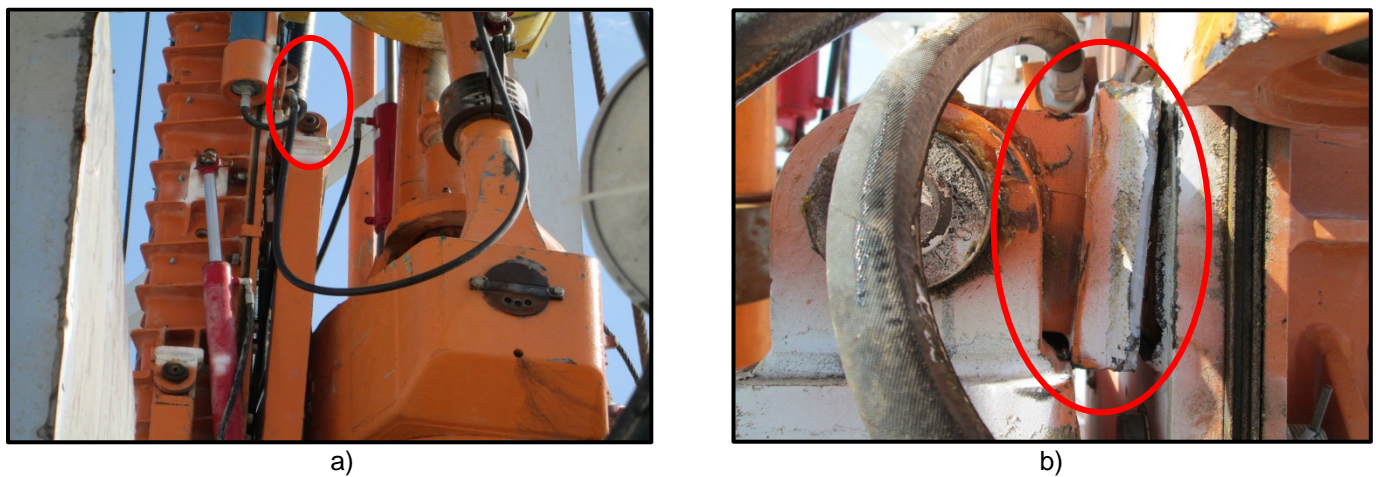
An incident has occurred where the extend frame clevises on a torque bushing used on a 500-ECI-1350 Top Drive failed at the welds during a drilling ahead operation (see Figure 1). A preliminary investigation points to a lack of fusion between the weld material and the clevises as the significant contributing factor in this failure. Figure 2a shows the failed weld; Figure 2b shows a portion of the weld with evidence of lack of fusion. TESCO has identified a single vendor that had provided faulty torque bushing products since 2010. As a field retrofit procedure, TESCO is recommending to grind out the existing welds and replace them with a revised weld. A revised drawing of the front plate (TESCO part number 14728 Rev 9) has been issued to assist in the rework of all existing units.

Figure 1: Overall failure of the extend frame clevises

1. The welds attaching the clevises to the torque bushing front plate (part number 14728) are to be fully ground out and replaced with 3/4" fillet welds under an approved weld procedure for A514 grade material (Quenched and Tempered 100 ksi yield plate) as specified in revision 9 of (part number 14728).
2. Ensure that the rework is performed by a qualified welder using an approved weld procedure specification suitable for A514.

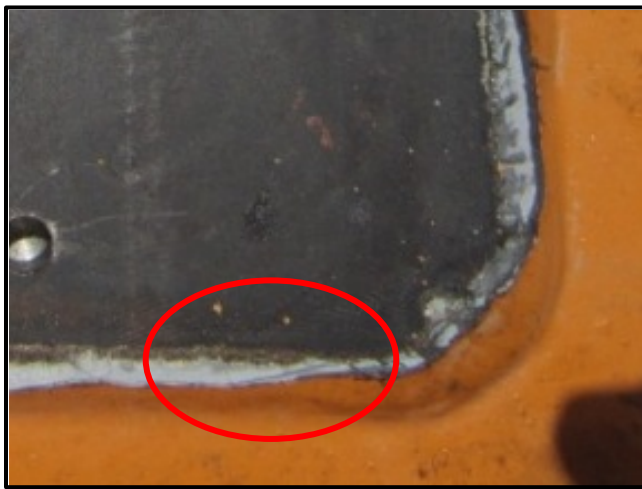
a)

Figure 2: (a) fractured weld, (b) area of weld showing lack of fusion
