Safety Bulletin			  Tesco Corporation 5616 – 80th Avenue SE Calgary, Alberta, Canada T2C 4N5 Tel: 1-877-TESCO-77 (North America) Tel: 1 (713) 359-7195 (AMSS 24-hour support) Tel: 1 (713) 359-7295 (International) Email: bulletins@tescocorp.com www.tescocorp.com www.tescoparts.com
No: SB081	Rev: 0	Date: July 22, 2013	
Weld Failure on F-Clamp Used to Stabilize TESCO Top Drives

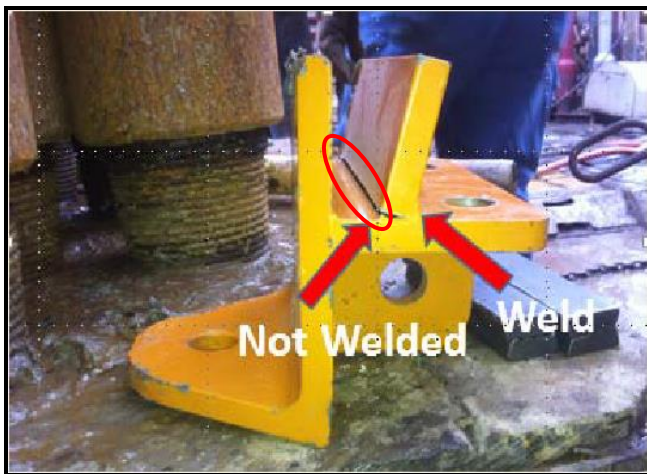
A recent incident occurred where a plate on an F-Clamp (TESCO part number 3888) that stabilizes the torque track in the derrick broke off and fell approximately 60 feet onto the rig floor (Figure 2). No injuries were reported. Upon inspection it was discovered that the F-Clamp had a complete weld on only one side of the plate (Figure 1) where it should have been fully welded on both sides (Figure 4). Because only one side of the plate was welded, the stability of the F-Clamp was compromised during top drive operation, directly resulting in the plate breaking off from the assembly. The welds on the F-Clamp and plate were insufficient and did not conform to the minimum required weld requirements as stated on TESCO's F-Clamp drawing for the torque track (Figure 5).

Figure 1: F-Clamp weld with one side of plate not fully welded

Customers should perform an immediate visual inspection of the F-Clamps and confirm that there is sufficient welds on both sides (Figure 4). Any defective F-Clamps found with insufficient or incomplete welds must be quarantined and fully welded to TESCO requirements (Figure 5) before being put to use.

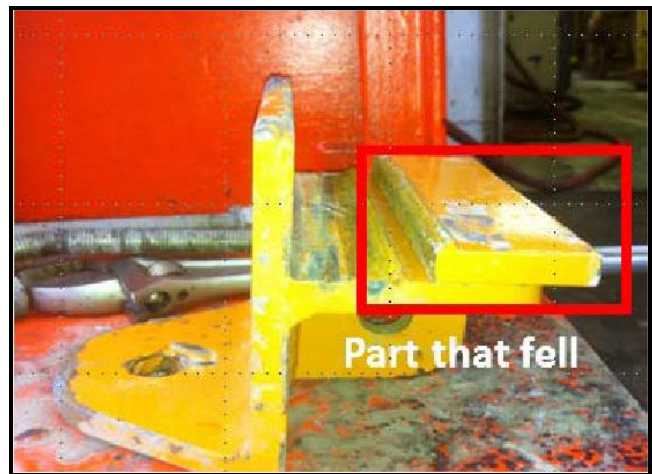
Figure 2: Plate from F-Clamp that fell onto the rig floor

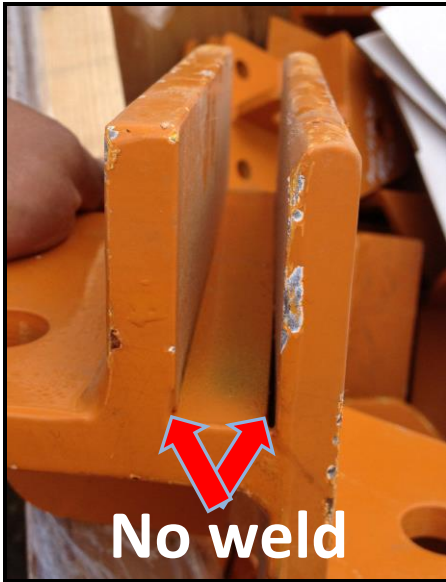
Further investigation revealed that although the F-Clamps underwent the TESCO quality control process for random inspection and passed with no issues found, some of the defective clamps (i.e., with no welds on the inside) may have bypassed inspection and shipped to the customer (see Figure 3).

Figure 3: Welds not present on F-Clamp plate

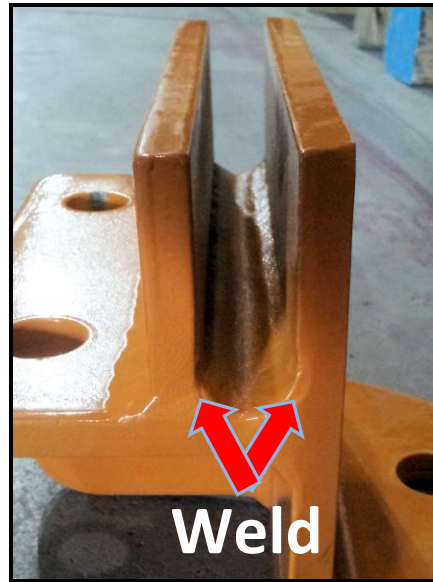
Figure 4: F-Clamp plate is fully welded on both sides

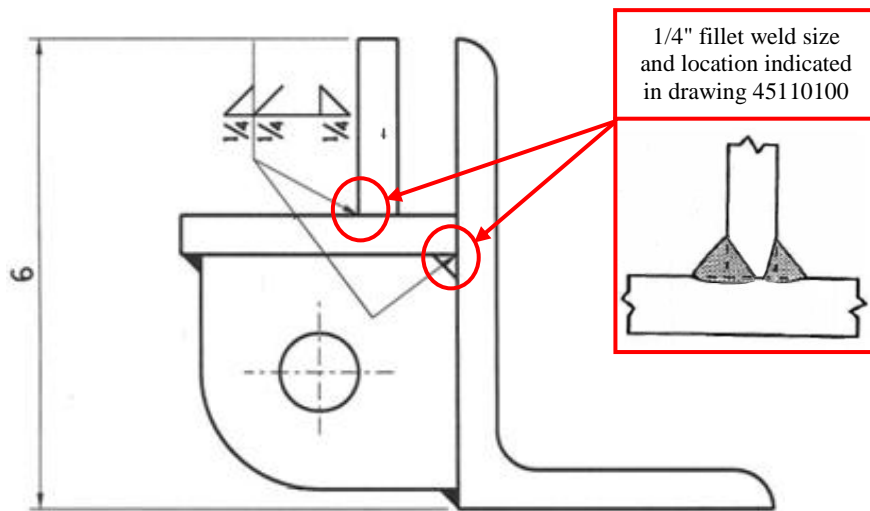
Figure 5: Size of weld on the F-Clamp
