Safety Bulletin			 	Tesco Corporation 5616 – 80th Avenue SE Calgary, Alberta, Canada T2C 4N5 Tel: 1-877-TESCO-77 (North America) Tel: 1 (713) 359-7195 (AMSS 24-hour support) Tel: 1 (713) 359-7295 (International) Email: bulletins@tescocorp.com www.tescocorp.com www.tescoparts.com
No: SB082	Rev: 0	Date: October 04, 2013		
Weld Failure on EMI Guard Hinges

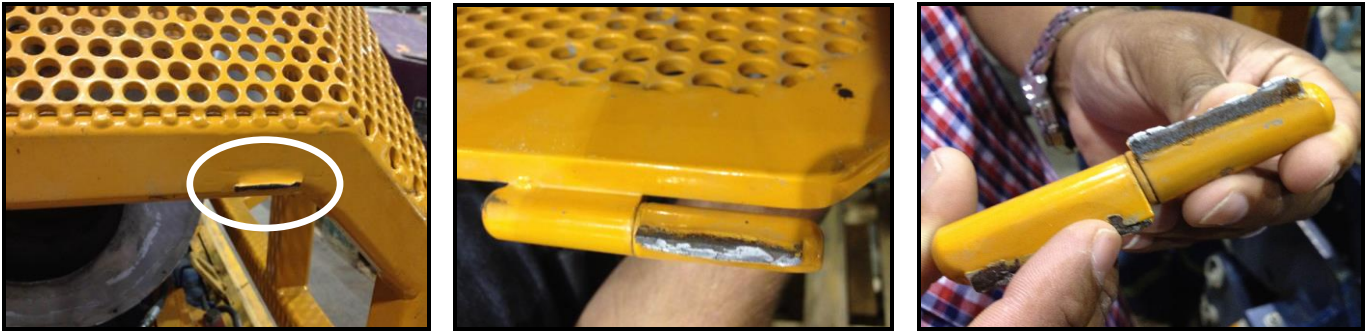
A recent incident occurred where a TESCO EMI Top Drive guard (TESCO part number 960057-1) was being lifted while the top drive was in the cradle and instead of turning, the hinges holding the top door (TESCO part number 920020-1) broke off (Figure 1). One hinge stayed on the guard and the other stayed attached to the top drive's guard frame.

Figure 1: Hinge weld failure on the top door of the EMI guards

TESCO recommends to visually inspect all hinges on all guards to ensure that the welds are present on both sides of the hinges. Any guards where the hinge is welded on only one side (Figure 3) must be re-welded so that both sides of the hinge are welded (i.e., for the top door, between the guard frame and hinge and between the top door frame and hinge), see Figure 4.

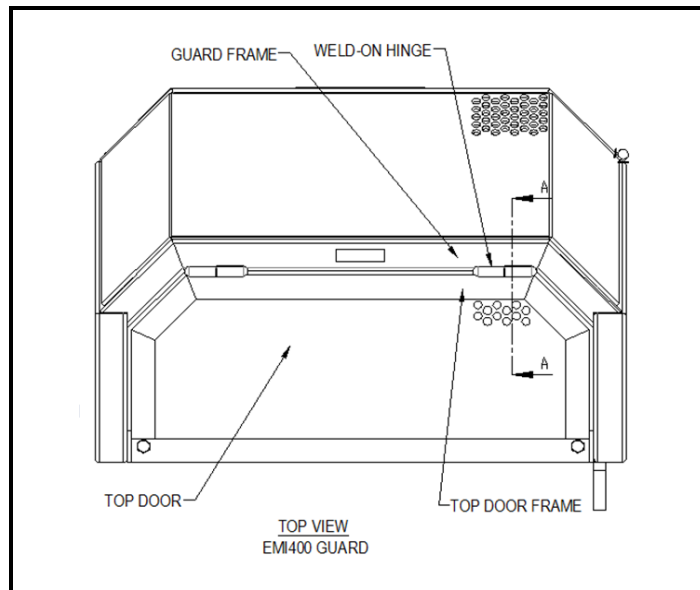
While the lid on the top door is secured by two hinges and two bolts (Figure 2), upon inspection it was discovered that the hinges were welded only on one side and not on the other. Further investigation revealed that although the top door hinges on a majority of the EMI guards are welded on both sides, it was found that some are welded to the frame and door only on one side.

Figure 2: Hinge weld arrangement on some of the existing EMI guards

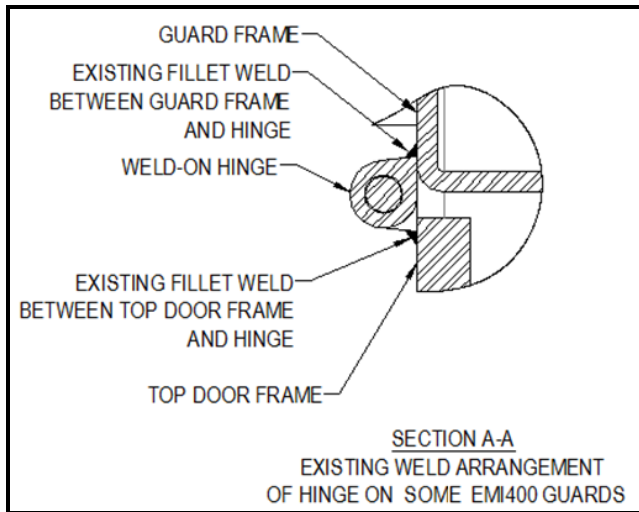
Figure 3: Hinge welded on one side

1. Grind or buff the hinge welding points on the frame guard, top door and hinge to remove any rust and paint up to 0.5" from each side.
2. Clean, degrease and dry the welding surface.
3. Preheat the welding point up to a minimum 100°F. In cases where the welding is multi-pass, the inter-pass temperature must also be a minimum 100°F.
4. Use E7018 electrode for welding. The fillet weld size should be a minimum of 3/16" (Figure 4).
5. Perform a magnetic particle inspection (MPI) to AWSD1.1 cyclically loaded criteria (welder must be qualified to AWSD1.1).

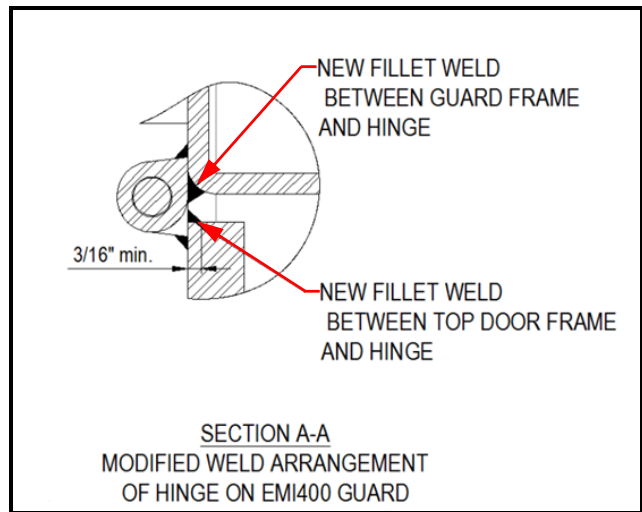
Figure 4: Hinge welded on both sides
