<b>Safety Bulletin</b>

<b>TESCO</b> ®	Tesco Corporation 5616 – 80th Avenue SE Calgary, Alberta, Canada T2C 4N5 Tel: 1-877-TESCO-77 (North America) Tel: 1 (713) 359-7195 (AMSS 24-hour support) Tel: 1 (713) 359-7295 (International) Email: <a href="mailto:bulletins@tescocorp.com">bulletins@tescocorp.com</a> <a href="http://www.tescocorp.com">www.tescocorp.com</a> <a href="http://www.tescoparts.com">www.tescoparts.com</a>
<b>No: SB086</b>	<b>Rev: 0</b>	<b>Date: September 26, 2014</b>		
<b>Dropped Object - Incorrectly Installed Castle Nut on Ward Leonard Motor</b>				
<input checked="" type="checkbox"/> <b>Internal Use Only</b>		<input checked="" type="checkbox"/> <b>External Use</b>	<input checked="" type="checkbox"/> <b>Mandatory</b>	<input type="checkbox"/> <b>Recommended</b>

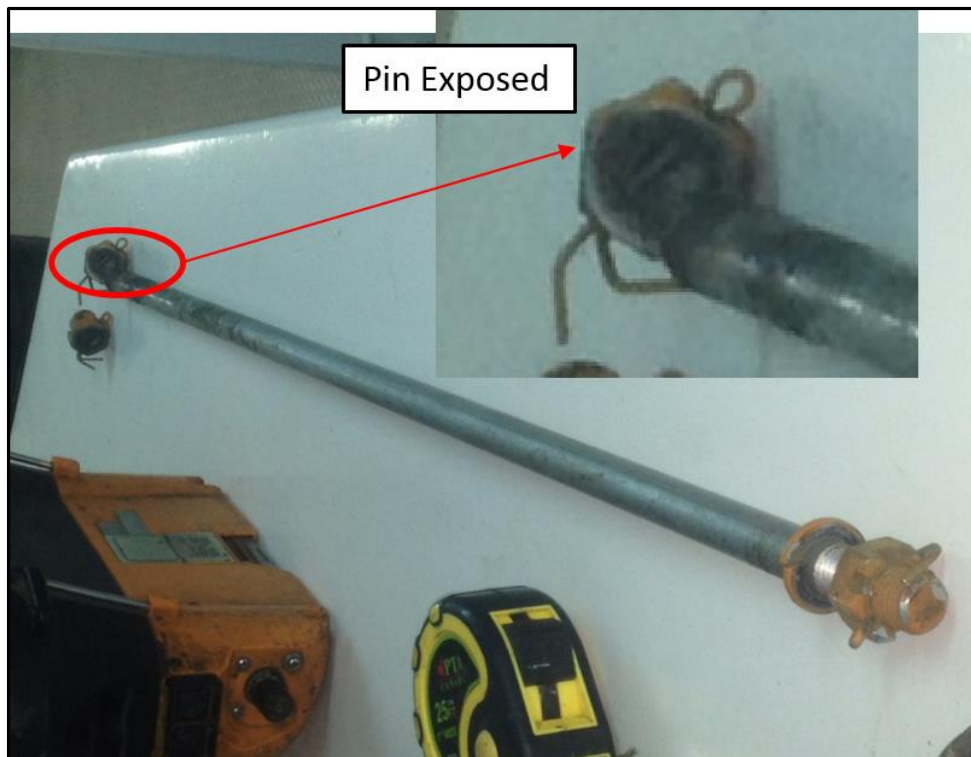
During field operation of a TESCO EXI Top Drive, a dropped object incident occurred where two through-stator studs (Figure 1) had broken on a Ward Leonard motor (840060) and the sheared ends fell to the rig floor. No injuries to personnel were reported, and there have not been any other incidents reported to date.

**Figure 1: Cotter pin exposed after through-stator stud on a Ward Leonard motor broke off**

2. **IMMEDIATELY INSPECT** the castle nut assembly to ensure that it is correctly installed. If it is not installed correctly, stop top drive operation and replace as soon as it is practical. If it is not practical to stop top drive operation, inspect the castle nut assembly every 6 hours for any signs of failure, such as cracks or loose pin connections.
3. When installing a new castle nut assembly, ensure that it is torqued to specification and installed with cotter pins.

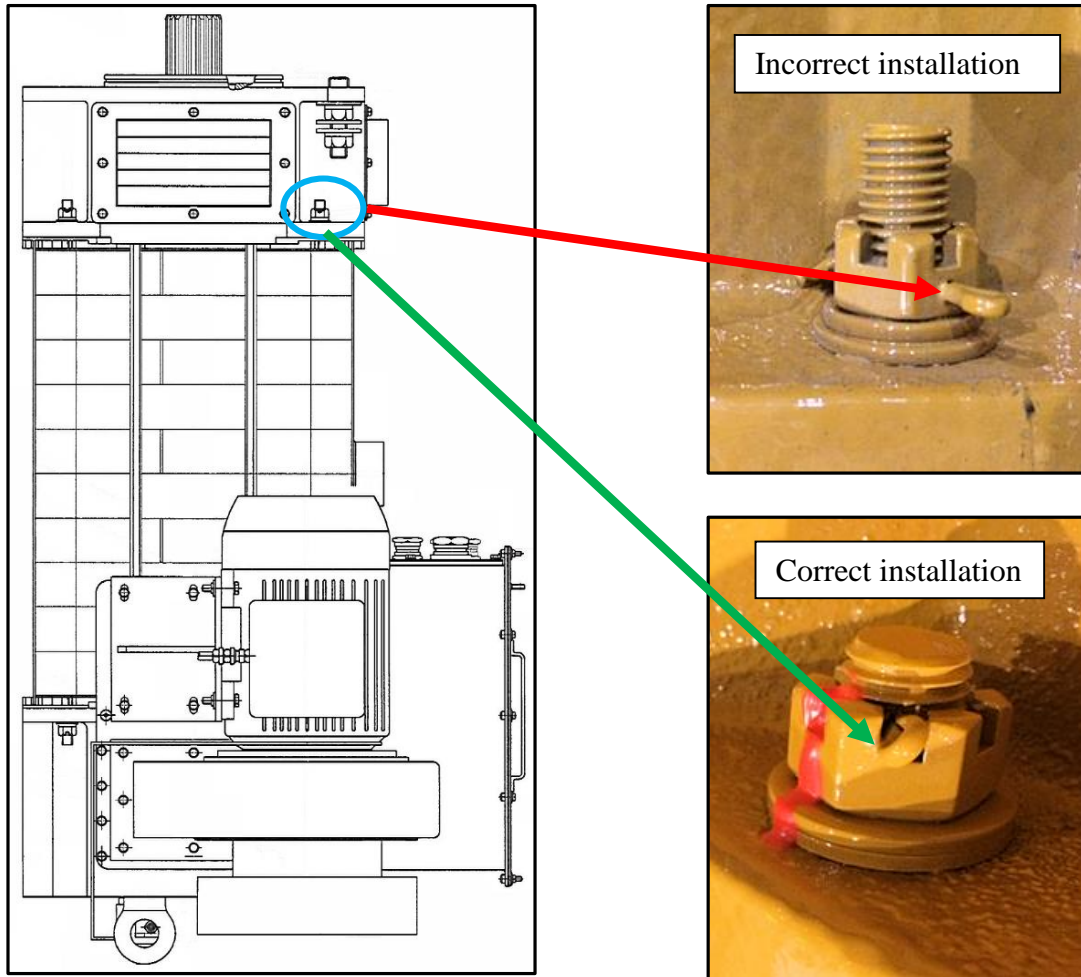
The motor assembly (stator and two ends of the motor) is held together with four through-stator studs secured by castle nuts on each end, using cotter pins for secondary retention (Figure 2). The hole for the cotter pin should normally be drilled through the castellated portion of the nut. In the dropped object incident, it was found that this hole was drilled through the body of the nut and into the stressed portion of the stud.

**Figure 2: Location of castle nut on Ward Leonard motor; incorrect vs correct installation of castle nut**

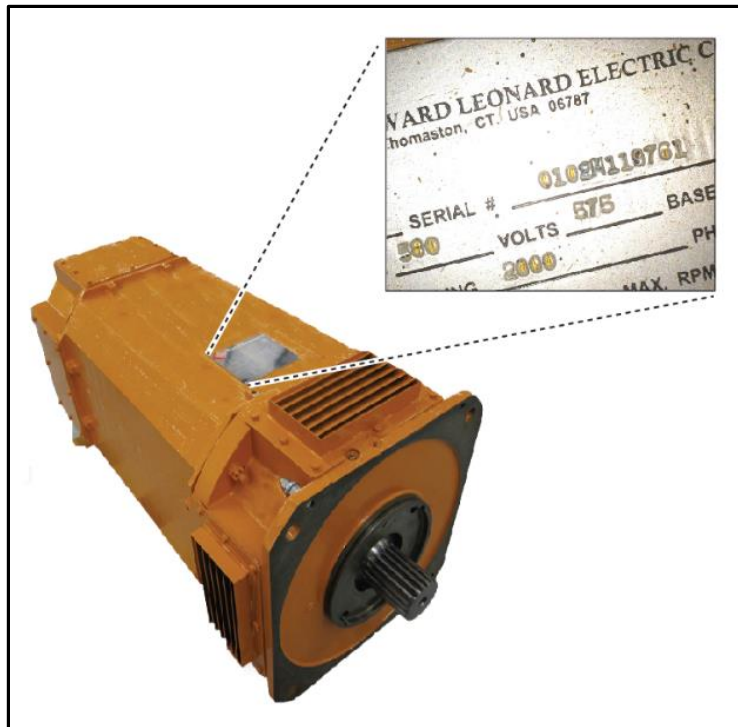
**Figure 3: Ward Leonard nameplate**

1. Find the motor nameplate on the top drive and confirm if the motor is a Ward Leonard motor (Figure 3).
