ATTENTION ALL CUSTOMERS / RENTERS / USERS OF ESI TOP DRIVES

THIS BULLETIN CONTAINS IMPORTANT SAFETY AND TECHNICAL INFORMATION CONCERNING POTENTIAL QUILL FAILURE

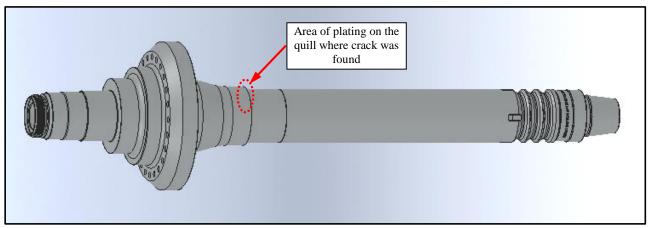
TESCO has confirmed that a quill used in an ESI Top Drive experienced failure. Mud leaked from the quill and seeped into the gearbox, which disrupted operation of the Top Drive. Upon inspection, a small series of cracks were discovered on the quill, originating at or near the boundary of the area where chromium plating had been applied (at the lower radial bearing and seal surface (Figure 1)). It was identified that this plating was used on quills installed on 14 ESI Top Drives. The metallurgical investigation is not yet complete; however, as a precautionary measure, TESCO recommends that the quills of the ESI units be replaced immediately as the area of concern is an essential load path component.

Figure 1: ESI quill with Plating

Only a small number of the ESI quills with plating were found to have structural deficiencies. However, to ensure the safety of customers, TESCO is recalling all affected quills as part of a thorough investigation to determine the full extent of the issue. Therefore, it is specifically recommended that all ESI Top Drive units listed above cease operating immediately. Contact your local TESCO service center for more information on obtaining a replacement quill.
