TECHNICAL BULLETIN TB009

Re: Air Intake-Detroit 12/16 V92 Engines

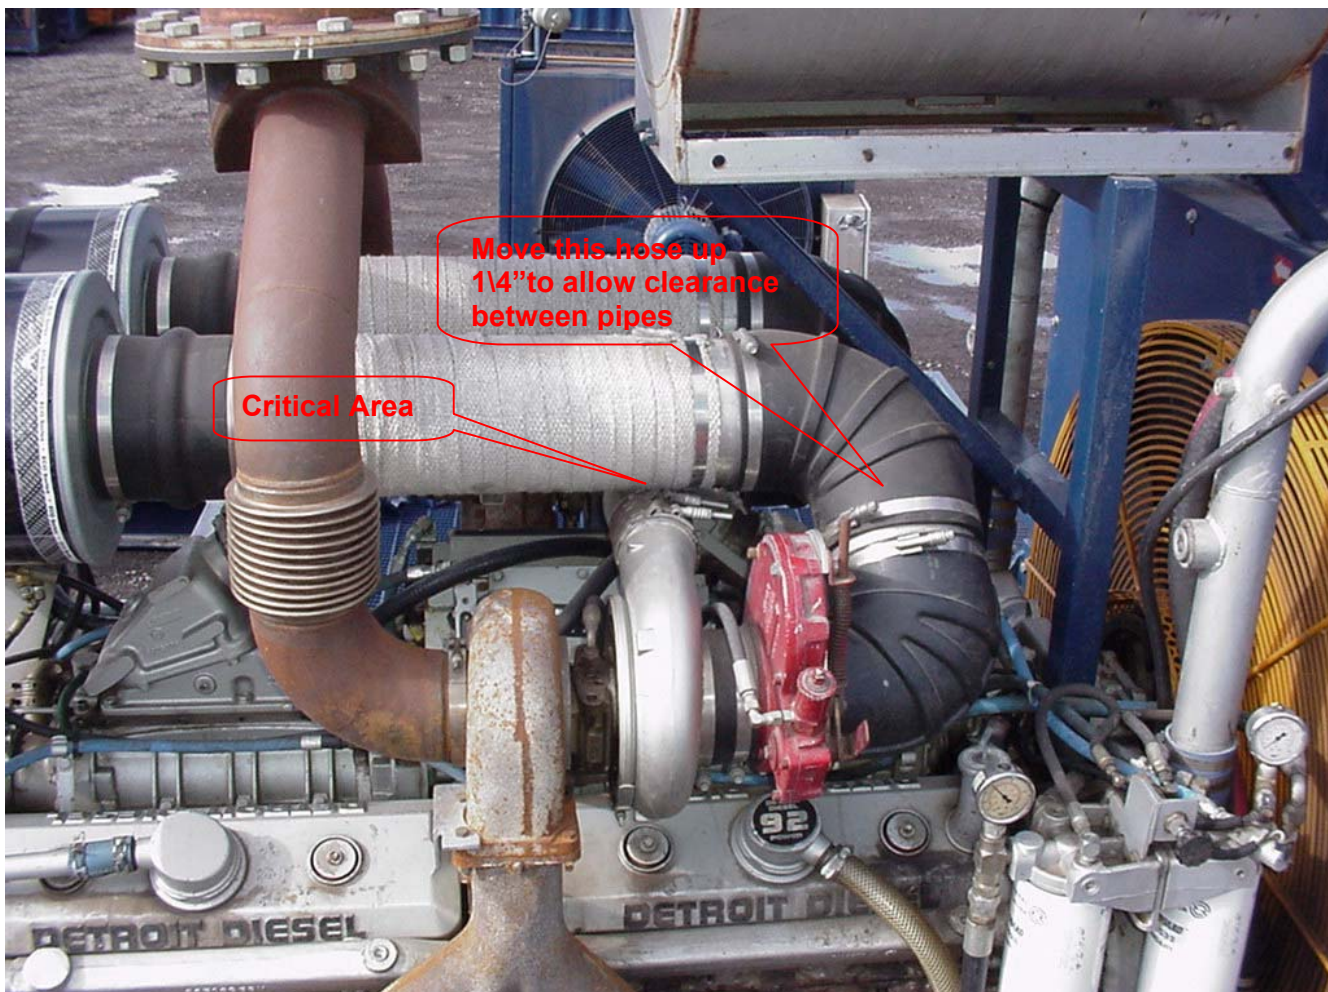
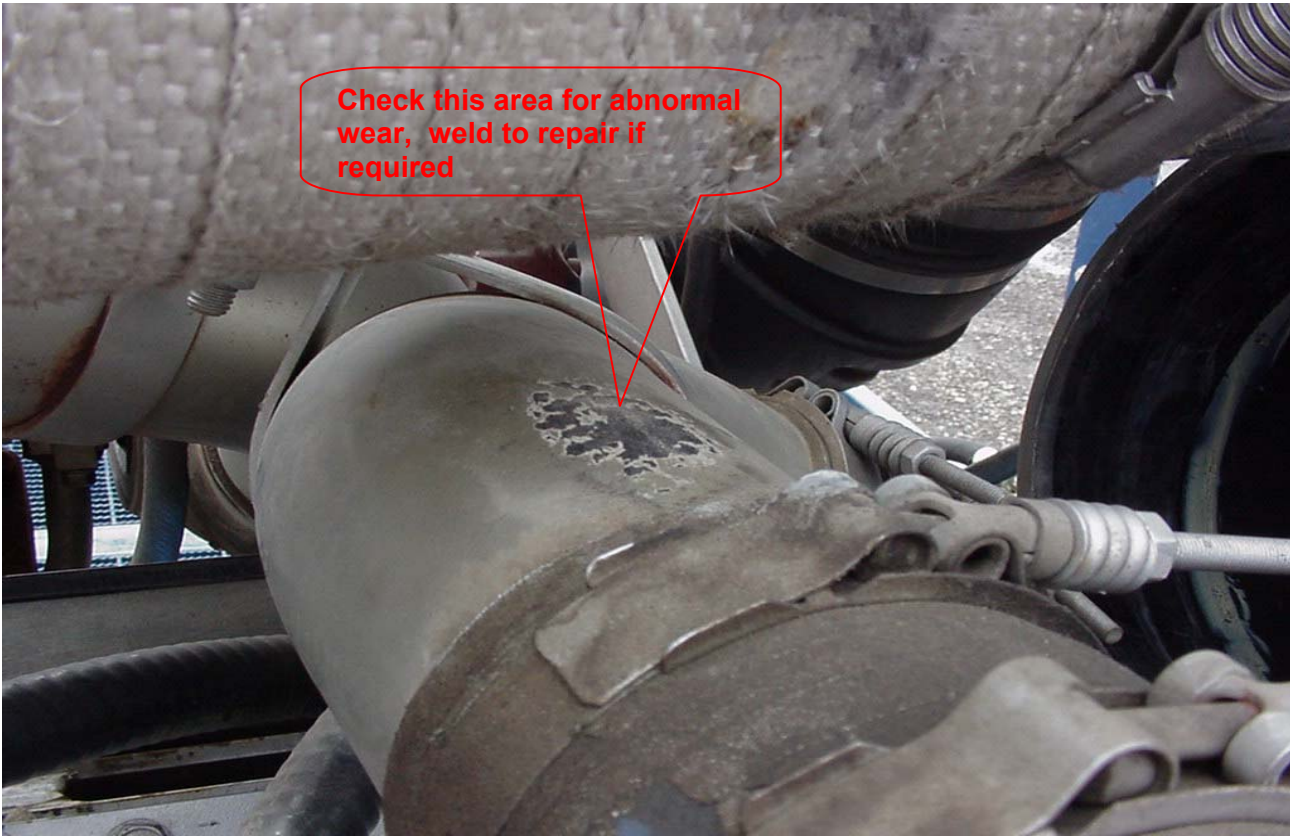
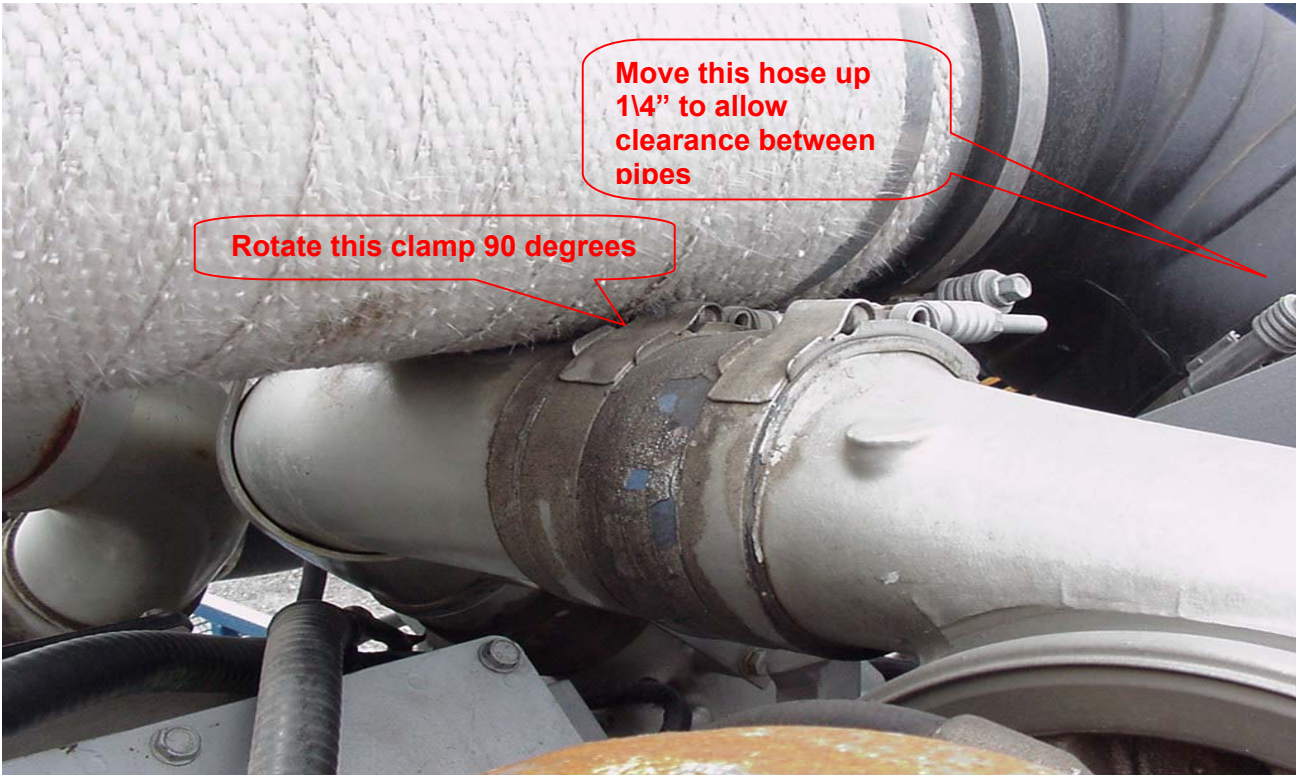
During recent inspections it was noted that abnormal wear was present on the right turbo air inlet pipe on 16V92 engines. In some cases a hole was worn completely through the air inlet pipe causing a critical contamination point. The issue can be addressed by backing off all clamps retaining both the turbo inlet hose and the main intake hose and separating the assemblies before retightening all clamps. The inner turbo intake hose clamp can be rotated 90 degrees to prevent contact with main inlet pipe.
