Technical Bulletin

No: TB046

Date: 31 Oct 2007

Description: Revise EMI / HXI Load Collar To Permit Full Freedom of Movement

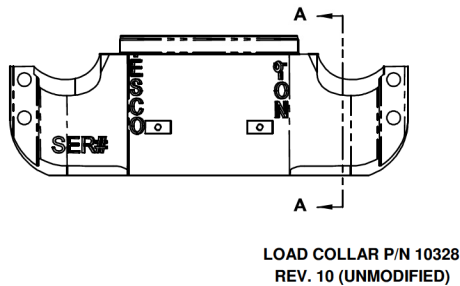
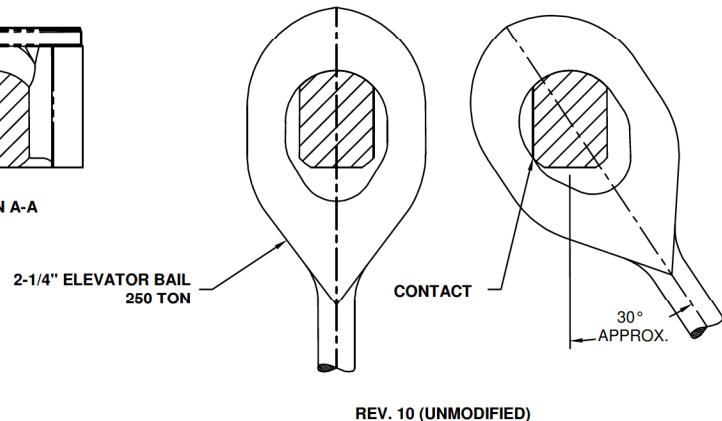
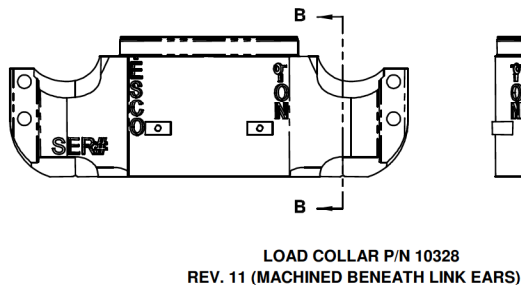
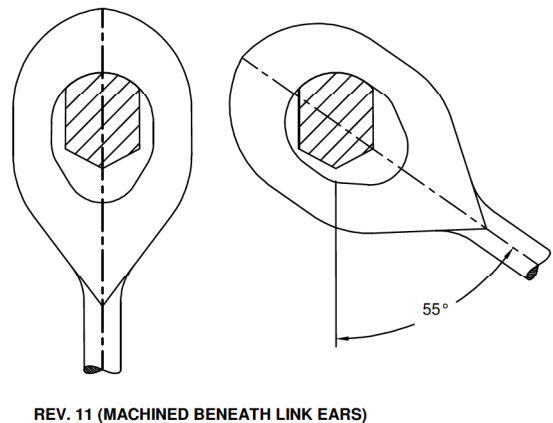
It had been observed in the field that some 250 Ton load collars for TESCO EMI and HXI top drives did not permit the full freedom of movement for the elevator link tilt. Investigation revealed that the cause of the interference was an excess of material beneath the load collar link ears. The correction was to machine away the excess material beneath the load collar link ears; however that created the secondary condition that it was possible for the link tilt cylinders to lift the elevator links until they impacted into the elevator link retainers. Therefore the elevator link retainers were also modified with additional clearance so as to eliminate the possibility of the elevator links ever impacting into the elevator link retainers.
