Technical Bulletin

No: TB063

Description: Spacer/Seal Arrangement EMI 400 (ECN-112-0185)

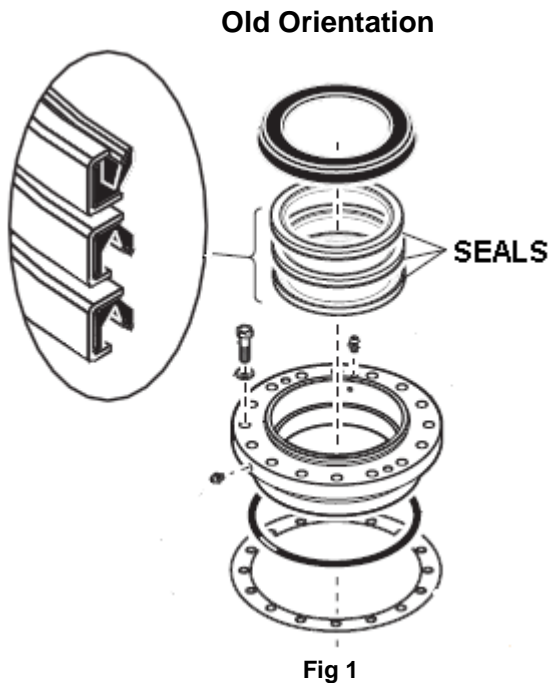
A condition has been identified, where over time the current orientation of the Upper Quill Bearing Seals has led to the seal lips cutting grooves into the Quill. This condition has created a pathway allowing water and dirt to enter the gearbox, leading to the premature wear of internal components such as gears and bearings.

- New seals should be installed with the revised seal orientation, top two seals facing upward and the bottom seal facing downward as per illustration I-720752 or I-1130110 or I-1130111 (see figs 1 & 2 for old and new orientation)
- If the grooves in the quill are deeper than 0.003" then a spacer, TESCO Part Number 1410108 – Spacer, Seal 150T & 250T, should be placed between the upper 2 seals lips to run on full dimensioned areas of the quill (see fig 3 for spacer dimensions)

New seals should be installed with the revised seal orientation, top two seals facing upward and the bottom seal facing downward as per applicable illustration: I-720752, I-1130110 or I-1130111 (see figs 1 & 2 for old and new orientation)
