# Technical Bulletin

No: TB067

## Description: H&P Specific 150/250-EMI-400 Split Block Spreader and Support

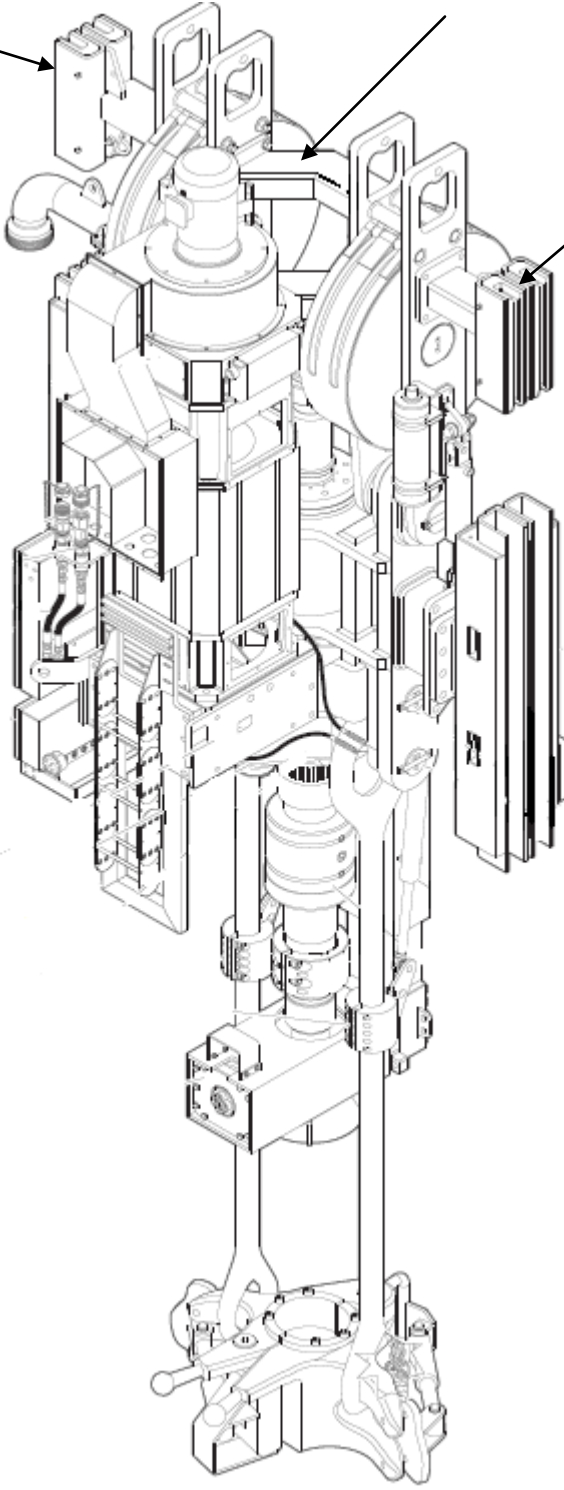
**Figure 1 – 150T EMI 400**

A number of H&P specific 150 and 250 Ton EMI 400 split block assemblies were inspected and indications of cracks were found in the spreader bar and block guide welds (see Figures 1 and 2 for identification of affected parts). TESCO has reviewed the design and introduced a number of changes to improve the function of the affected parts; these include welding process changes for full penetration welds, the addition of radiographic and/or ultrasonic inspection of full penetration welds, changes to some of the fillet welds to make them full penetration welds and the addition of Wet Fluorescent Magnetic Particle Inspection (WFMPI) to all welds on these components. TESCO will provide replacements for the affected components.

#### H&P Specific 150-EMI-400 (Figure 1)

TESCO Part Number	Description
810205	Spreader, Machined, Split Block, 150T, EMI 400
810228	Support, Split Block, 150T, EMI 400

810228  
Support, Split  
Block, 150T,  
EMI 400

810205  
Spreader, Split Block,  
150T, EMI 400,

Please contact your local TESCO representative to obtain replacement parts. In the event that a replacement cannot be implemented immediately, TESCO recommends that the inspection interval for these components be shortened to 60 days from the current 250 day cycle until the component can be replaced and/or a safety cable be fitted to prevent a dropped object incident in the event of a failure.

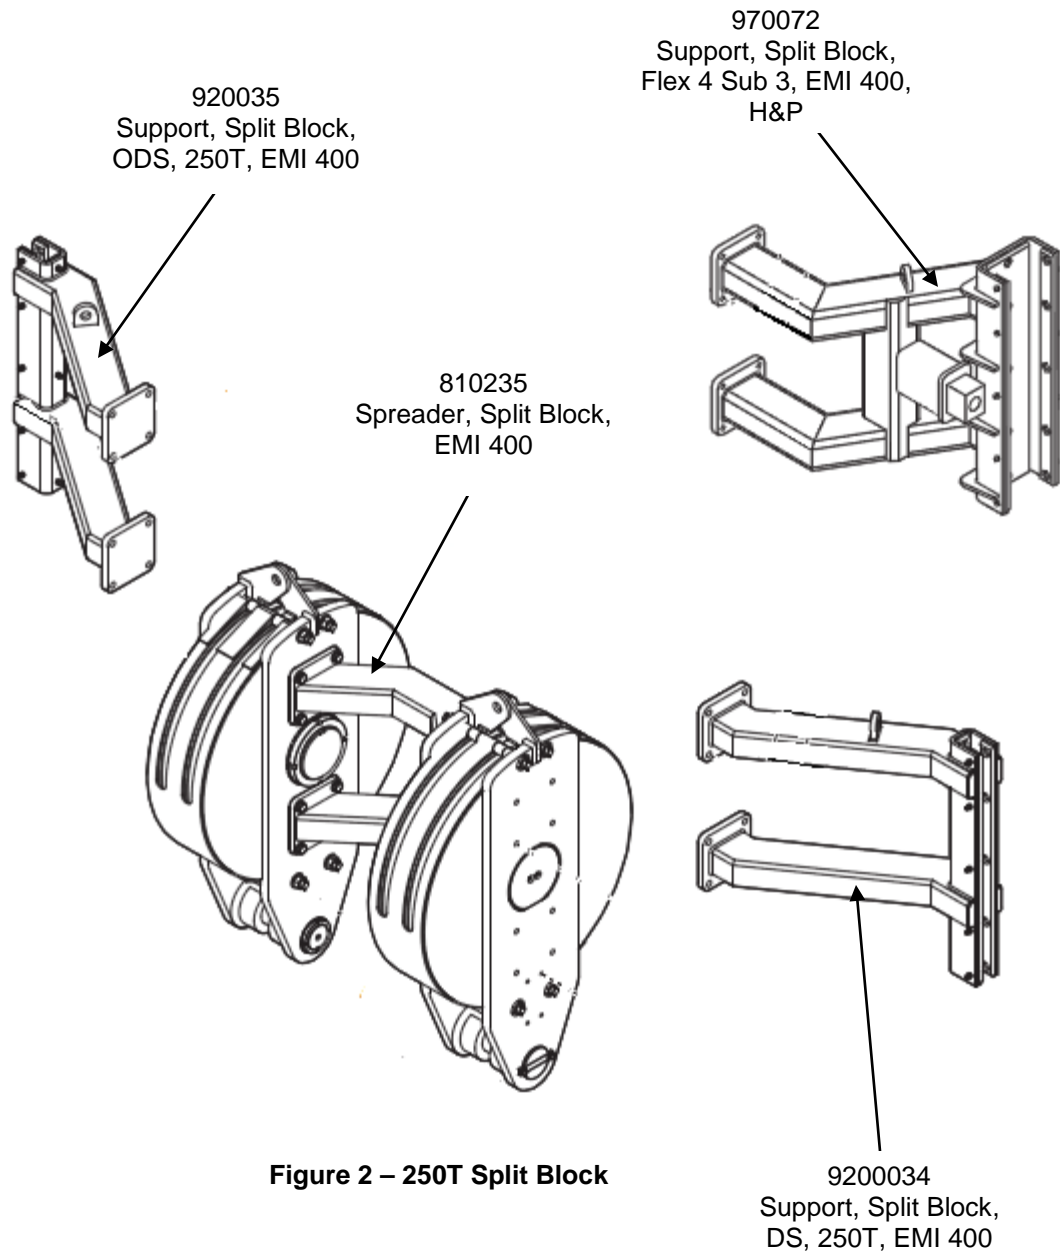
**Figure 2 – 250T Split Block**

#### H&P Specific 250-EMI-400 (Figure 2)

TESCO Part Number	Description
810235	Split Block Assembly, 250EMI400, H&P
920034 & 920035	Support, Split Block 250T, EMI 400 (DS&ODS)
970072	Support, Split Block, Flex 4 Sub 3, EMI 400, H&P
