Technical Bulletin

No: TB069

Description: Torque Bushing Clevis Weld Interference (ECN-168-0006)

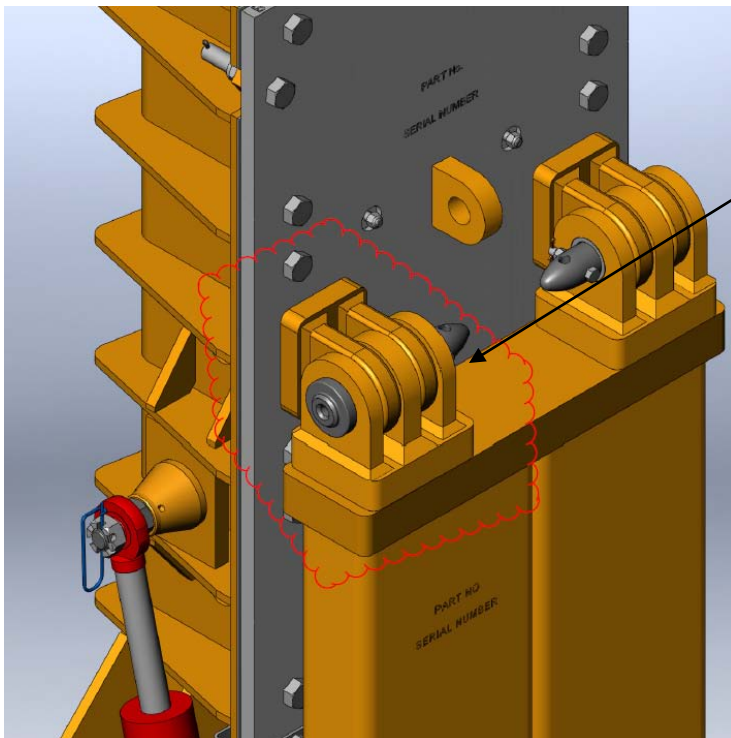
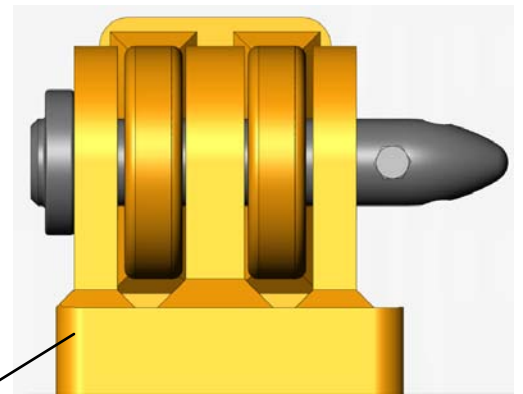
Figure 1

An interference problem has been identified during the manufacturing of Top Drive Torque Bushings. Weld interference is being caused due to the manufacturing tolerances of the following mating parts (See figs 1 & 2):

1. P/N 7750 – 'Clevis, Upper, Torque, Bush, HCI' – Dwg # 40000121
2. P/N 3941 - 'Clevis, Lower, Extend Frame – Dwg # 43030314
