Technical Bulletin

Tesco Corporation 5616 – 80th Avenue SE Calgary, Alberta, Canada T2C 4N5 Tel: 1-877-TESCO-77 (North America) Tel: 1 (713) 359-7195 (AMSS 24-hour support) Tel: 1 (713) 359-7295 (International) Email: bulletins@Tescocorp.com www.Tescocorp.com	
No: TB104	Rev: 0	Date: February 25, 2016		
Failure of 8x12" Torque Track Connector Pin

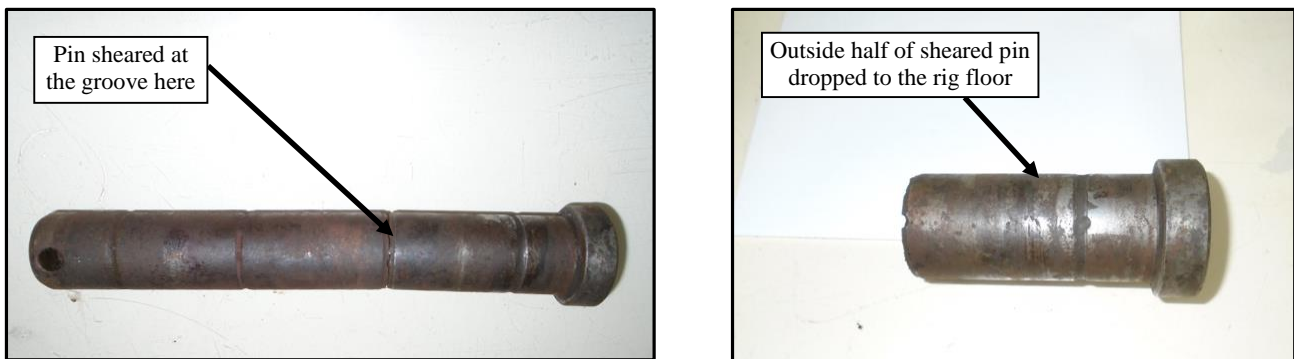
Figure 1: 8x12" torque track connector pin sheared at the second groove closest to the pin head

While drilling a 28" surface hole section, prolonged vibration caused the connector pin (13902) of a second section of torque track to shear at the second groove closest to the pin head. One piece of the pin weighing 2.2 lb. (1 kg) fell onto rig floor near the rotary table from a height of approximately 20 ft. (6.1 m). The other half of the pin remained secured in the torque track dual-pin connector.

No injuries to personnel or additional damage to equipment were reported. This was an isolated occurrence from a single customer, and there have not been any other incidents reported to date. Upon further investigation, it was revealed that the standard weekly maintenance schedule of inspecting torque track pin connections may not have been routinely followed, which could have contributed to the pin's gradual loss of structural integrity that resulted in it shearing.

If connector pins are showing excess wear, they must be replaced immediately. Any other components that are found to have excessive wear or indications of cracking must be replaced or repaired at the earliest convenience to maintain the integrity of the torque arrest system.

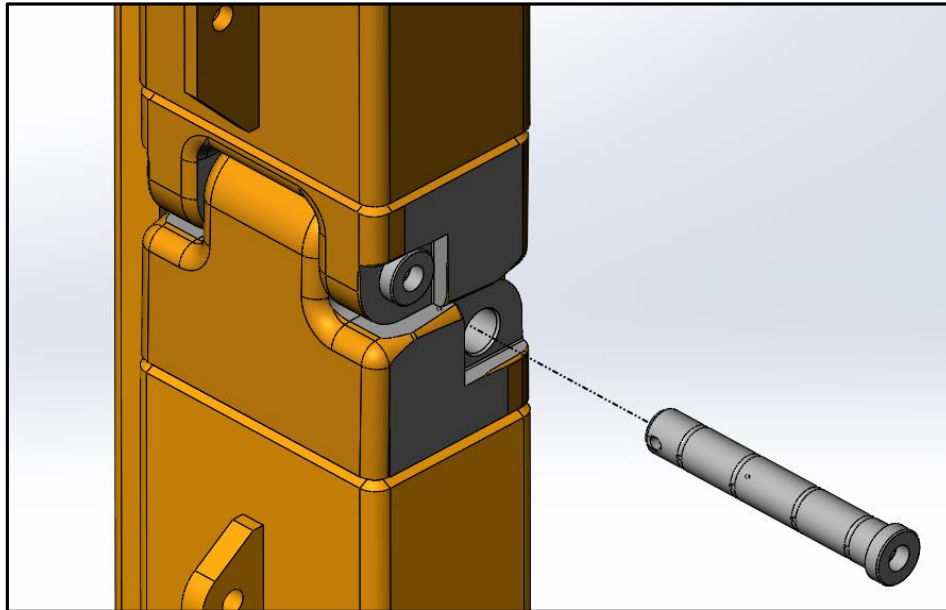
All 8x12" torque track connector pins (13902) used on Tesco ESI Top Drives (Figure 2).

Figure 2: 8x12" torque track connector pins
