Technical Bulletin			Tesco Corporation 5616 – 80th Avenue SE		
No: TB121	Rev: 0	Date: November 03, 2017		Calgary, Alberta, Canada T2C 4N5 Tel: 1-877-TESCO-77 (North America)	
New Elevator Link Retainer Design Reduces Risk of Premature Wear and Failure			Tel: 1 (713) 359-7195 (AMSS 24-hour support) Tel: 1 (713) 359-7295 (International) Email: bulletins@tescocorp.com www.tescocorp.com www.tescocorp.com		
☐ Internal U	se Only	☑ External Use	☐ Mandator	y 🗹 Recommended

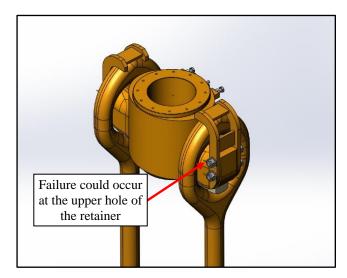
A potential exists where the current elevator link retainer (PN 810396) on the Tesco ESI Top Drive may allow the link's upper eye to come in contact with the curved area of the retainer while the hydraulic cylinder retracts during tripping operations. This could lead to premature wear and/or eventual permanent deformation/failure of the retainer.

Figure 1: Current elevator link retainer (left), new elevator link retainer (right)

Inspect the current retainer for any wear and sign of permanent deformation. If the vertical bars of the retainer are bent, stop top drive operations as soon as it is practical. Tesco personnel can assist in identifying acceptable wear limits. Tesco customers operating ESI Top Drives are encouraged to upgrade their units to the new elevator link retainer design if there is visual confirmation of excessive wear and deformation.

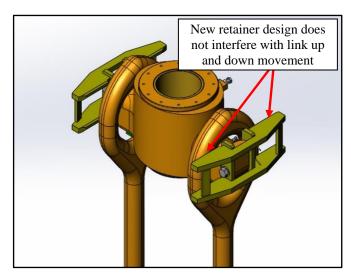
As part of Tesco's commitment to continuous design improvement, a new elevator link retainer (PN 5064367) has been developed that will substantially reduce the risk of premature wear and failure by eliminating the risk of the link applying direct axial force to the retainer.

Contact your local Tesco representative for more information regarding the new elevator link retainer upgrade kit.
