Model: TM-100

Product Bulletin # TM-032 Rev 1

TM-100 Pressure Transducer Mounting Support

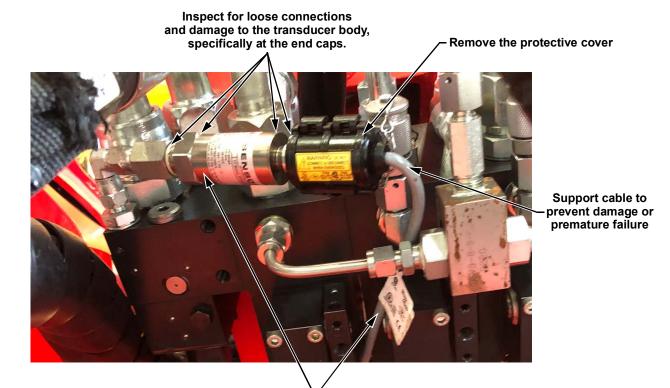
Figure 1: TM-100 Pressure Transducer

The mounting configuration of pressure transducers was recently changed on the TM-100. It has become apparent that this mounting configuration is causing transducers to fail due to excessive vibration loads reacting on the cables in the manner of which the transducers are mounted.

Weight of cable over time, can cause transducer to break.

Figure 1 shows the System Pressure transducer, please note that all pressure transducers on the TM-100 need to be inspected and supported.

- Inspect all transducers for signs of damage at the connections as well as along the body of the transducer itself, especially at the end caps of the transducer.
- Ensure the weight of the cable at connection of transducer is supported as to not put undue weight onto the end of the transducer.
- Remove the protective cover over the M12 connector to reduce stresses on the connection.

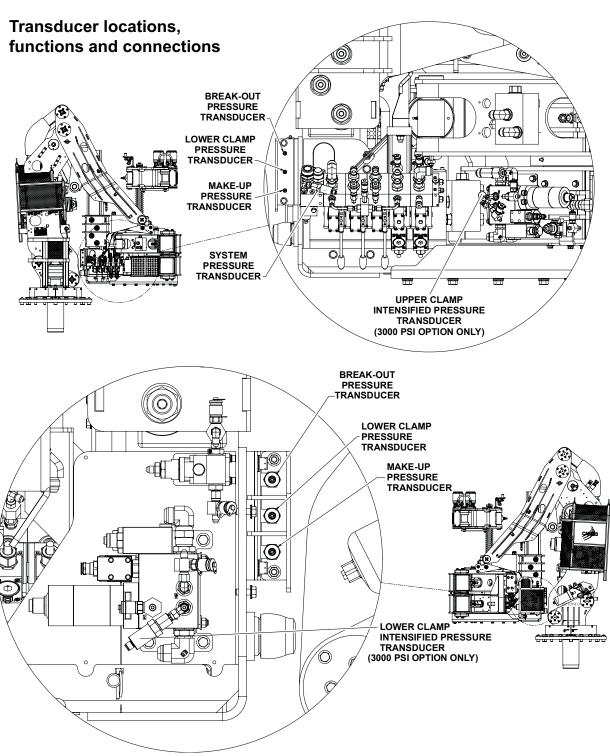
Figure 2: TM-100 Pressure Transducer Map

- TM-100, 3,000 psi 6x Pressure transducers total
- TM-100, 5,000 psi 4x Pressure transducers total

See Figure 2 on page 3 for pressure transducer locations on the Wrench.
