Model: See Affected Units	Mar. 18, 2025
Serial #: N/A	
Product Bulletin # TDS-264 Rev 1

Sigma BUW Inner Tube Upper Wear Pad Improvement

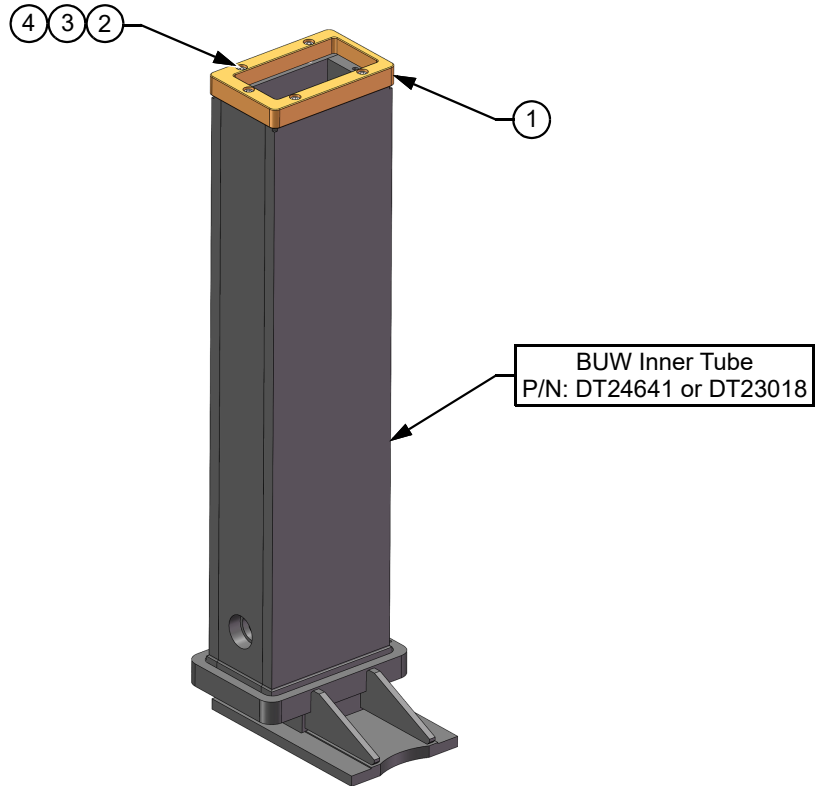
Figure 1: Modification Kit (AY26054)

On the Sigma 500-ton top drive, the fasteners of the Back-up Wrench (BUW) position wear pad are exposed to contact with the mechanical stop pin during operation. Over time, this may cause the fasteners to break and damage the threads of the BUW inner tube.

1. Contact parts.sales@canrig.com to order the new wear pad modification kit AY26054.

3. Install the wear pad DT27313 and fasteners per modification kit AY26054 in Figure 1 on page 2. Ensure the fasteners are torqued to 96 ft-lb and that Loctite is applied.
