Product Bulletin # PC-057 Rev 1

## Power Catwalk Carrier Beckhoff J-Box Issue

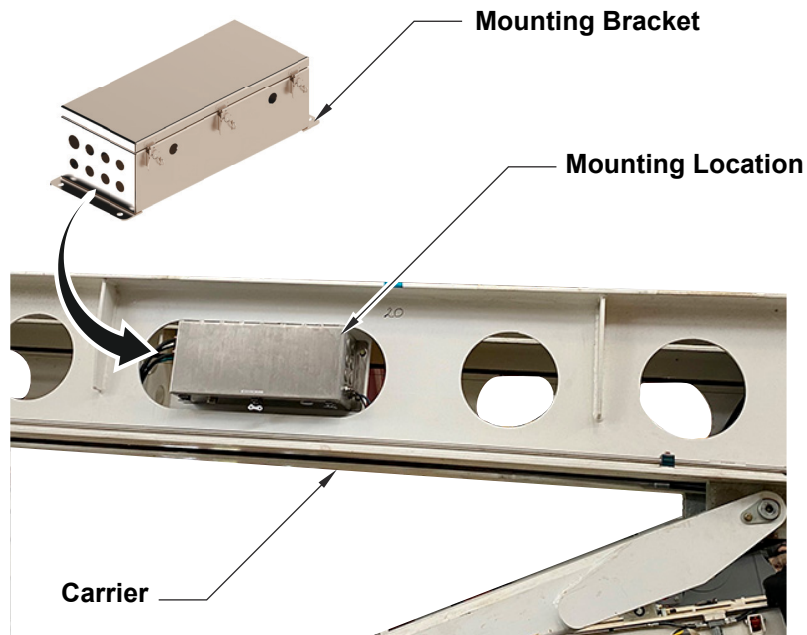
Figure 1: J-Box with mounting brackets

Canrig was notified of an incident in which the Carrier's Beckhoff Input/Output junction box broke off the mounting brackets and got caught between the carrier and the skid, destroying the box and its components.
