Safety Bulletin

<p>Tesco Corporation 6204 – 6A Street SE Calgary, AB. T2H 2B7 Phone: (403) 692 5700 www.tescocorp.com</p>
No: SB038	Rev: 0	Date: 23 Jan 2009	
Description: 10 Station Manifold Enclosure on 150 EMI 400 and 250 EMI 400 Top Drive

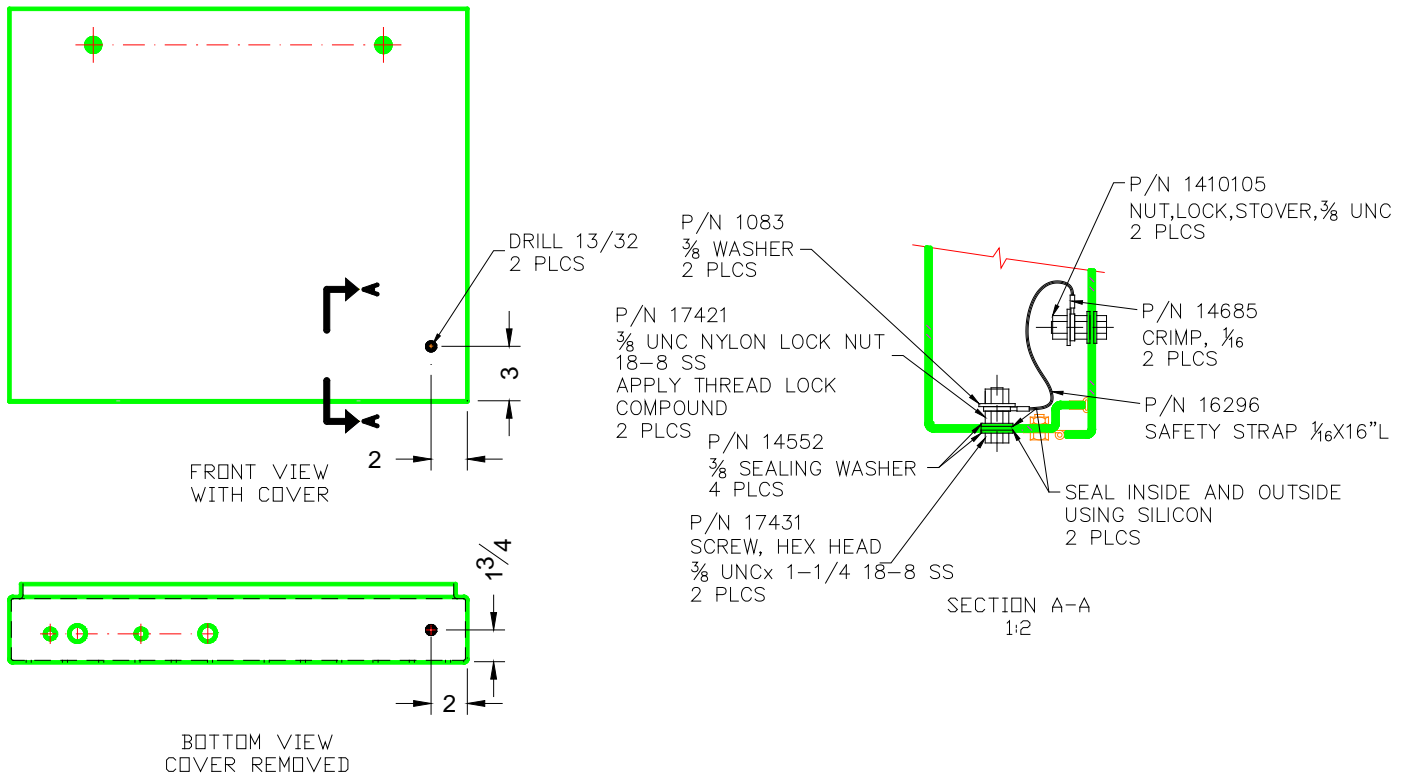
Figure 1

2. Drill 13/32” holes at specified location as shown in Figure 1.
3. Install hardware and seal holes with silicone sealant as shown in Figure 1.

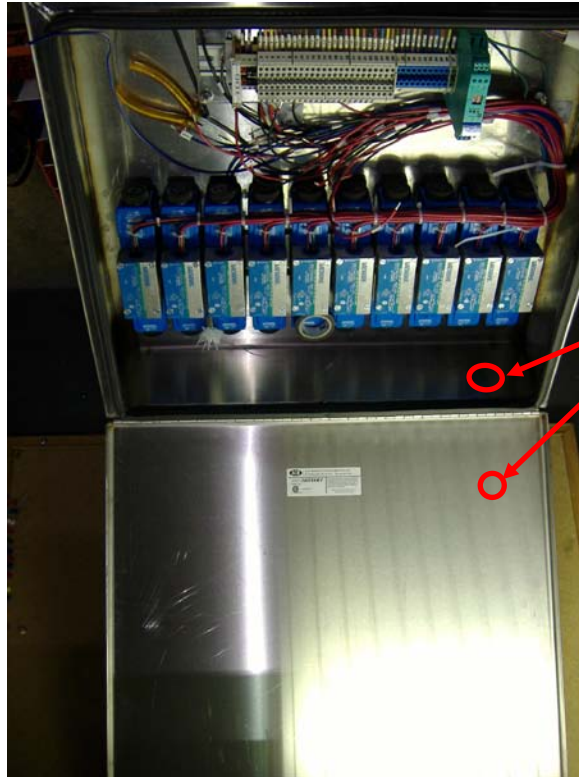
DRILL
HOLES
2 PLCS

Figure 2 shows location of drilled holes.

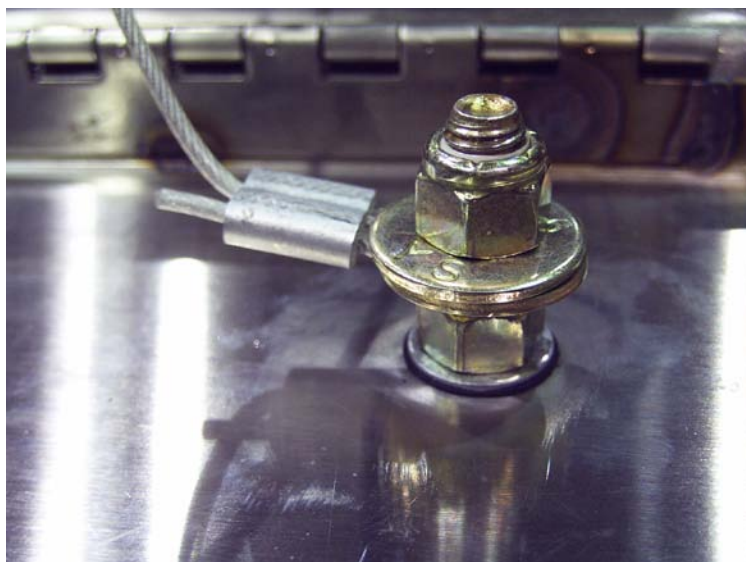
Figure 3 shows detail of assembled parts on bolt.

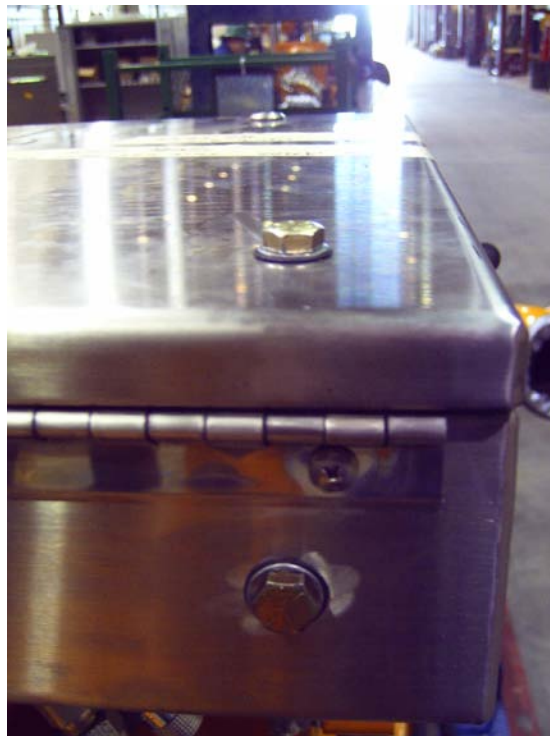
Figure 4 shows outside of enclosure after assembling.

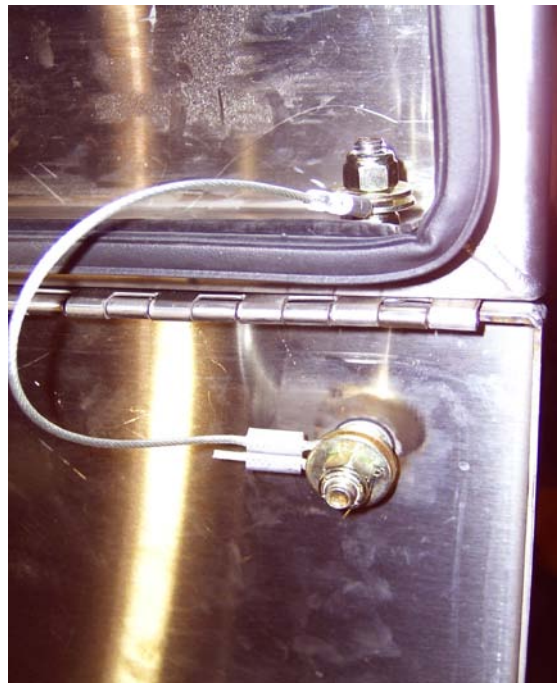
Figure 5 shows inside of enclosure after assembling.
