# Safety Bulletin

No: SB051

## Tesco Hydraulic Cylinders

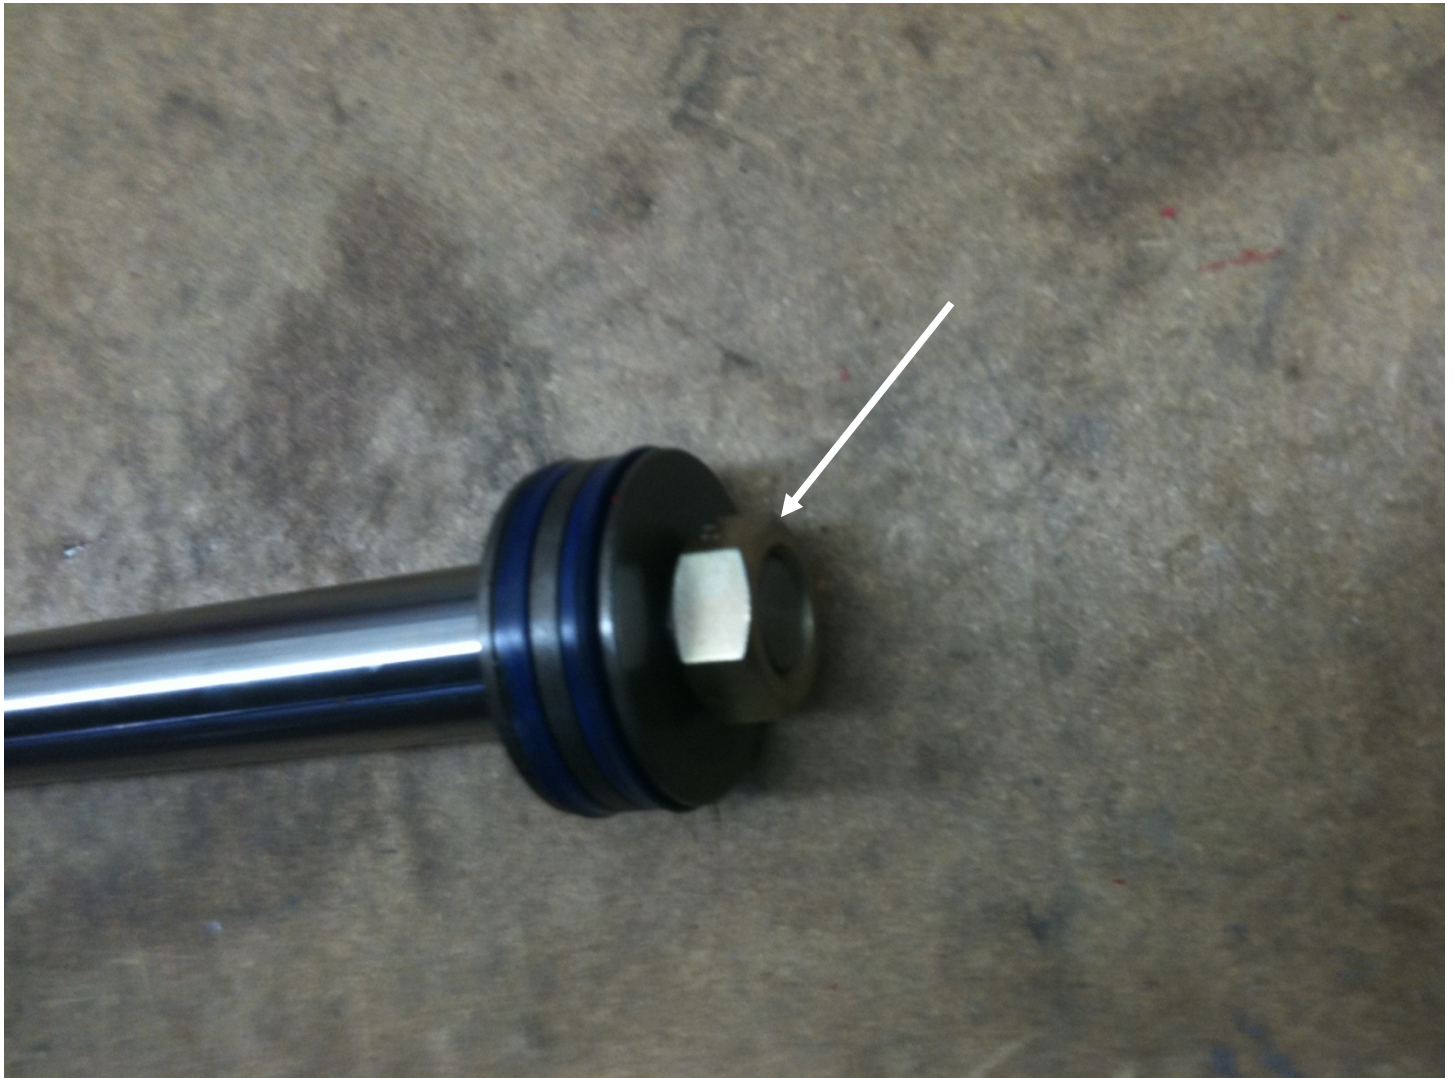
During a recent investigation into failed hydraulic cylinders Tesco has discovered a number of cylinders do not conform to desired specification. The fasteners holding the cylinder piston to the rod were not the locking Stover<sup>®</sup> type used by Tesco (Figure 1). This may allow the nut to separate from the cylinder rod during normal use allowing the cylinder rod end to part from the cylinder piston.

Figure 1: Cylinder rod end without locking Stover<sup>®</sup> nut

Tesco has identified that should the locking nut become loose, it may allow the cylinder rod end to part from the cylinder piston, posing a risk of falling objects. The following precautions should be taken during operation and/or while servicing the affected cylinders.

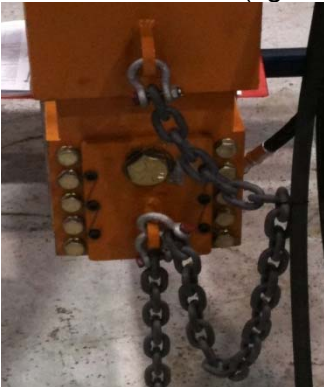
Figure 2: Grabber leg safety chain

- 1) Ensure the grabber leg safety chain is in place at all times and is securely attached to the lower grabber leg assembly as per OEM specifications using 3/8" GR80 chain and 3/8" 1Ton G-2130 shackles (Figure 2). The cylinder should be inspected to verify the manufacturing number in accordance with the instructions below (figure 3 & 4).

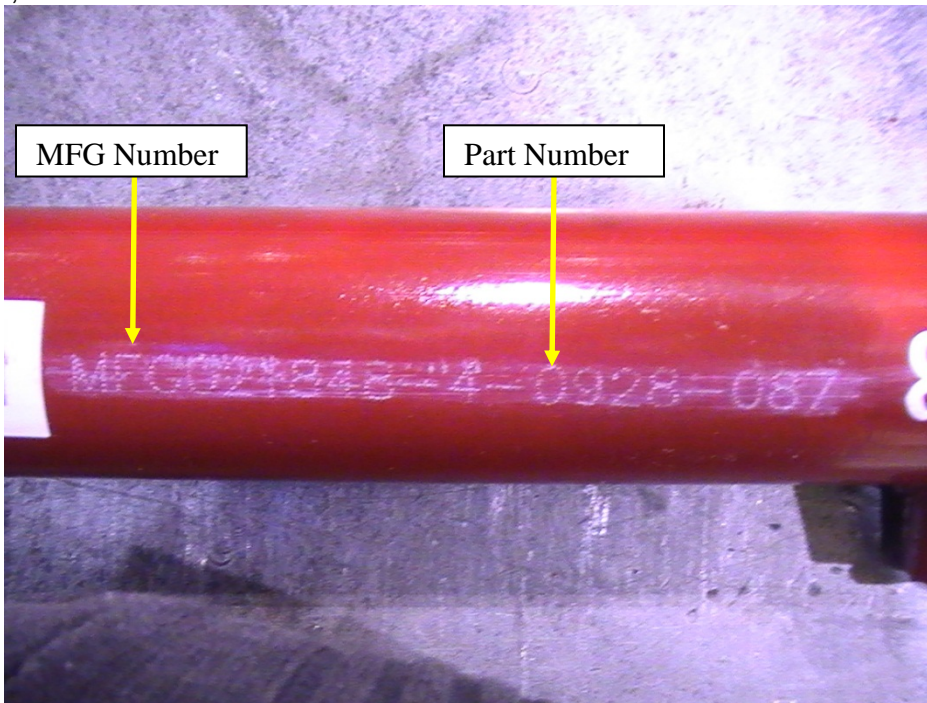
Figure 3: Manufacturer number and part number shown on cylinder piston

- 1) Visually inspect all other cylinders listed and locate manufacturer number (Figure 3 & 4).
- 2) Use caution when servicing cylinders on the top drive that match the manufacturer numbers identified below.
- 3) Secure both ends of cylinder prior to removing from anchor point on top drive to prevent objects falling to rig floor should the cylinder rod part from the cylinder piston.

Please review figure 3 & 4 below to understand the label and markings that must be identified.

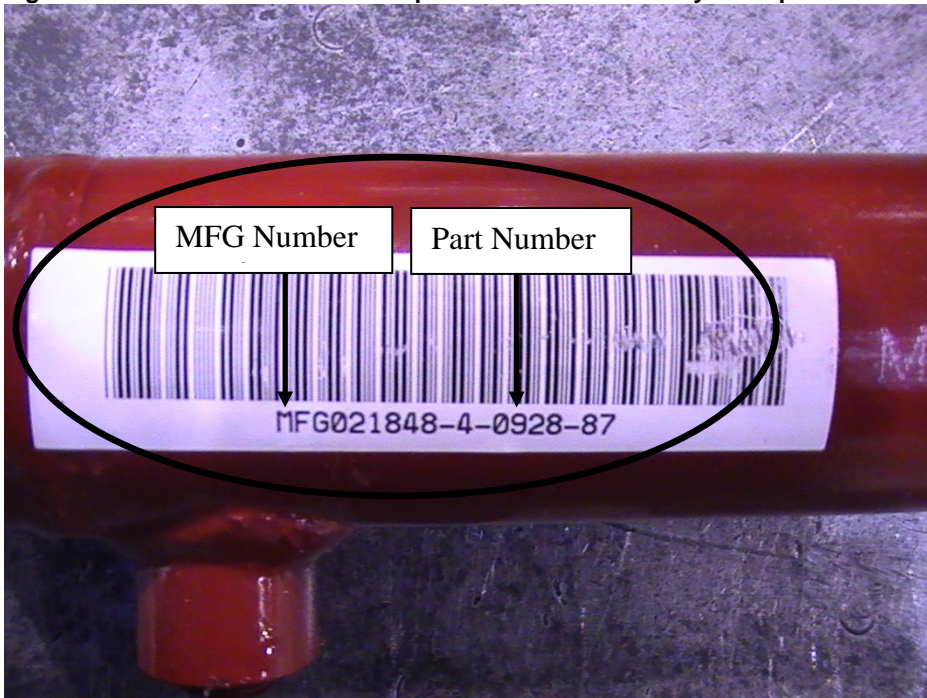
Figure 4: Manufacturer number and part number shown on cylinder piston
