Safety Alert

SUBJECT: Torque Guide – Casing Entrapment

SERIAL NUMBERS: All Portable Torque Guides on TD serial numbers below 270

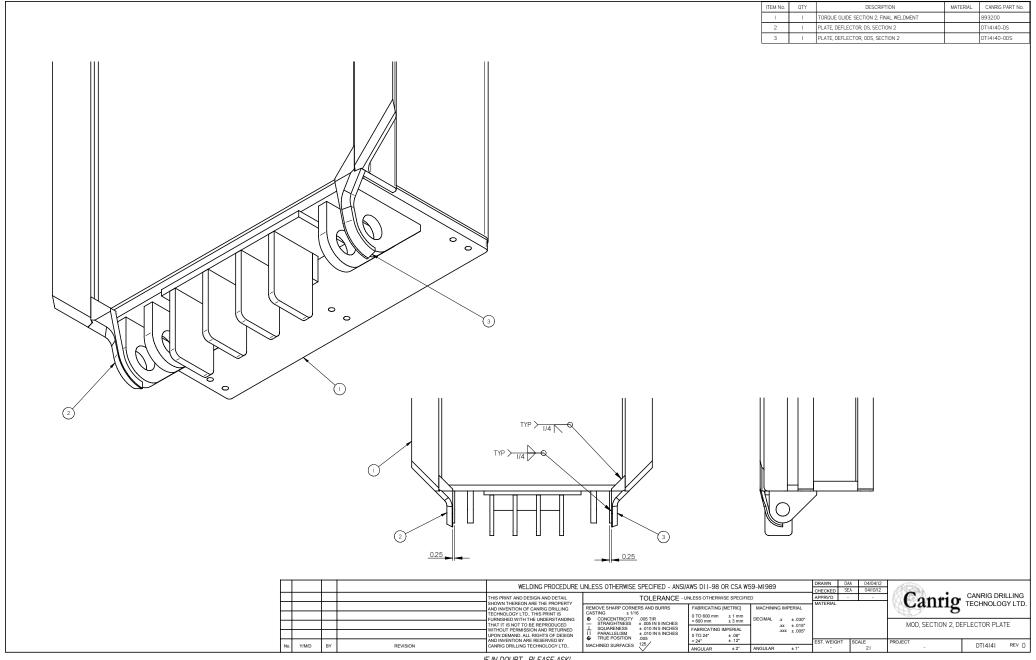
DISCUSSION: When running casing, angles on the Torque Guide Section 2 can be a snag

hazard if using a pick-up/lay down machine to push the casing.

RECOMMENDATION: The angles can be trimmed back approximately ½ inch to be flush or
